RADIOLOGIC AND ENGINEERING ASSESSMENT

DOE ID NO.: GJ-04153-RS
ADDRESS: 1630 NORTH 17TH STREET

AUGUST 1985

BENJIX FIELD ENGINEERING CORPORATION
P.O. Box 1569
Grand Junction, Colorado 81502

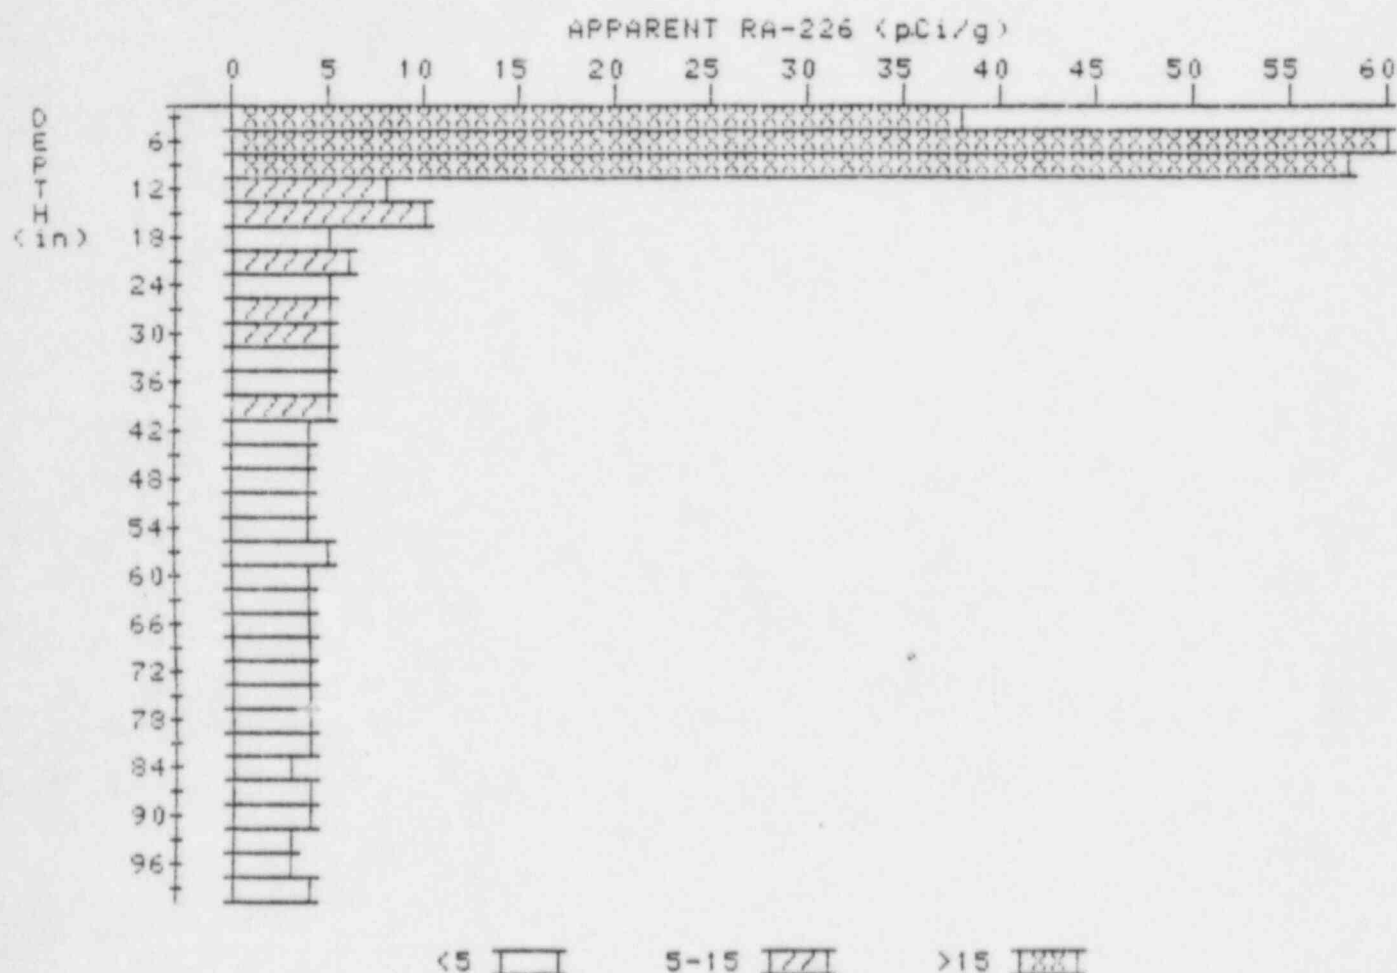
APPARENT RADIUM-226 CONCENTRATION DECONVOLUTION GRAPH

- (Area B) Surface Material: Concrete
Direction From Primary Structure: East
Other Directions: Abuts the east side of the primary structure
Total Depth of Contamination: 12 inches
Other (height or thickness): 4-inch-thick concrete
Comments: The material underlying the concrete sidewalk is contaminated.
Approximate Square Footage: 144

The recommended remedial action for this property, DOE ID No. GJ-04153-RS, includes removal of all areas identified as containing radioactive material (as discussed in Section 3.5 and shown in Appendix Figure 3.3) and transport of removed material to the disposal site.

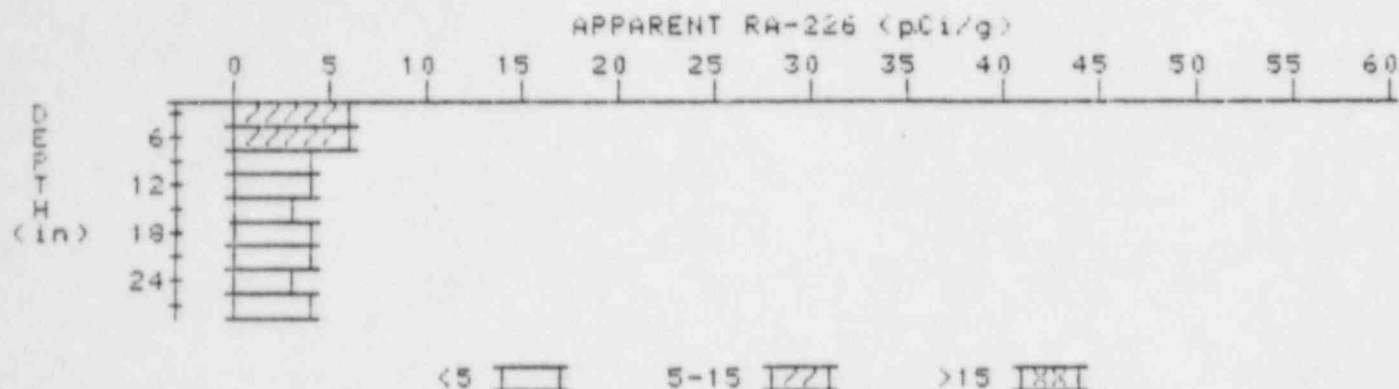
APPARENT RADIUM-226 CONCENTRATION 18 DECONVOLUTION GRAPH

- (Area D) Surface Material: Road base/flagstone
Direction From Primary Structure: East
Other Directions: In alley
Total Depth of Contamination: 9 inches
Approximate Square Footage: 39
