RADIOLOGIC AND ENGINEERING ASSESSMENT

DOE ID NO.: GJ-11579-RS
ADDRESS: 2508 ELM AVENUE

AUGUST 1985

BENDIX FIELD ENGINEERING CORPORATION
P.O. Box 1569
Grand Junction, Colorado 81502

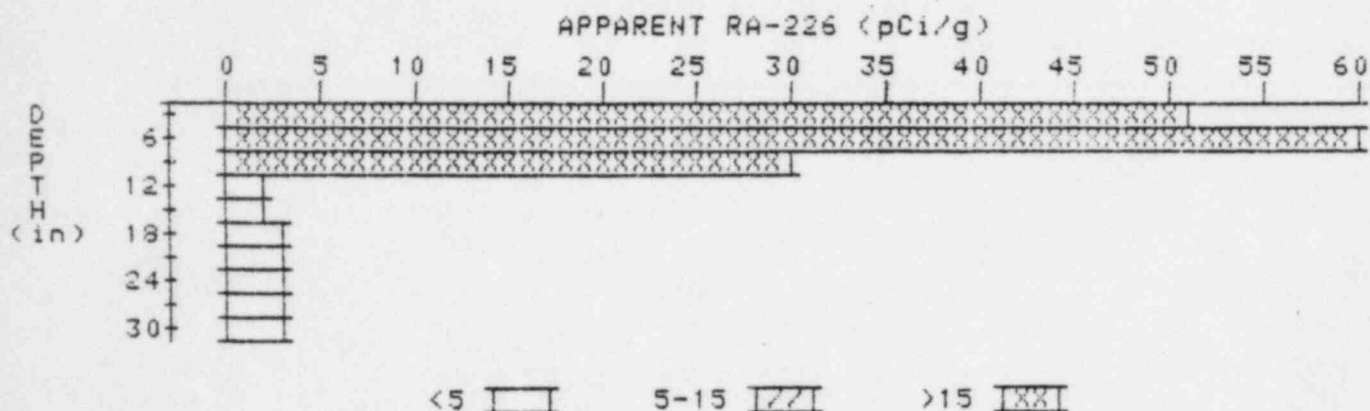
HOLE NUMBER: 3

Depth (in)	Apparent Radium-226 (pCi/g) Undeconvolved	Apparent Radium-226 (pCi/g) Deconvolved
3	50.9	50.9
6	55.1	98.3
9	35.0	29.7
12	17.9	1.9
15	9.8	1.6
18	6.3	3.1
21	4.6	3.0
24	3.8	2.9
27	3.5	3.3
30	3.3	3.3

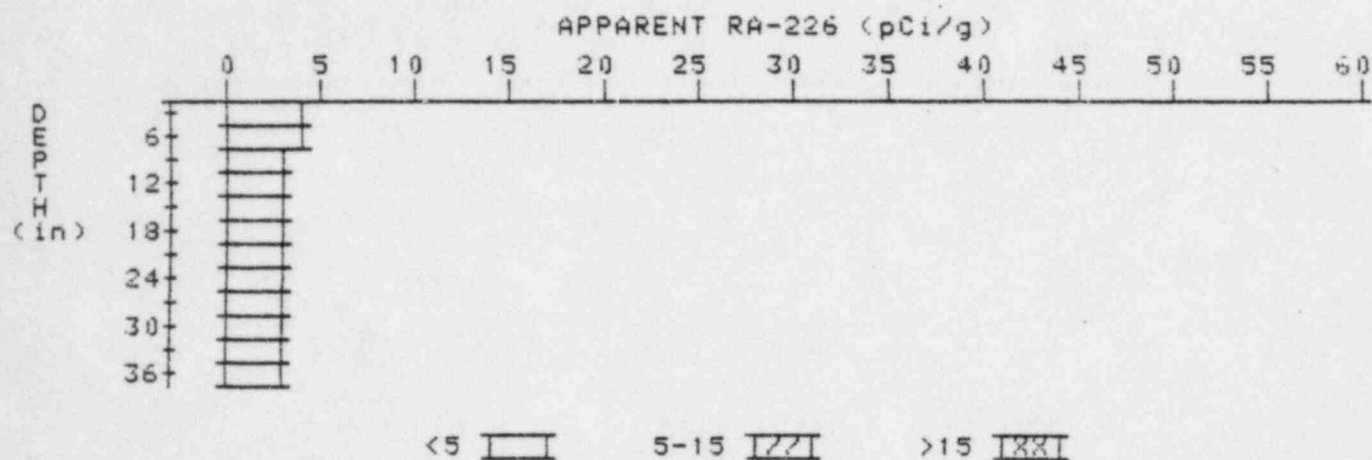
HOLE NUMBER: 6

Depth (in)	Apparent Radium-226 (pCi/g) Undeconvolved	Apparent Radium-226 (pCi/g) Deconvolved
3	4.4	4.4
6	4.1	4.5
9	3.6	3.2
12	3.3	3.1
15	3.1	2.9
18	3.0	2.8
21	3.0	3.0
24	3.0	3.0
27	3.0	3.0
30	3.0	3.0
33	3.0	3.0
36	3.0	3.0

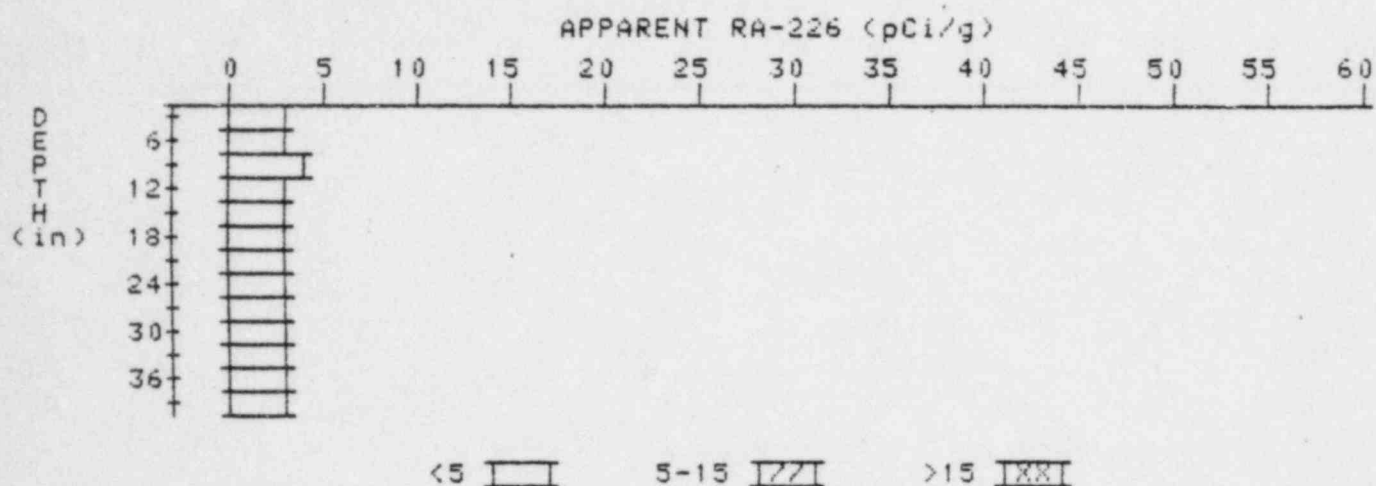
HOLE NUMBER: 7

Depth (in)	Apparent Radium-226 (pCi/g) Undeconvolved	Apparent Radium-226 (pCi/g) Deconvolved
3	3.0	3.0
6	3.2	3.4
9	3.3	3.7
12	3.2	3.4
15	3.0	2.8
18	2.9	2.7
21	2.9	2.7
24	3.0	3.4
27	2.9	2.7
30	2.9	3.1
33	2.8	2.6
36	2.8	2.8
39	2.8	2.6

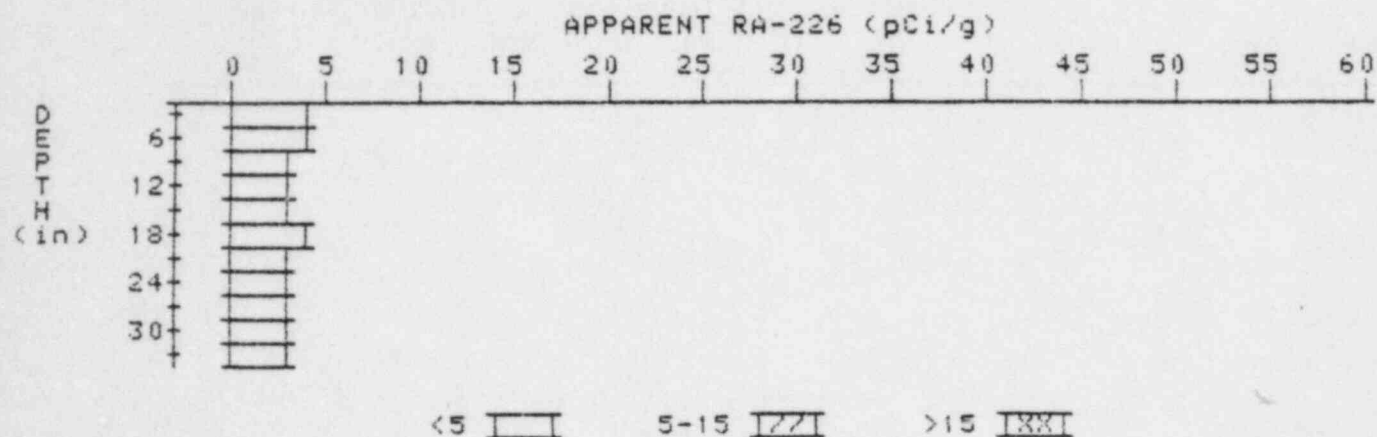
HOLE NUMBER: 11

Depth (in)	Apparent Radium-226 (pCi/g) Undeconvolved	Apparent Radium-226 (pCi/g) Deconvolved
3	4.2	4.2
6	3.9	3.9
9	3.6	3.4
12	3.4	3.0
15	3.4	3.4
18	3.4	3.6
21	3.3	3.1
24	3.3	3.3
27	3.3	3.3
30	3.3	3.5
33	3.2	3.2

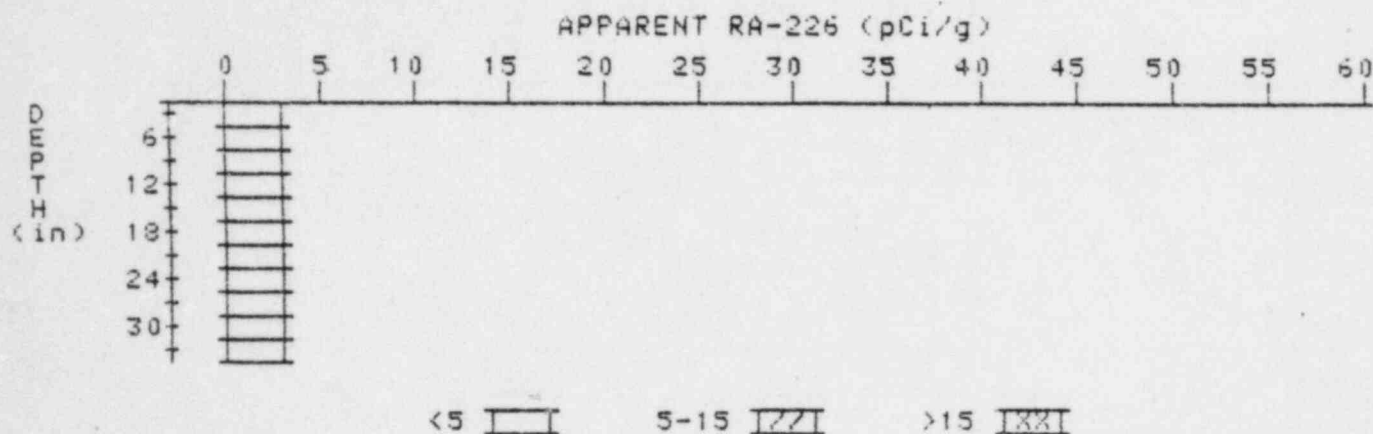
PROPERTY NUMBER: GJ-11579-RS
HOLE NUMBER: 12
LOCATION: 200280

Depth (in)	Apparent Radium-226 (pCi/g) Undeconvolved	Apparent Radium-226 (pCi/g) Deconvolved
3	2.8	2.8
6	2.9	2.9
9	3.0	3.2
12	3.0	3.0
15	3.0	3.0
18	3.0	2.8
21	3.1	3.3
24	3.1	3.1
27	3.1	3.1
30	3.1	3.3
33	3.0	3.0

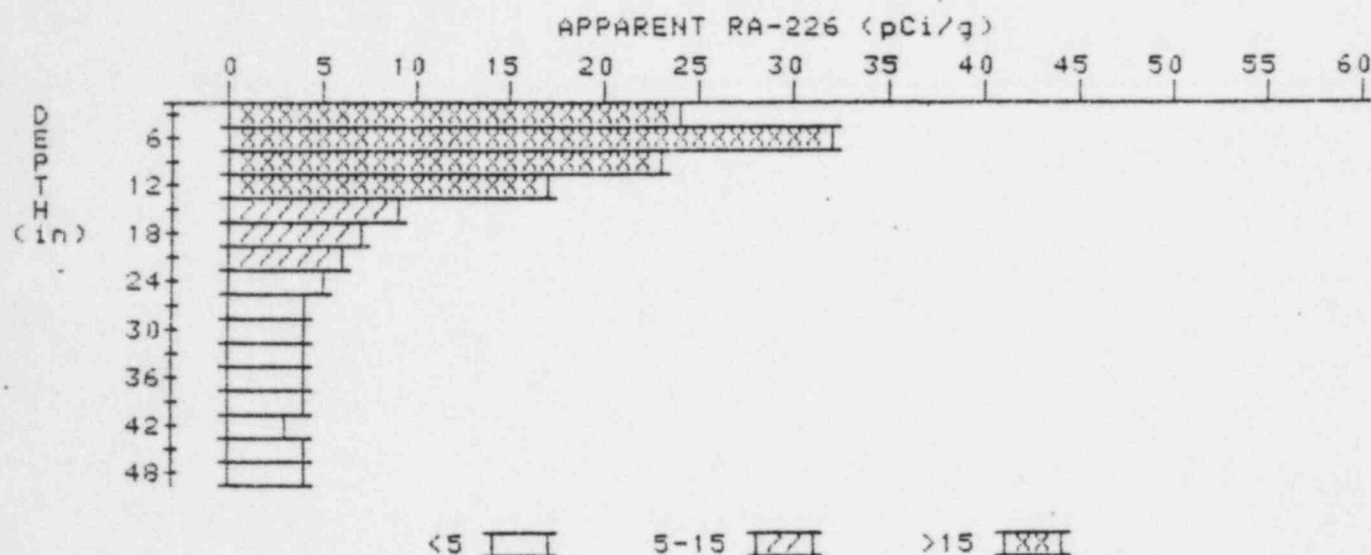
PROPERTY NUMBER: GJ-11579-RS
HOLE NUMBER: 21
LOCATION: 264265

Depth (in)	Apparent Radium-226 (pCi/g) Undeconvolved	Apparent Radium-226 (pCi/g) Deconvolved
3	23.7	23.7
6	24.6	32.1
9	21.3	23.4
12	16.8	17.0
15	12.2	9.4
18	9.2	7.4
21	7.2	6.1
24	5.8	4.7
27	5.0	4.5
30	4.5	4.1
33	4.2	4.2
36	3.9	3.7
39	3.7	3.5
42	3.6	3.4
45	3.6	3.6
48	3.6	3.6
