RADIOLOGIC AND ENGINEERING ASSESSMENT

DOE ID NO.: GJ-11489-RS
ADDRESS: 523 28 3/4 ROAD

AUGUST 1985

BENDIX FIELD ENGINEERING CORPORATION
P.O. Box 1569
Grand Junction, Colorado 81502

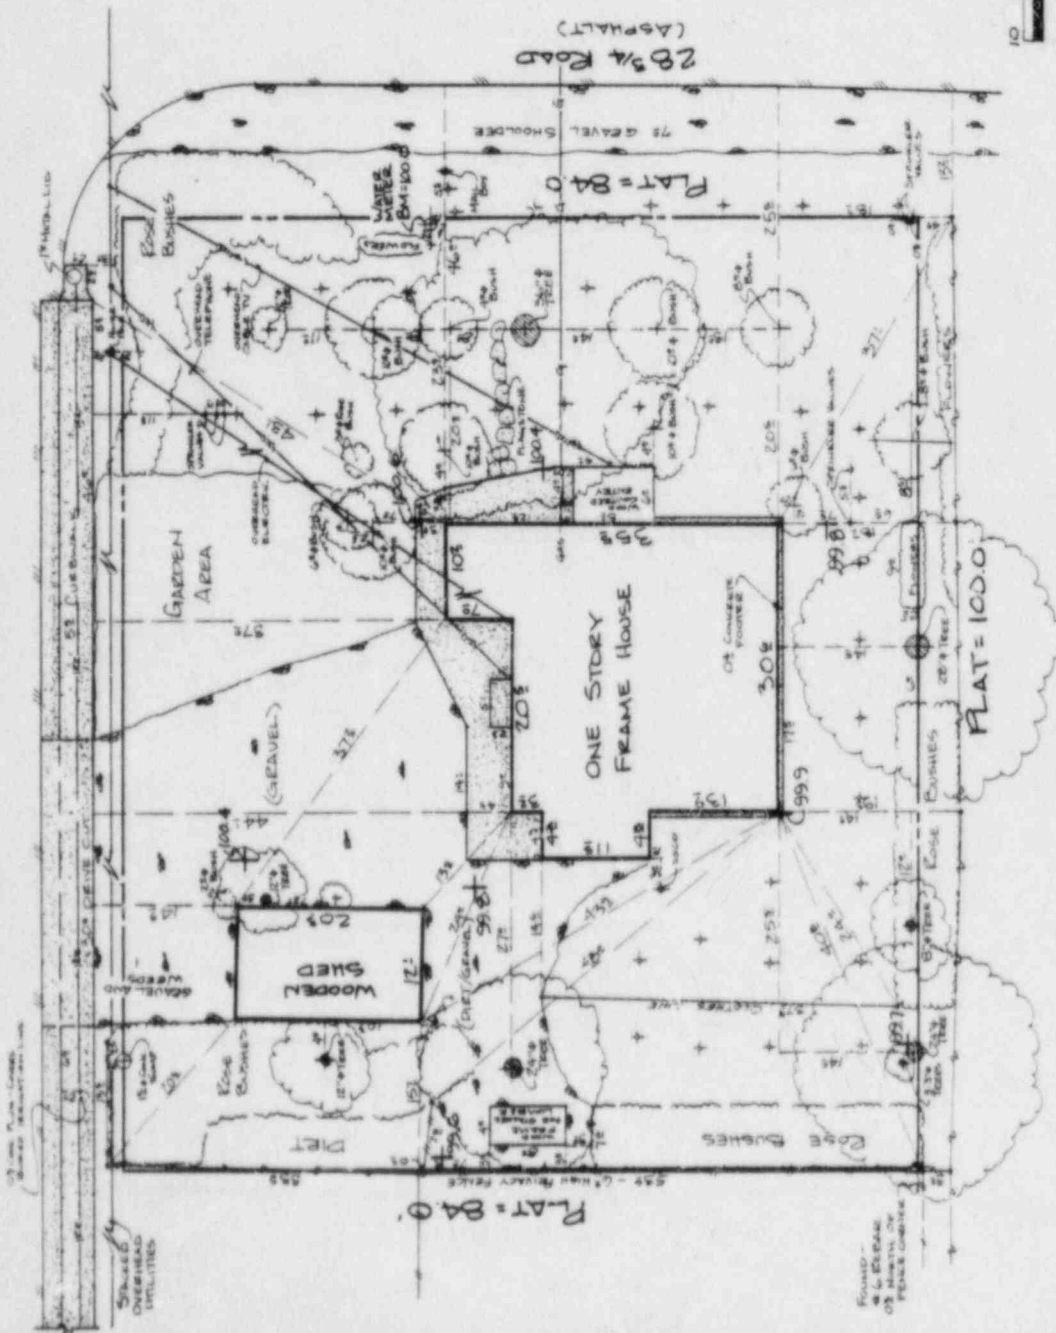
FIGURE 2.2 SITE PLAN

General landscaping and exterior improvements are good. Structures, utilities, landscaping, and other special features of this property are included in Appendix Figure 2.2.

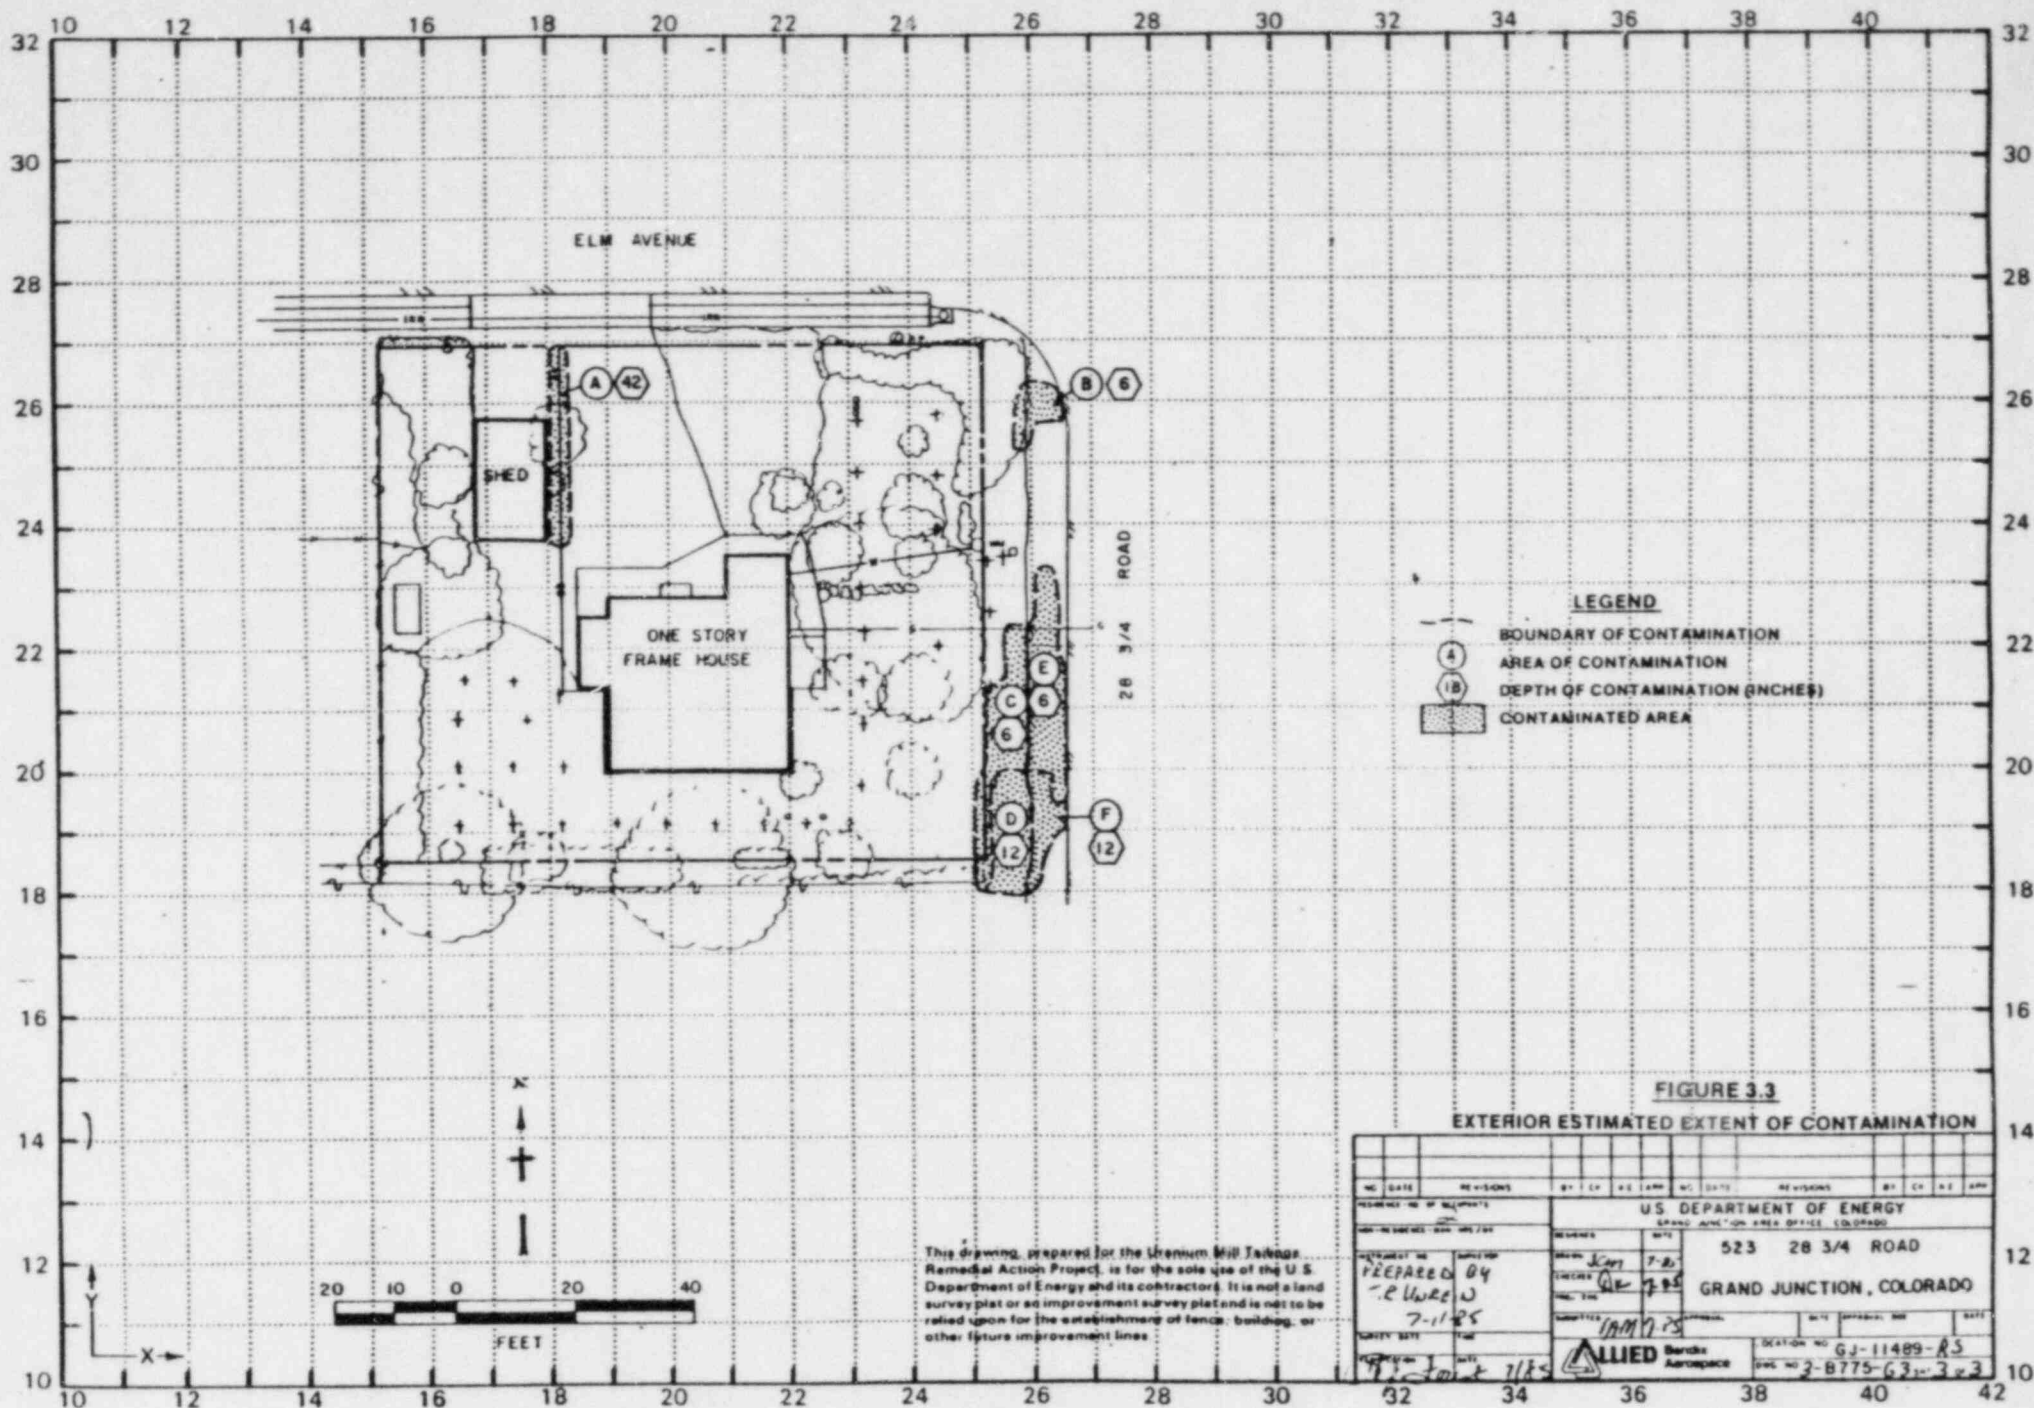
Appendix Figure 3.3 shows identified areas and estimated depths of contamination on this property, based on assessments of all measurements taken. As noted in this figure, areas recommended for remedial action that contain identified residual radioactive materials are:

- (Area A) Surface Material: Gravel
 Direction From Primary Structure: Northwest
 Other Directions: East of shed
 Total Depth of Contamination: 42 inches
 Comments: The sewer line is bedded in tailings.
 Approximate Square Footage: 160

- (Area B) Surface Material: Soil
 Direction From Primary Structure: Northeast
 Other Directions: Adjacent to 28 3/4 Road
 Total Depth of Contamination: 6 inches
 Comments: This area is in a road right-of-way.
 Approximate Square Footage: 60

- (Area C) Surface Material: Lawn
 Direction From Primary Structure: East
 Other Directions: Adjacent to 28 3/4 Road right-of-way
 Total Depth of Contamination: 6 inches
 Approximate Square Footage: 250

- (Area D) Surface Material: Lawn
 Direction From Primary Structure: Southeast
 Other Directions: Adjacent to 28 3/4 Road right-of-way
 Total Depth of Contamination: 12 inches
 Approximate Square Footage: 160

- (Area E) Surface Material: Soil
 Direction From Primary Structure: East
 Other Directions: Adjacent to 28 3/4 Road
 Total Depth of Contamination: 6 inches
 Comments: This area is in a road right-of-way.
 Approximate Square Footage: 226

- (Area F) Surface Material: Soil
 Direction From Primary Structure: Southeast
 Other Directions: Adjacent to 28 3/4 Road
 Total Depth of Contamination: Estimated at 12 inches
 Comments: This area is in a road right-of-way. The
 depth of contamination is based on data collected
 in Area D.
 Approximate Square Footage: 85

The recommended remedial action for this property, DOE ID No. GJ-11489, includes removal of all areas identified as containing radioactive material (as discussed in Section 3.5 and shown in Appendix Figure 3.3) and transport of removed material to the disposal site.

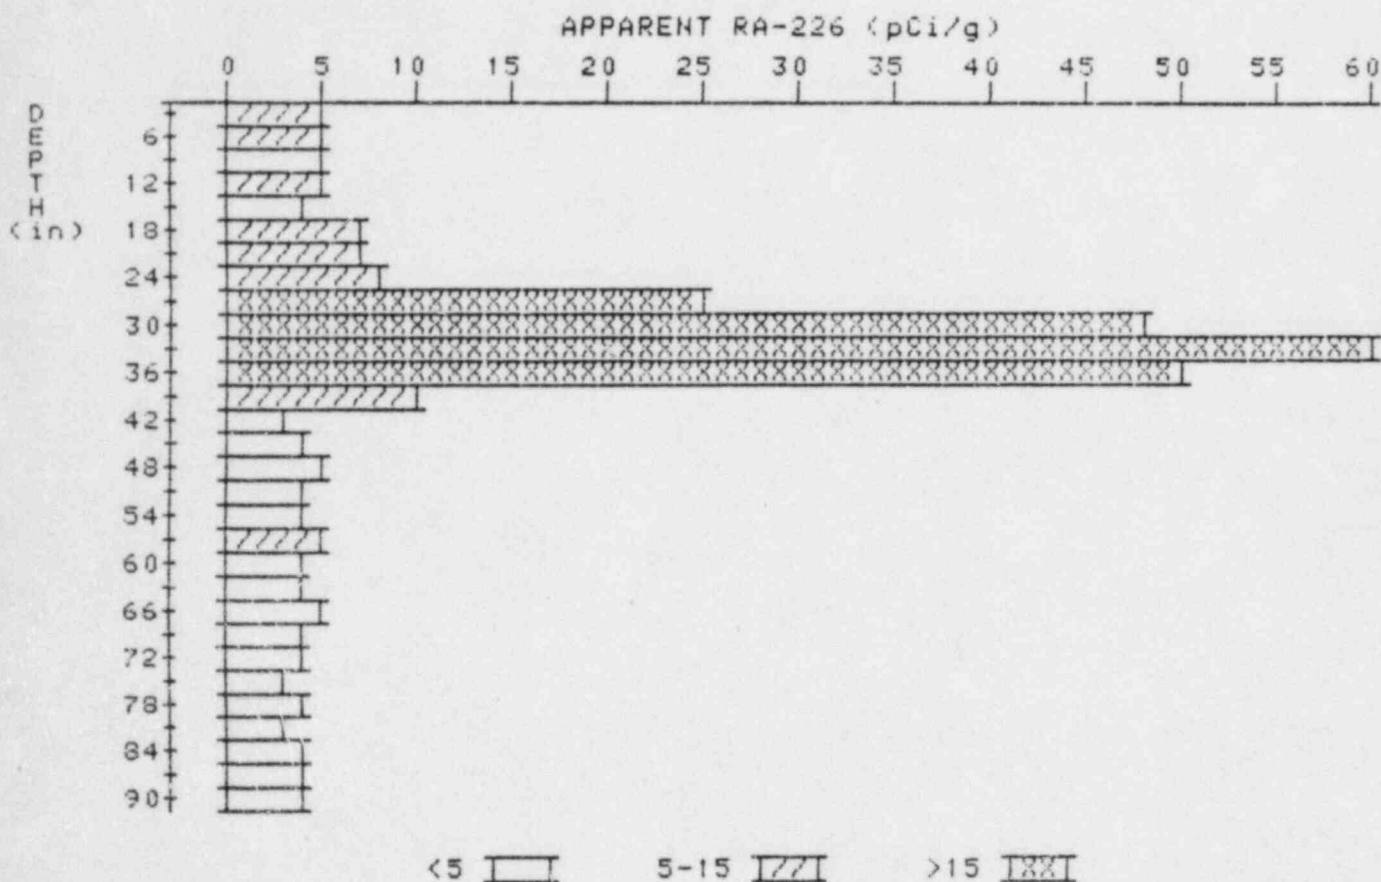
HOLE NUMBER: 1

At the property I talked with the owner; he informed me that he once worked at the Climax mine, and the only area where tailings were used was the sewer line. The tailings were used to bed the pipe. He also stated that from his house (west side) to the south part of his garage he had previously excavated the pipe and tailings. He did not remove any pipe or tailings from that point to

to the street. Two holes were augered, one by the house which showed no contamination, and one by the garage which showed contamination. The owner also stated that the pipe is approximately 36-inches deep.

Replace sewer line
