RADIOLOGIC AND ENGINEERING ASSESSMENT

DOE ID NO.: GJ-11490-RS
ADDRESS: 537 28 3/4 ROAD

AUGUST 1985

BENDIX FIELD ENGINEERING CORPORATION
P.O. Box 1569
Grand Junction, Colorado 81502

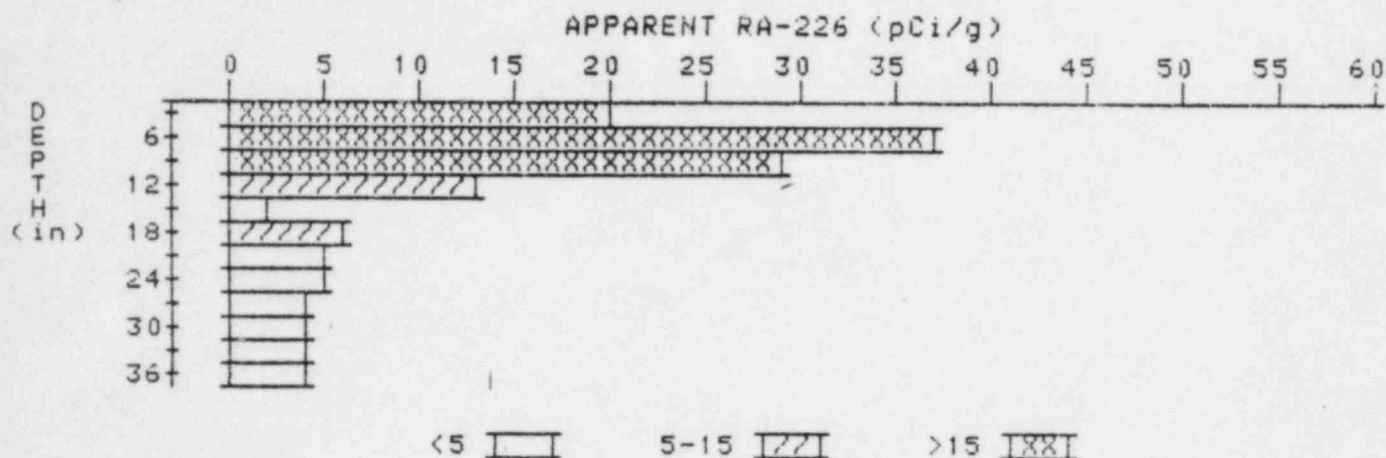
9

The only exterior contamination found is in the road right-of-way (28-3/4 Road) and in a concrete slab next to a concrete irrigation divider box (which is not contaminated). The owner stated this is the only place he ever used tailings.
