Commonwealth Edison

August 23, 1985

Subject: Byron Station Unit 1
Environmental Effects of High
Energy Line Breaks
NRC Docket No. 50-454

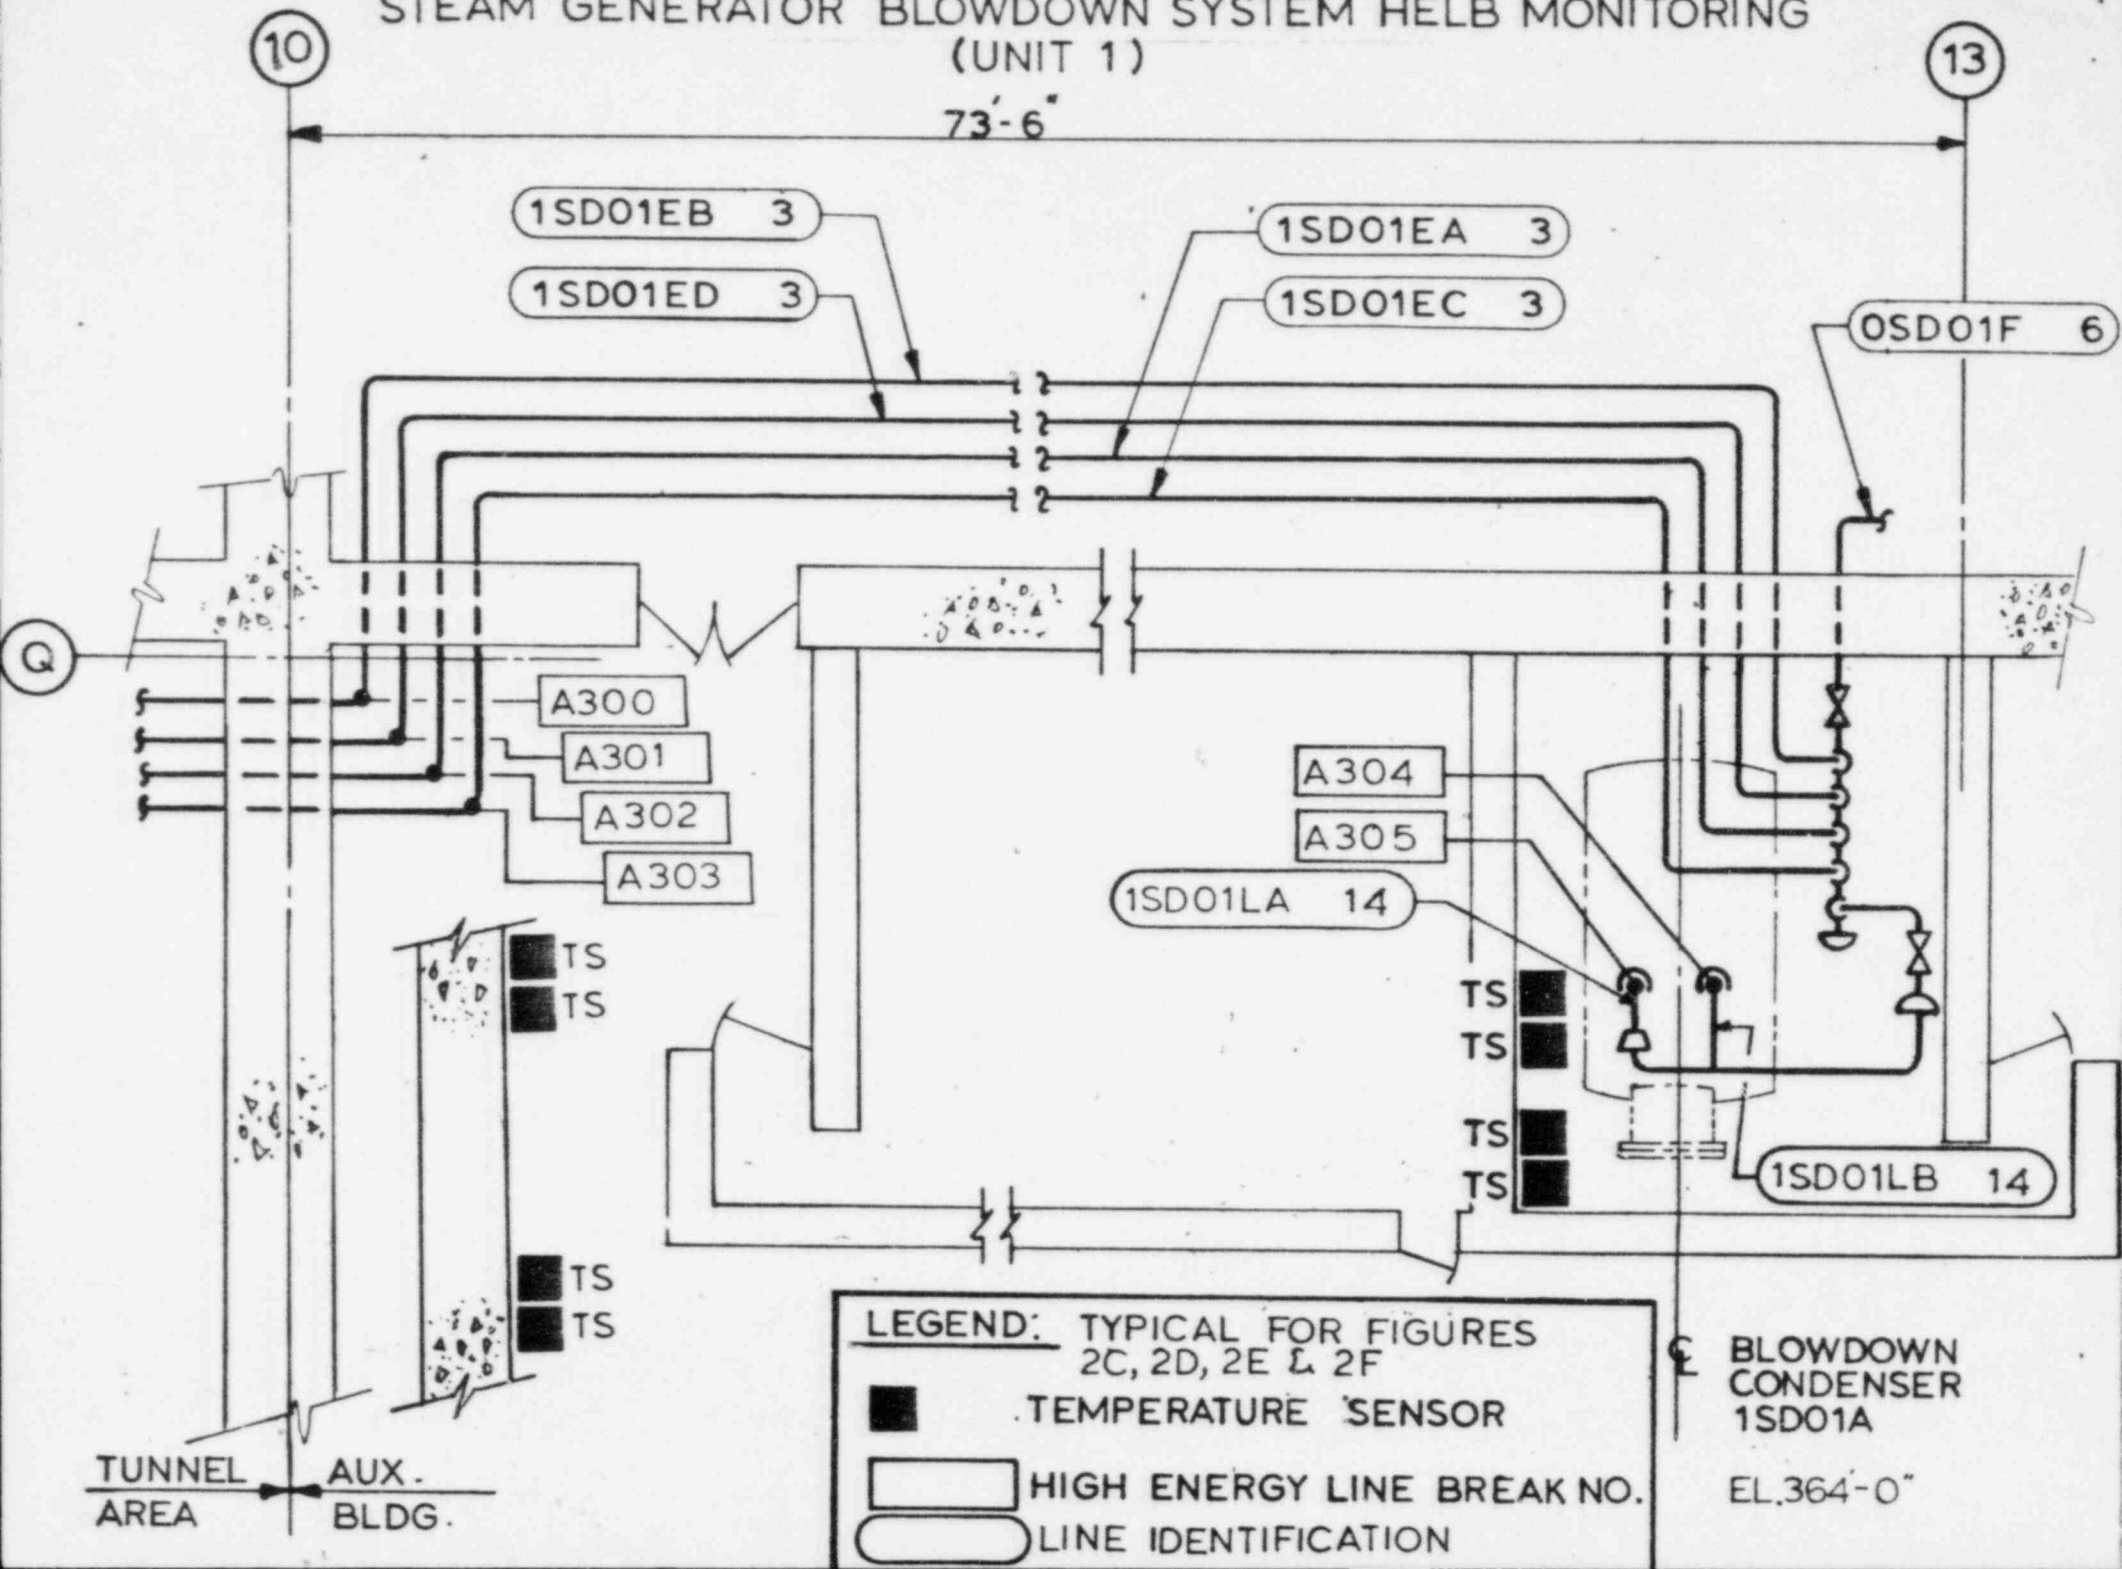
FIGURE 1C
STEAM GENERATOR BLOWDOWN SYSTEM HELB MONITORING
(UNIT 1)

Equipment interference problems have prevented the installation of some of the temperature sensors in locations as originally described in reference (a). The revised locations of these sensors are shown on the attached figures. The relocation of these sensors does not reduce their effectiveness to promptly detect the adverse environmental conditions associated with high energy line breaks in the SD and AS systems.

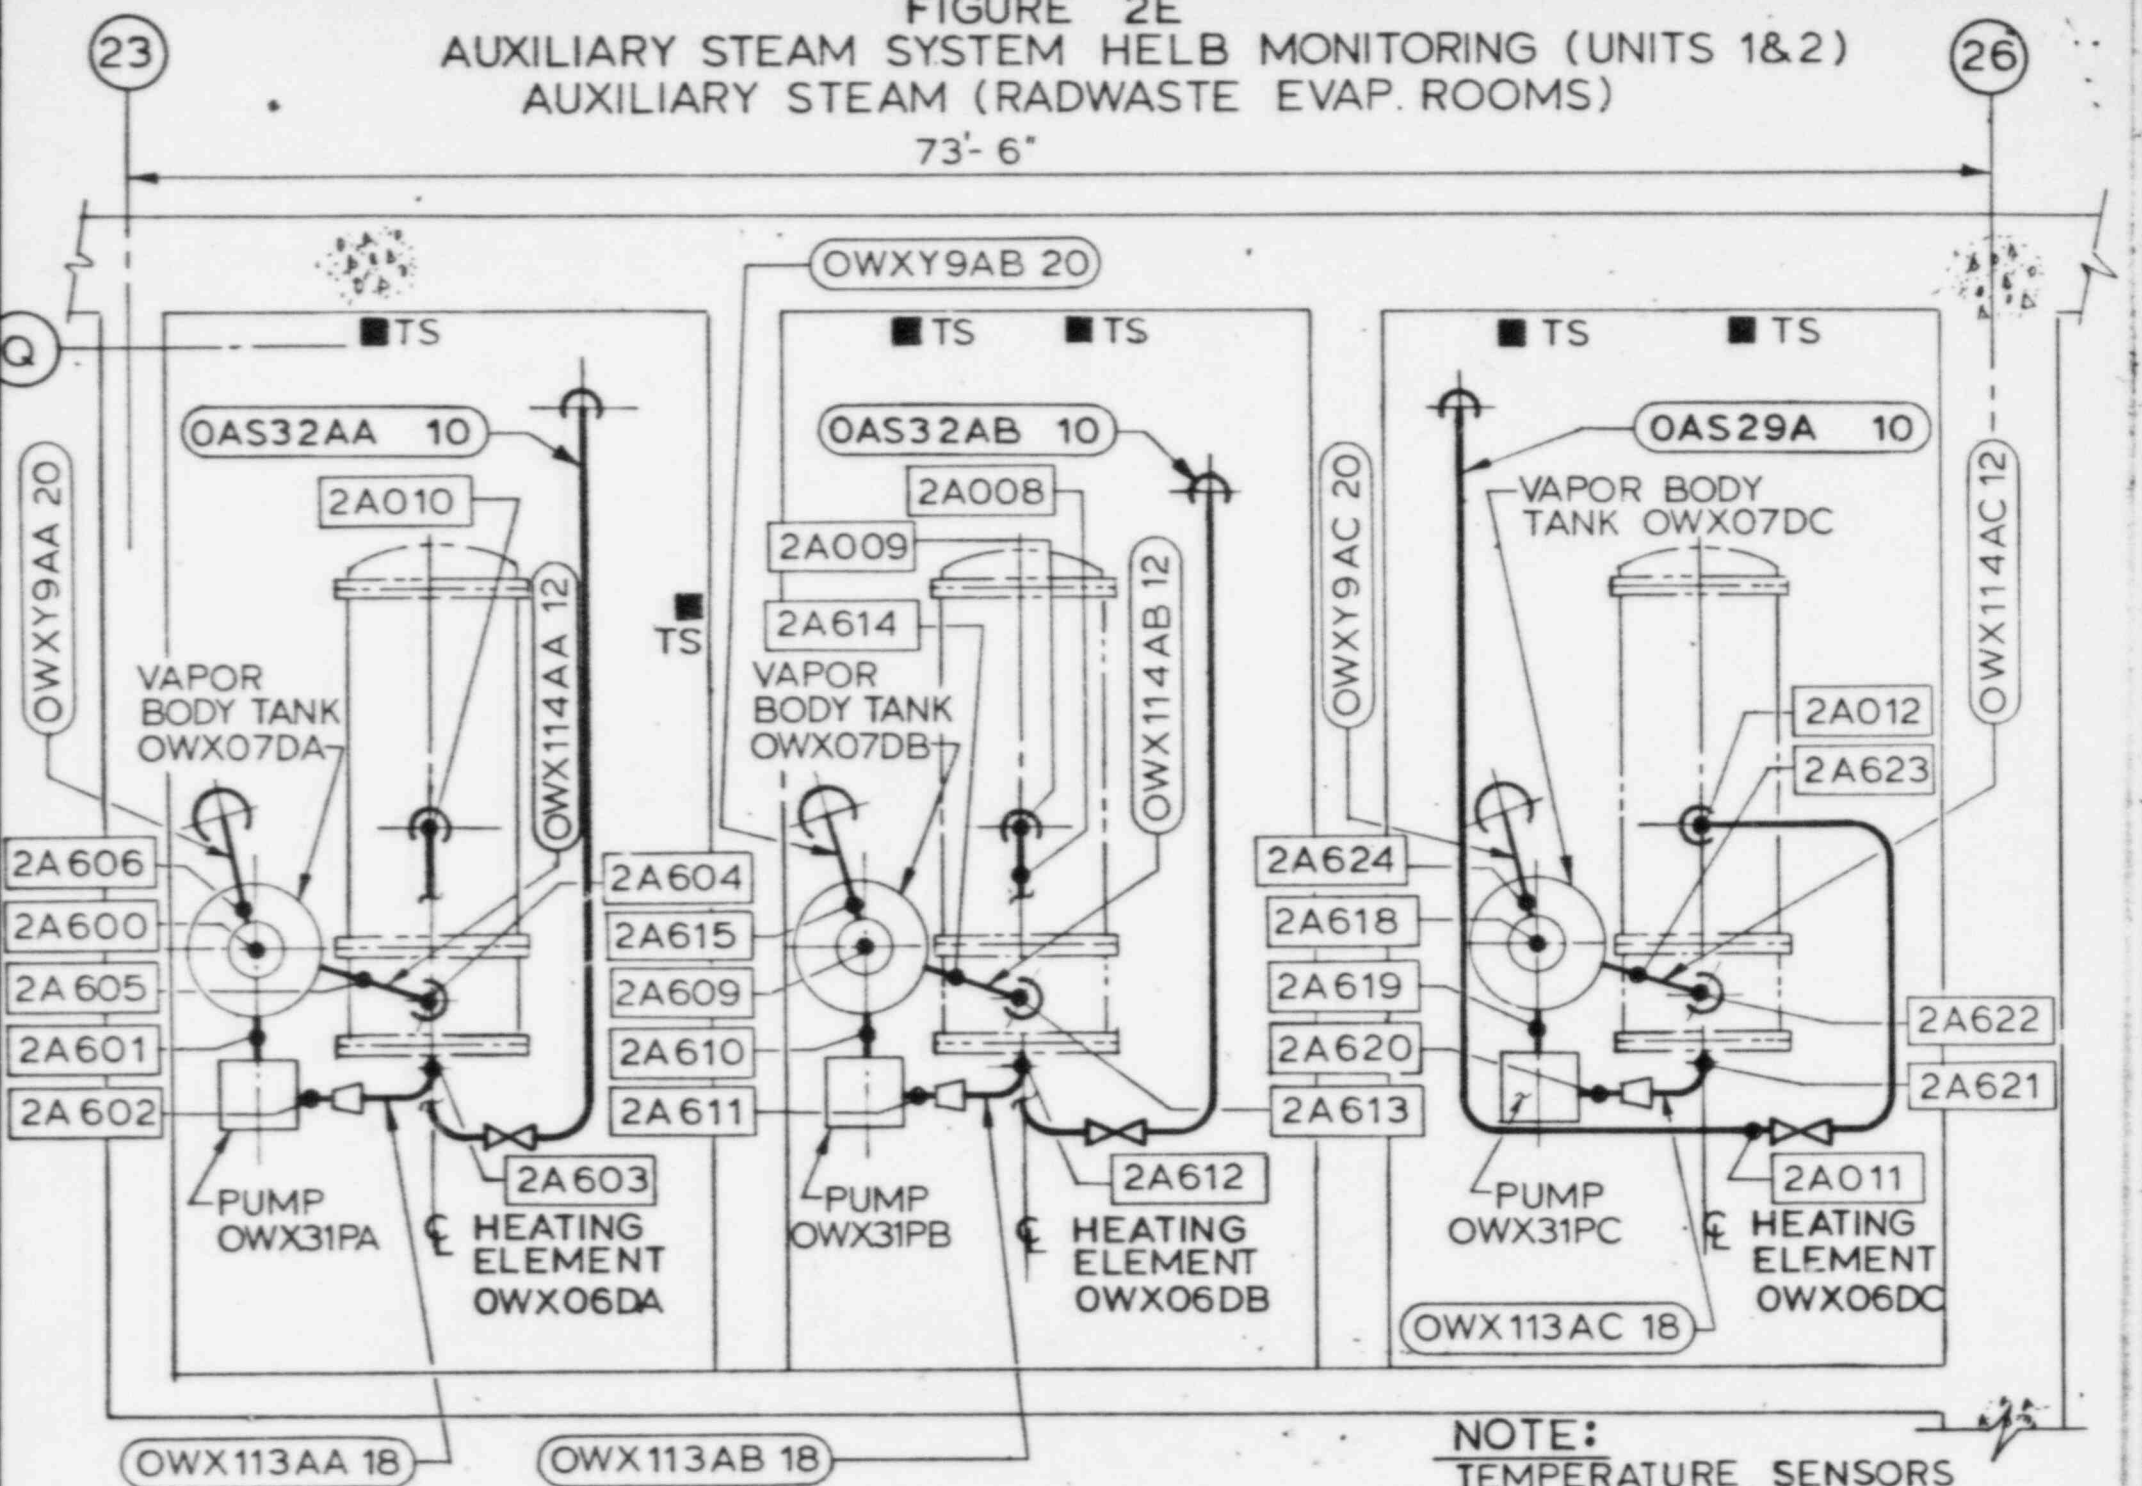
FIGURE 2E

TEMPERATURE SENSORS
PROTECTING THESE AREAS
ALSO PROTECT AREAS SHOWN
ON FIG. 2F (401'-0")
