RADIOLOGIC AND ENGINEERING ASSESSMENT

DOE ID NO.: GJ-00137-MR
ADDRESS: 221 HILL AVENUE

AUGUST 1985

BENDIX FIELD ENGINEERING CORPORATION
P.O. Box 1569
Grand Junction, Colorado 81502

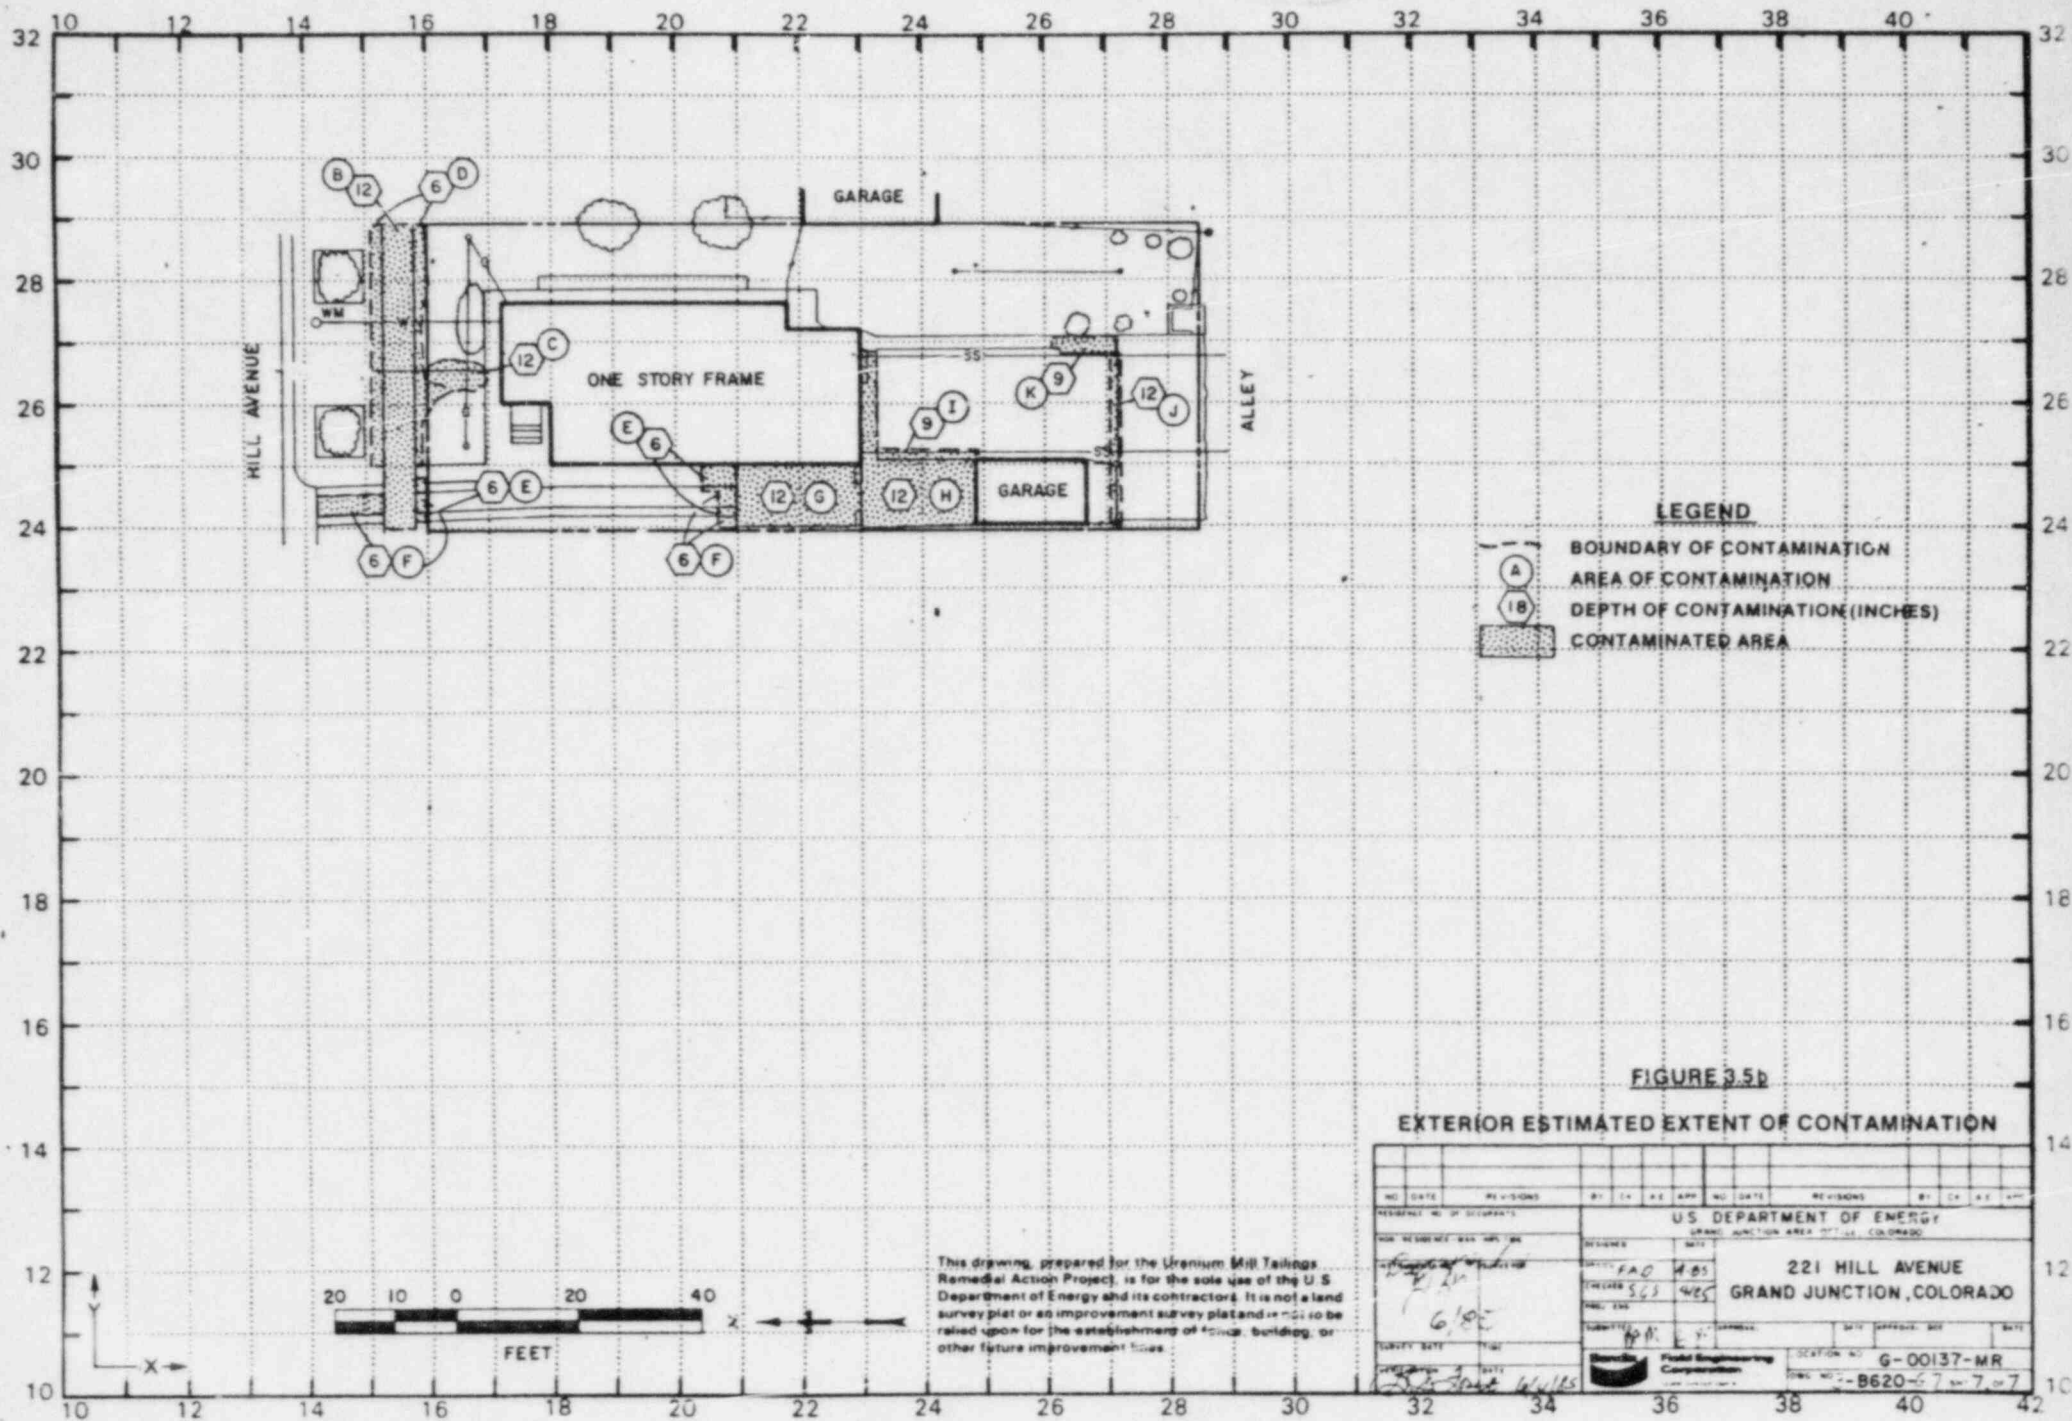
FIGURE 3.5

- (AREA A) The soil beneath the concrete slab on the south end of the primary structure is contaminated. The total estimated depth of contamination is 15 inches, based on engineering design. The estimated thickness of the slab is 4 inches (approximately 264 sf).

AREA A should be monitored during remedial action. The depth of contamination is estimated, since a borehole was not possible in this area.

INTERIOR ESTIMATED EXTENT OF CONTAMINATION

The recommended remedial action for this property, DOE ID No. GJ-00137-MR, includes removal of all areas identified as containing radioactive material (as discussed in Section 3.5 and shown in Appendix Figures 3.5a and 3.5b) and transport of removed material to the disposal site.
