# MEMORANDUM

**DATE:** December 5, 1996  
**TO:** Vermont State Nuclear Advisory Panel  
**FROM:** Citizens Awareness Network  
**RE:** CAN'S analysis of Vermont Yankee's July 23,  
1996 presentation on RHR minimum flow valve  
**CC:** U.S. NRC and general release

**Summary of CAN's Analysis of VY's Presentation, "RHR Minimum Flow Valve Enforcement Conference," (July 23, 1996).<sup>1</sup>**

***RHR Minimum Flow Valve  
Enforcement Conference***

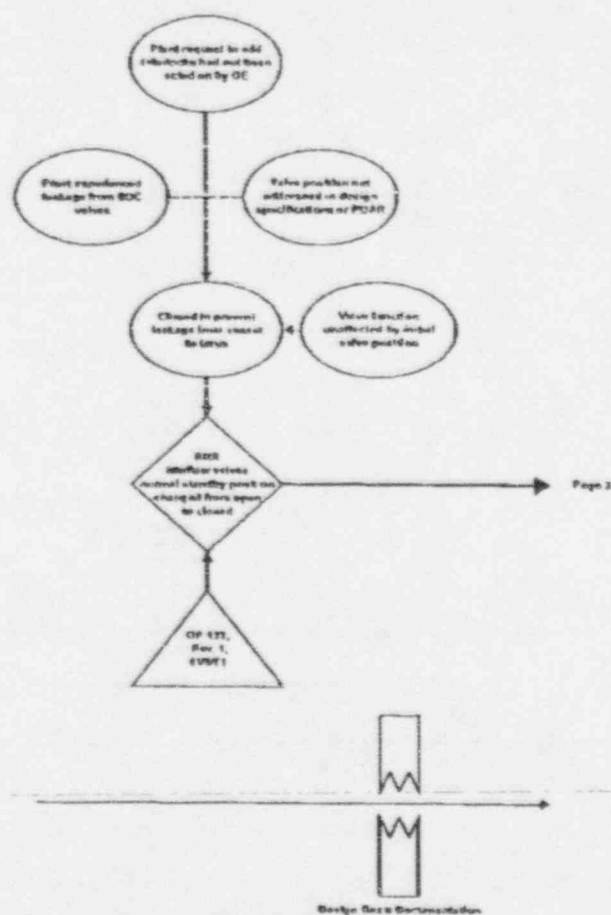
## Loss of RHR Minflow Protection

- **Event Definition**
  - **Failure to provide minimum flow protection for cross-powered RHR pumps**
- **Primary Effects**
  - **Minimum flow valves closed by procedure, but P&ID unchanged**
  - **RHR Pumps B and C cross-powered but not minimum flow valves**

- **Root Cause**
  - Inadequate design/single failure evaluation
- **Contributing Causes**
  - Inadequate documentation of minimum flow design basis
  - ECCS design focus on large break phenomena
  - Design engineers assumed minimum flow valves were open when they were closed

- **Maintain minimum flow valves open during normal operation**
- **Revise LOCA analysis to account for failure of valve to close**
- **Review current design change process to ensure broad scope, comprehensive reviews**

- Complete single failure vulnerability review for all ECCS
- Revise FSAR description of minimum flow function
- Revise P&ID to show minimum flow valves open
- Develop policy on use of P&ID as design basis document
