RADIOLOGIC AND ENGINEERING ASSESSMENT

DOE ID NO.: GJ-12163-RS  
ADDRESS: 1410 WALNUT AVENUE

AUGUST 1985

URANIUM MILL TAILINGS REMEDIAL ACTION PROJECT OFFICE

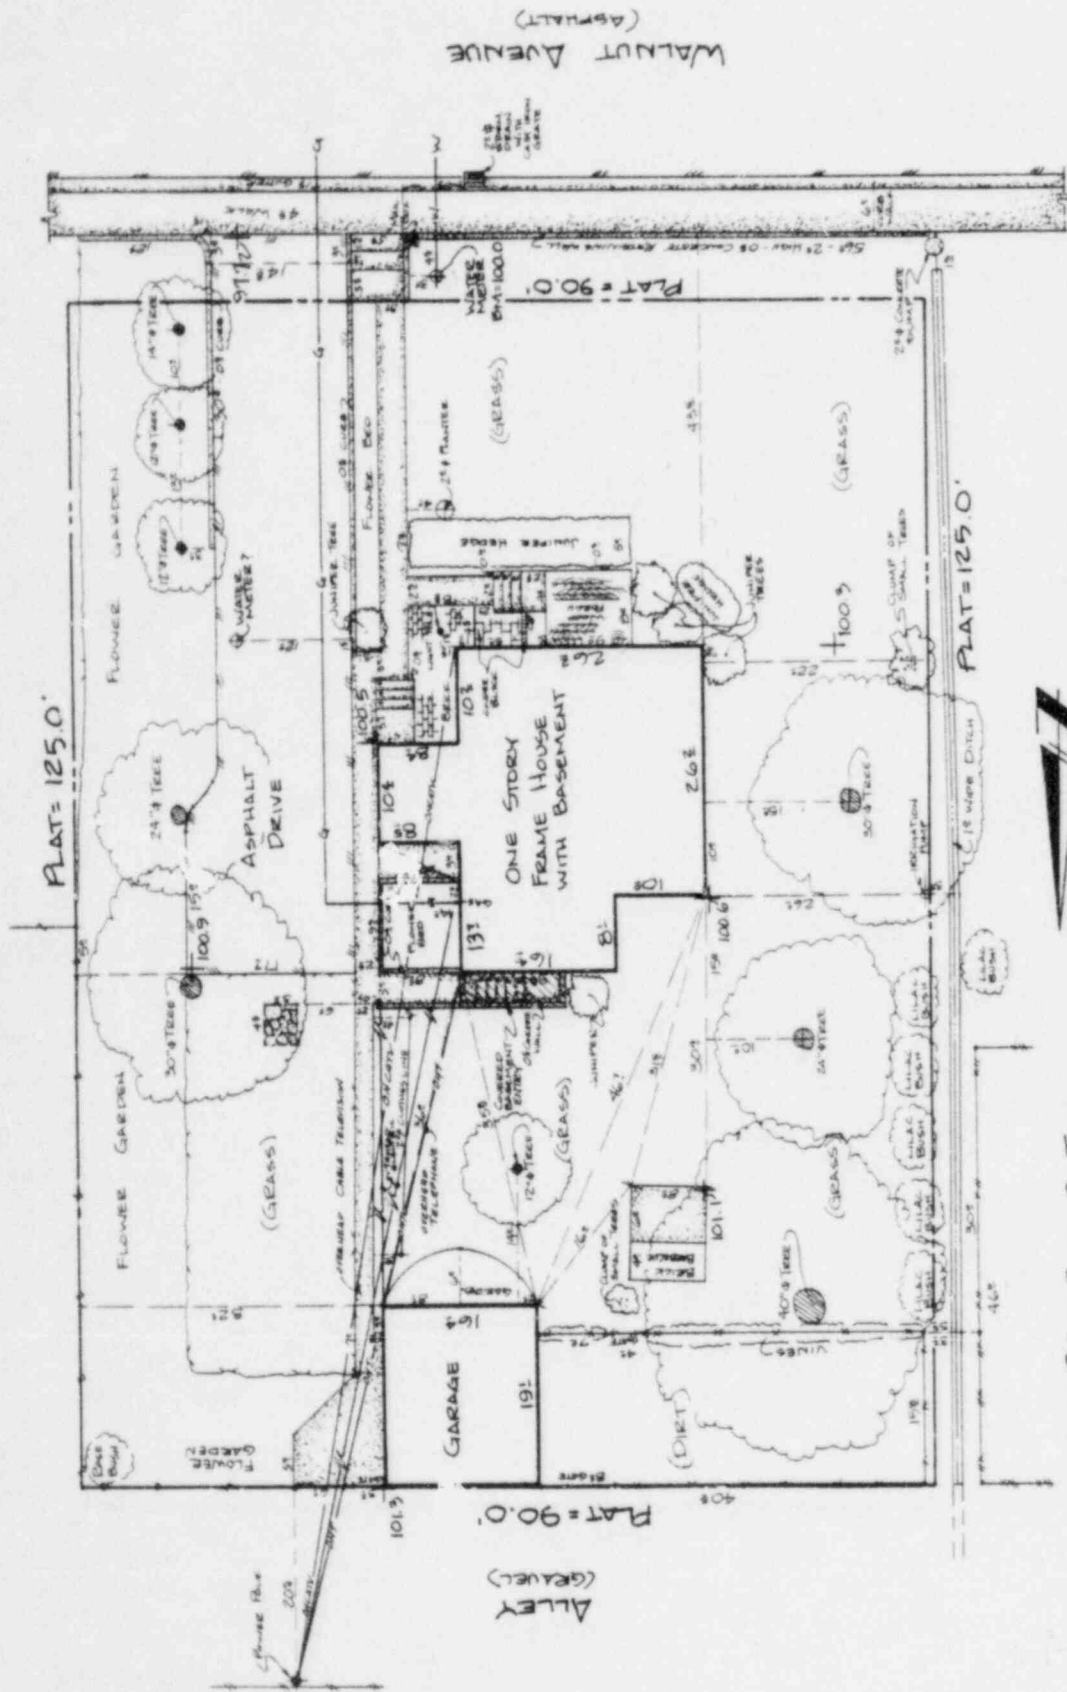
FIGURE 2.2 SITE PLAN

Structures, utilities, landscaping, and other special features of this property are included in Appendix Figure 2.2.

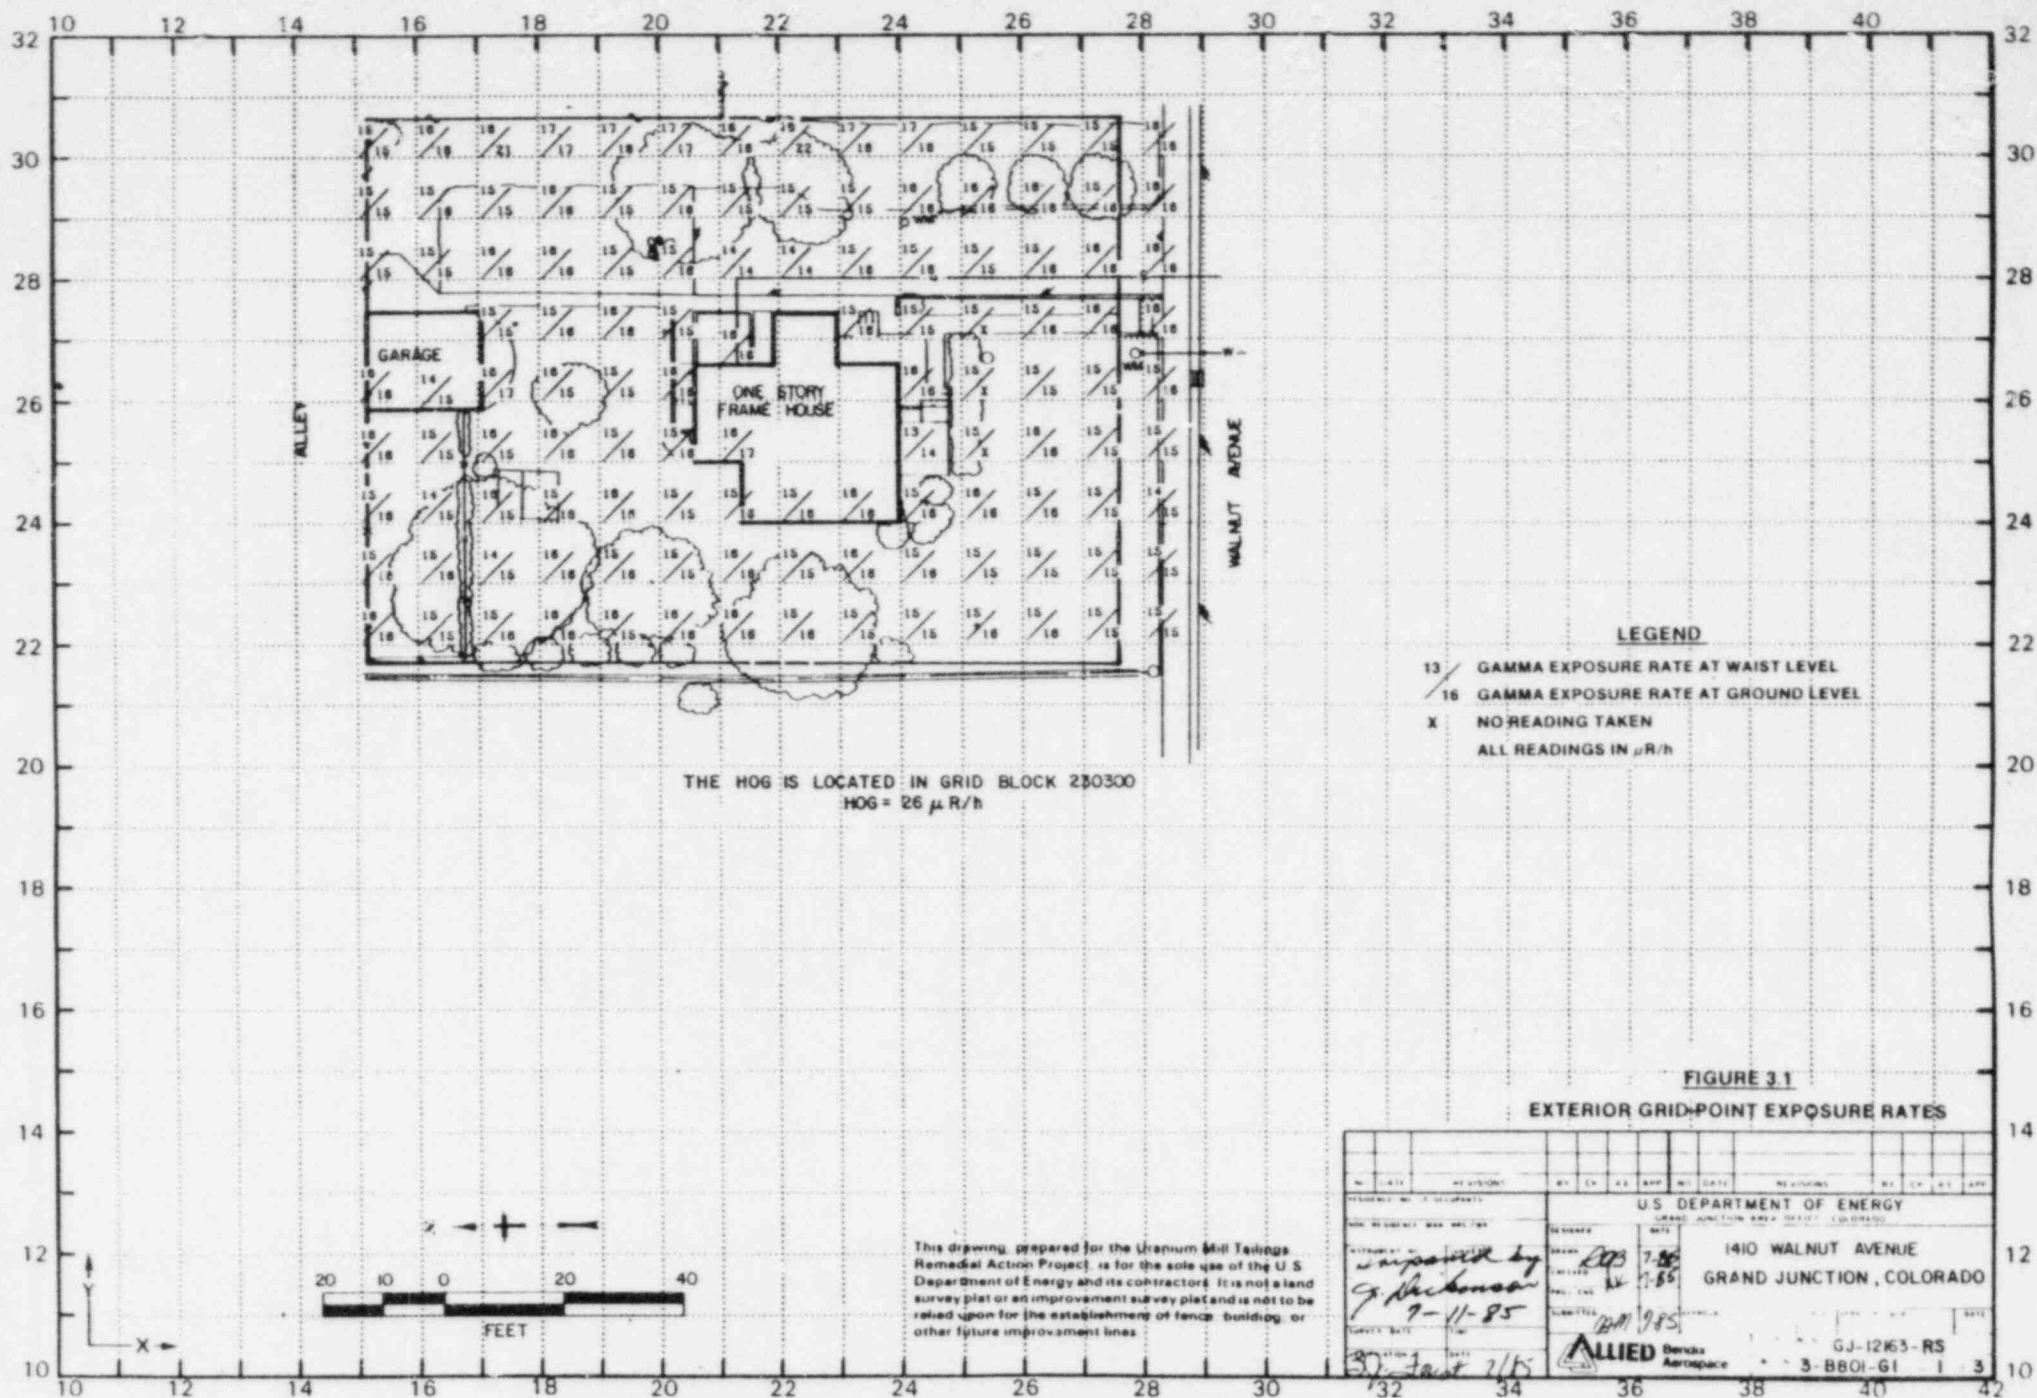
| Figure 3.1 | Exterior Grid-Point Exposure Rates |

Exterior radium-concentration measurements are presented in Appendix Table 3.1. Grid-point survey results are shown in Appendix Figure 3.1.

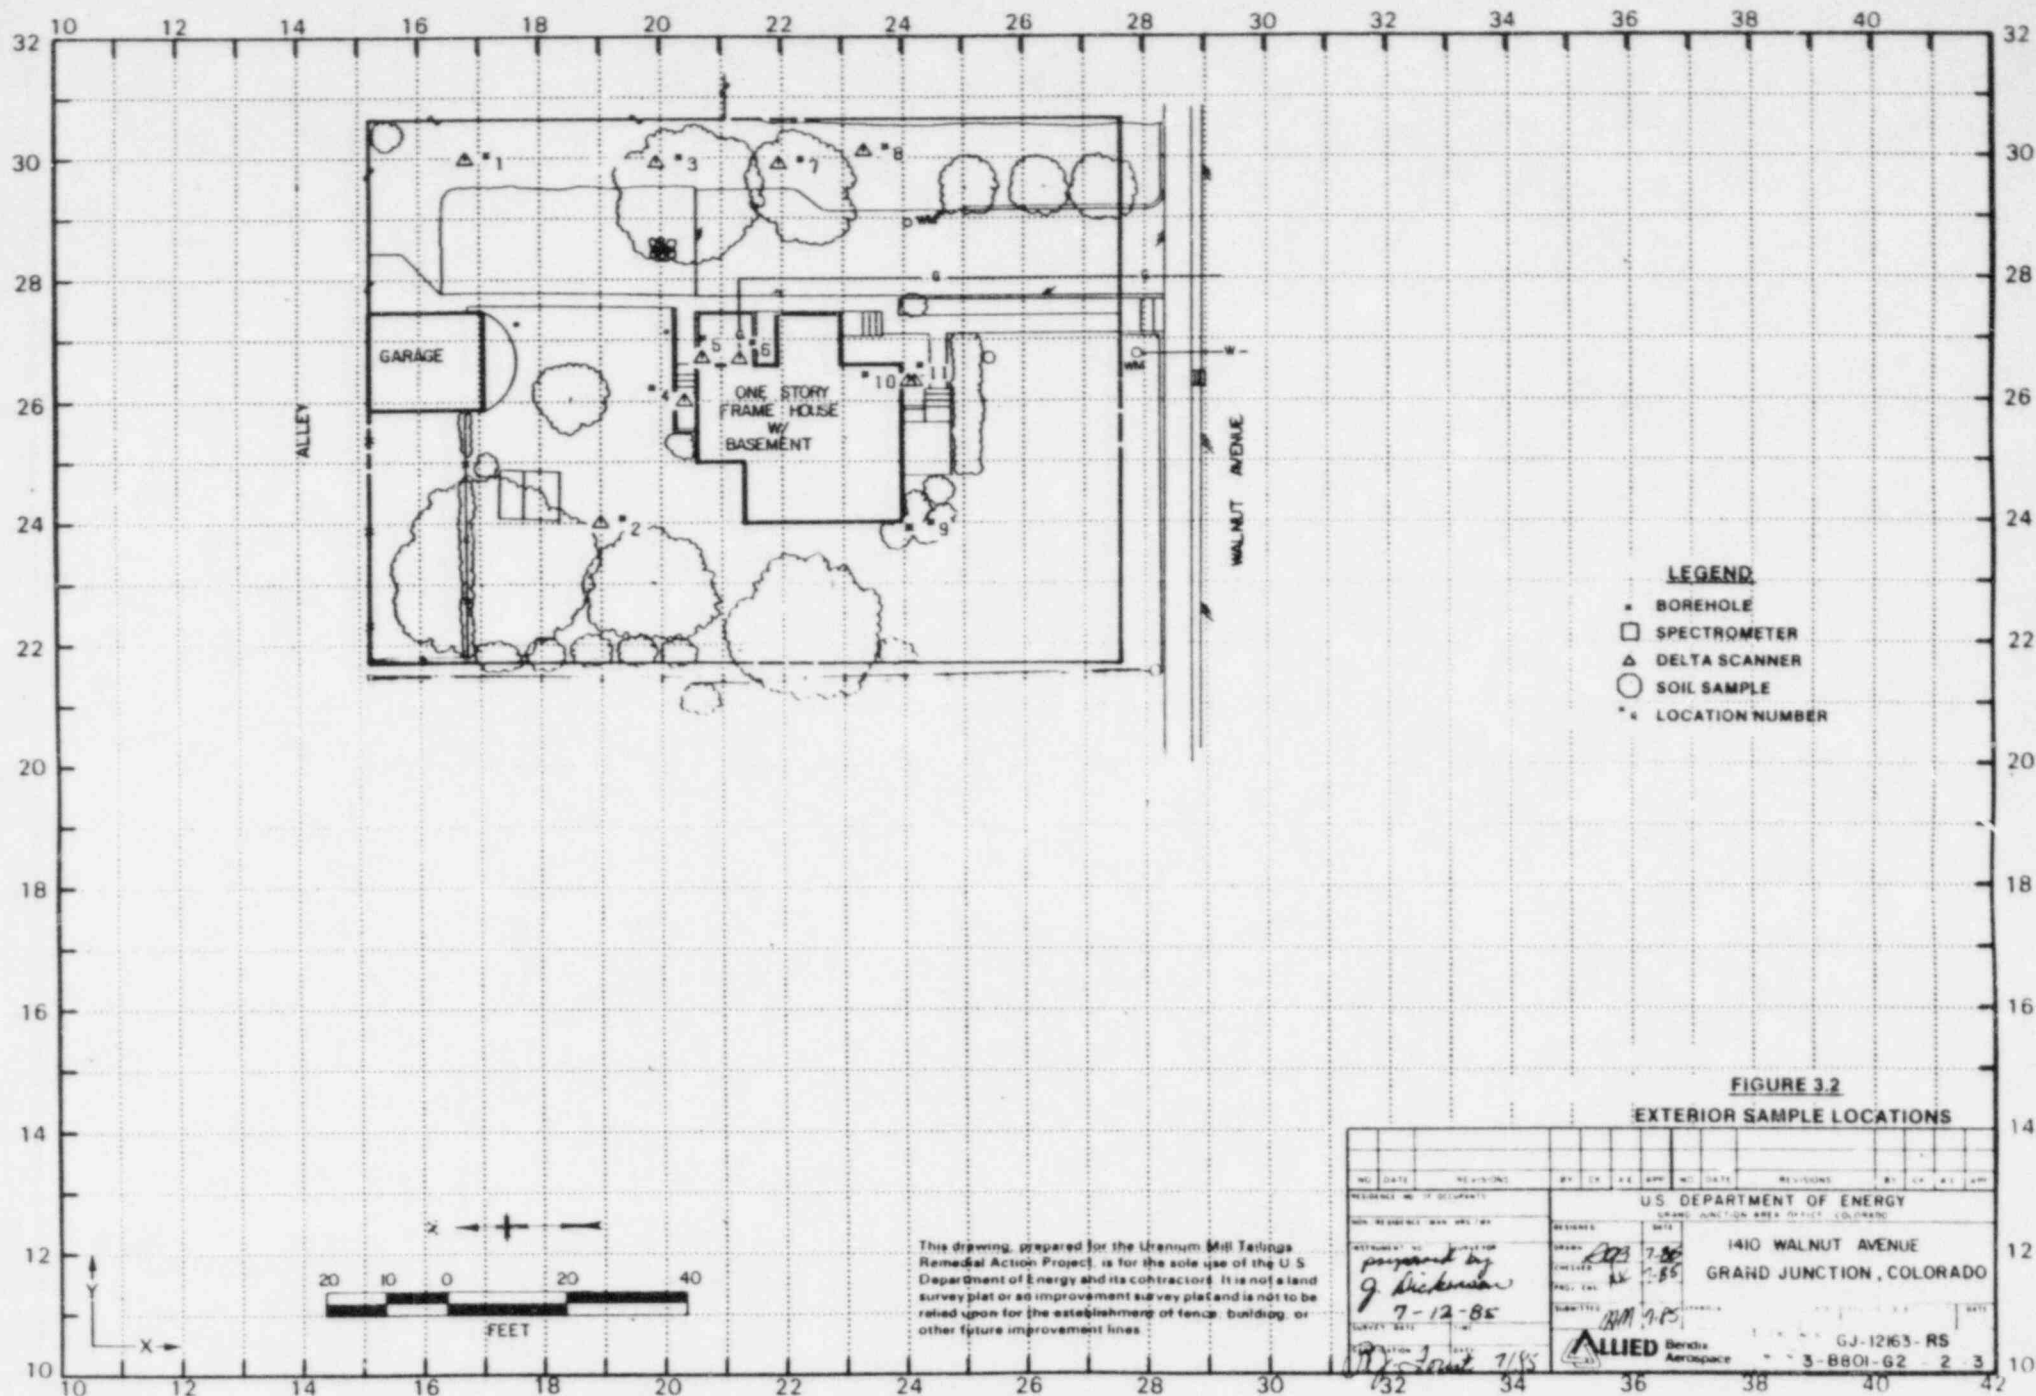
| Figure 3.2 | Exterior Sample Locations |

Areas which displayed elevated gamma levels were further investigated; these areas are shown in Appendix Figure 3.2. Data from these investigations are included in Appendix Table 3.1.

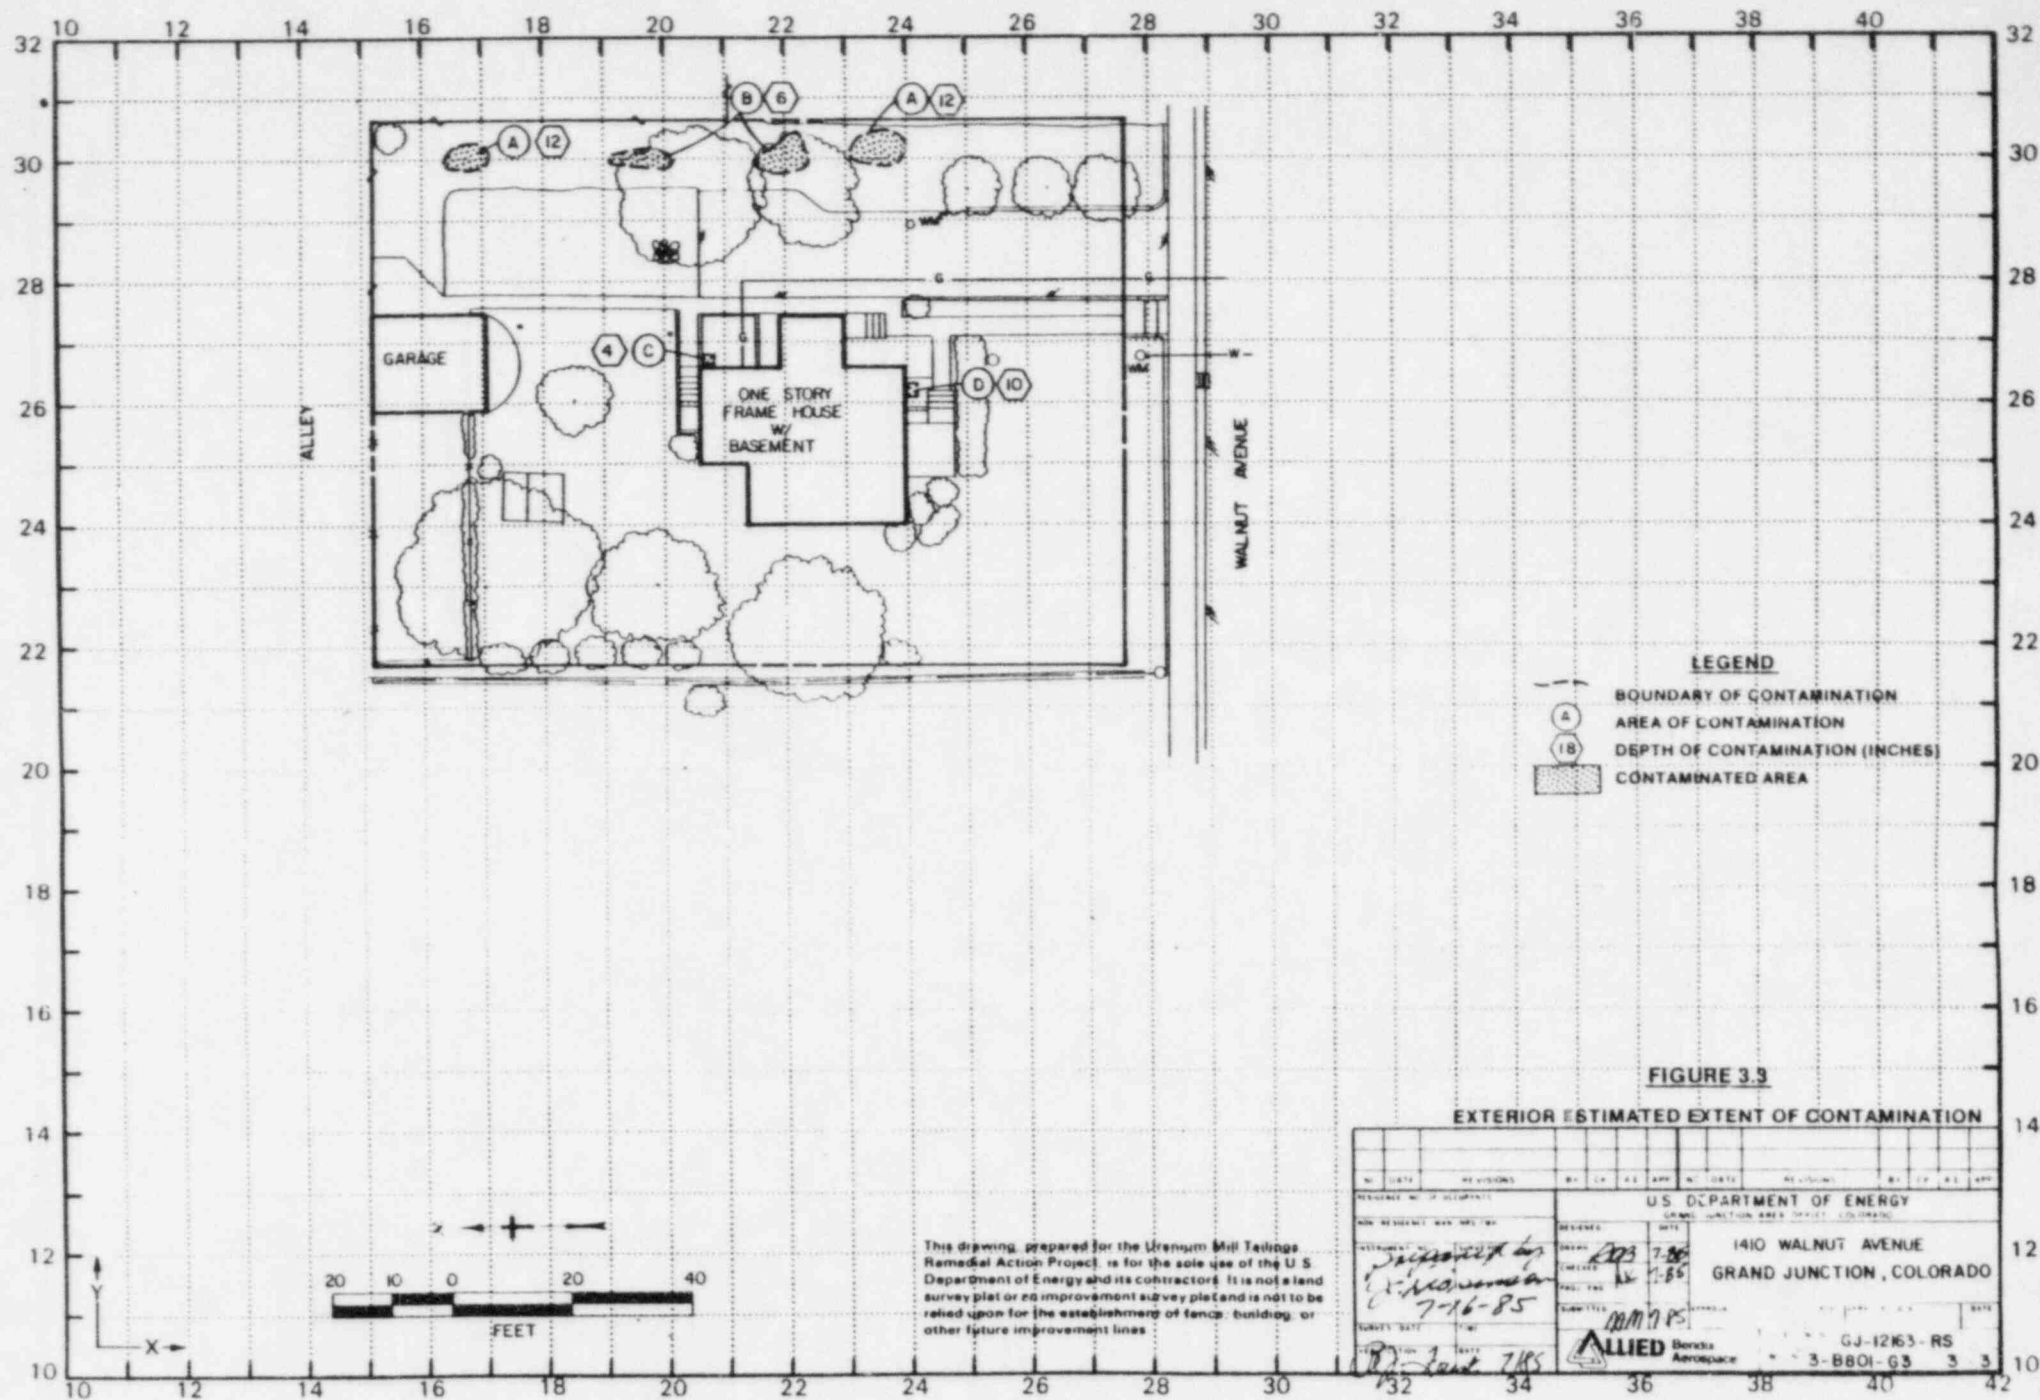
| Figure 3.3 | Exterior Estimated Extent of Contamination |

Appendix Figure 3.3 shows identified areas and estimated depths of contamination on this property, based on assessments of all measurements taken. As noted in this figure, areas recommended for remedial action that contain identified residual radioactive materials are:

- (Area A) Surface Material: Soil  
Direction From Primary Structure: Northeast and east  
Total Depth of Contamination: 12 inches  
Comments: 2 isolated deposits in garden  
Approximate Square Footage: 88

- (Area B) Surface Material: Soil  
Direction From Primary Structure: East  
Total Depth of Contamination: 6 inches  
Comments: 2 isolated deposits in garden  
Approximate Square Footage: 88

- (Area C) Surface Material: Concrete  
Direction From Primary Structure: Northeast  
Total Depth of Contamination: 4 inches  
Other (height or thickness): 4 x 18 x 24 (inches)  
Comments: Pre-poured concrete block is contaminated  
Approximate Square Footage: 4

- (Area D) Surface Material: Concrete  
Direction From Primary Structure: South  
Total Depth of Contamination: 10 inches  
Other (height or thickness): 4 x 18 x 24 (inches)  
Comments: Pre-poured concrete block and the underlying soil are contaminated  
Approximate Square Footage: 6

It is recommended that no remedial action be performed and that an indoor RDC measurement be completed on this property. If the RDC measurement exceeds EPA standards, then the REA will be revised and remedial action accomplished in accordance with the Vicinity Property Management and Implementation Manual. If EPA standards are not exceeded, then the no-action recommendation will be considered valid, and a Property Completion Report will be prepared for DOE certification.

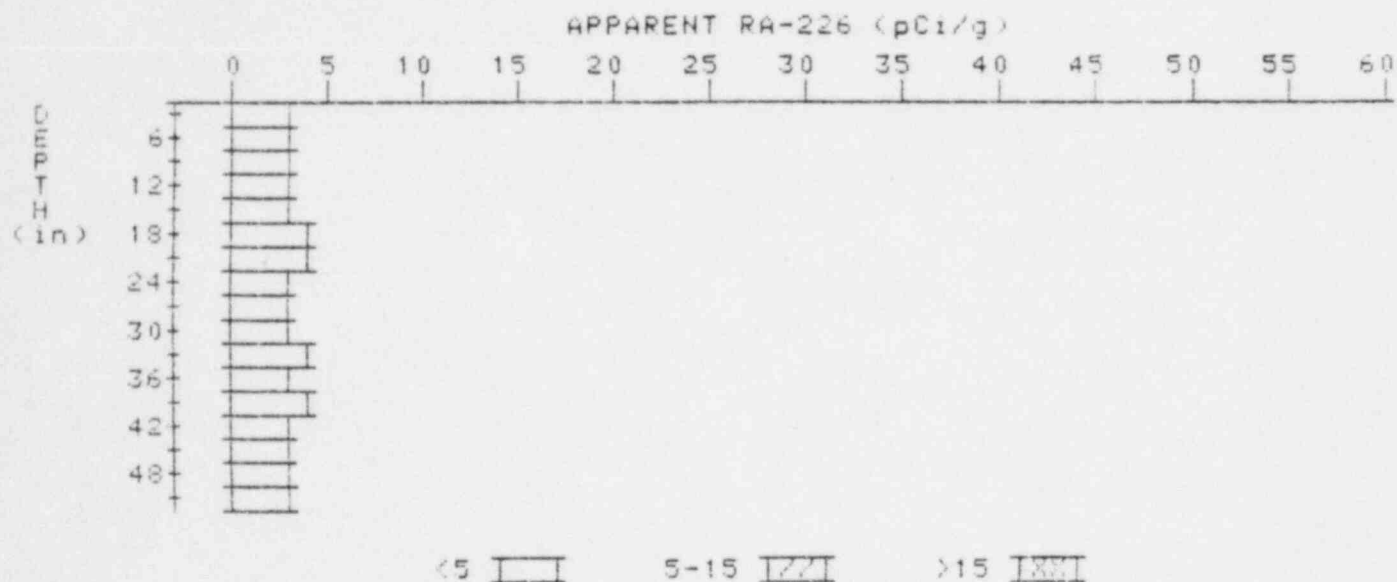
# APPARENT RADIUM-226 CONCENTRATION DECONVOLUTION GRAPH

HOLE NUMBER: 9

LOCATION: 241239
