Subject: Waterford 3 SES
Docket No. 50-382
License No. NPF-38
Reporting of Licensee Event Report

Reporting of Licensee Event Report (LER 95-005-01)

WATERFORD STEAM ELECTRIC STATION UNIT 3

REVISION 1 TO ROSEMOUNT INSTRUMENT TRANSMITTER ERRORS

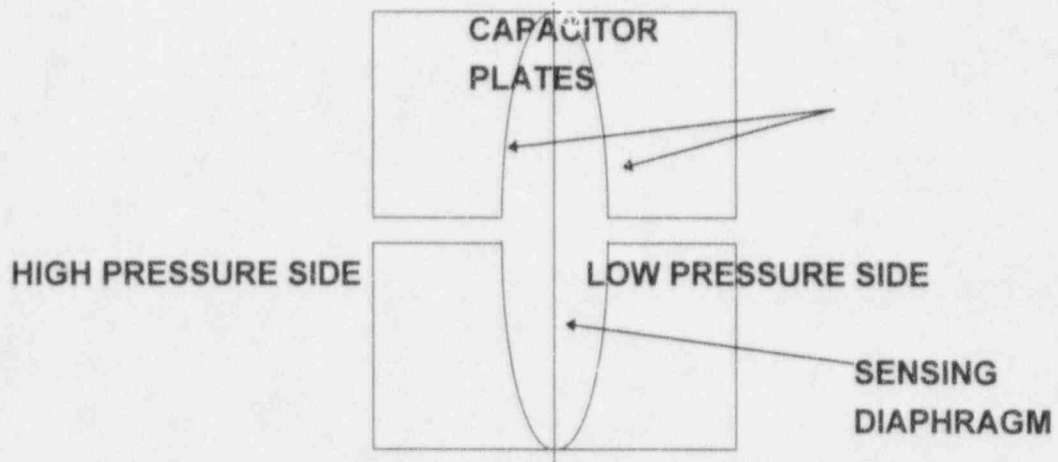
FIGURE 1

The Rosemount D/P cell is a variable capacitance device. In the cell, differential pressure moves the sensing diaphragm between two fixed capacitor plates (See Figure 1, Attachment A). The sensing diaphragm is centered between the fixed plates and welded to the cylindrical body of the cell. The varying capacitance between the sensing diaphragm and the plates (caused by application of a differential pressure across the diaphragm) is converted electronically to a 4-20 mA dc output that is directly proportional to the differential pressure.

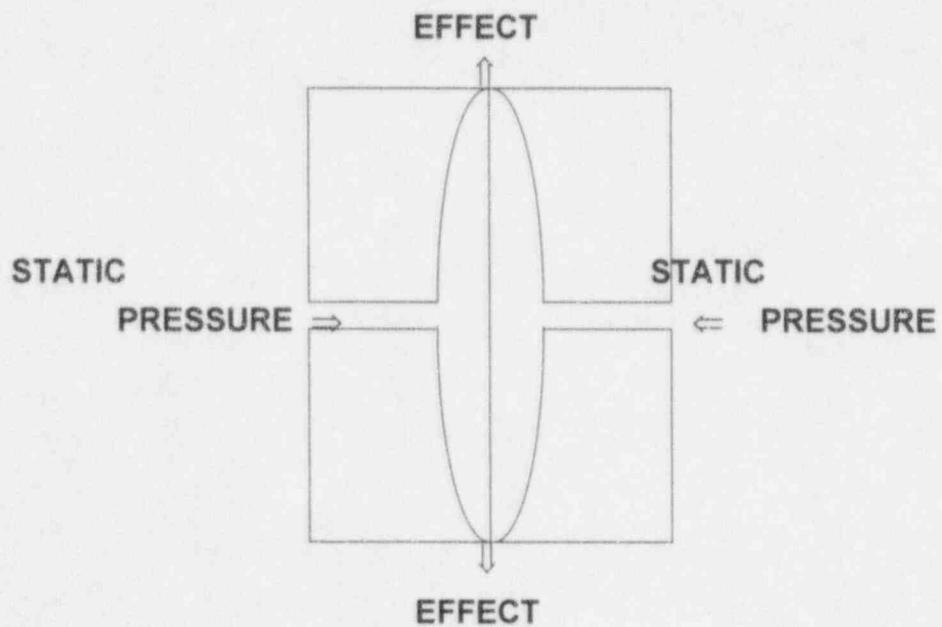
FIGURE 2

When high pressure (such as system operating pressure) is applied to both sides of the cell, a slight movement takes place increasing tension radially in the sensing diaphragm (See Figure 2, Attachment A). The net effect of the increased tension is that the sensing diaphragm moves toward the true center of the transmitter (this happens at all differential pressures except for zero differential pressure, where the diaphragm is already centered). As the static pressure increases, the tension increases causing a greater movement of the diaphragm. The movement of the diaphragm is always toward the zero differential, or center position. The effect of this movement (toward the center) on transmitter output depends on the application in which the transmitter is used.
