## LICENSEE EVENT REPORT (LER)

FACILITY NAME (1) Fort St. Vrain, Unit No. 1										DOCKET NUMBER (2) 0 5 0 0 0 2 6 7				PAGE (3) 1 OF 0 5	
TITLE (4) Loop Shutdown By The PPS On Loss Of Circulator Bearing Water															
EVENT DATE (5)			LER NUMBER (6)				REPORT DATE (7)			OTHER FACILITIES INVOLVED (8)					
MONTH	DAY	YEAR	YEAR	SEQUENTIAL NUMBER	REVISION NUMBER	MONTH	DAY	YEAR	FACILITY NAMES N/A				DOCKET NUMBER(S) 0 5 0 0 0		
0 7	2 2	8 5	8 5	0 1 1	0 0 0	0 8	2 1	8 5					0 5 0 0 0		
OPERATING MODE (9) N		THIS REPORT IS SUBMITTED PURSUANT TO THE REQUIREMENTS OF 10 CFR 5: (Check one or more of the following) (11)													
POWER LEVEL (10) 0.5		20.402(b)				20.408(c)				99.73(a)(2)(iv)				73.71(b)

SUBJECT: Licensee Event Report  
85-011, Final Report

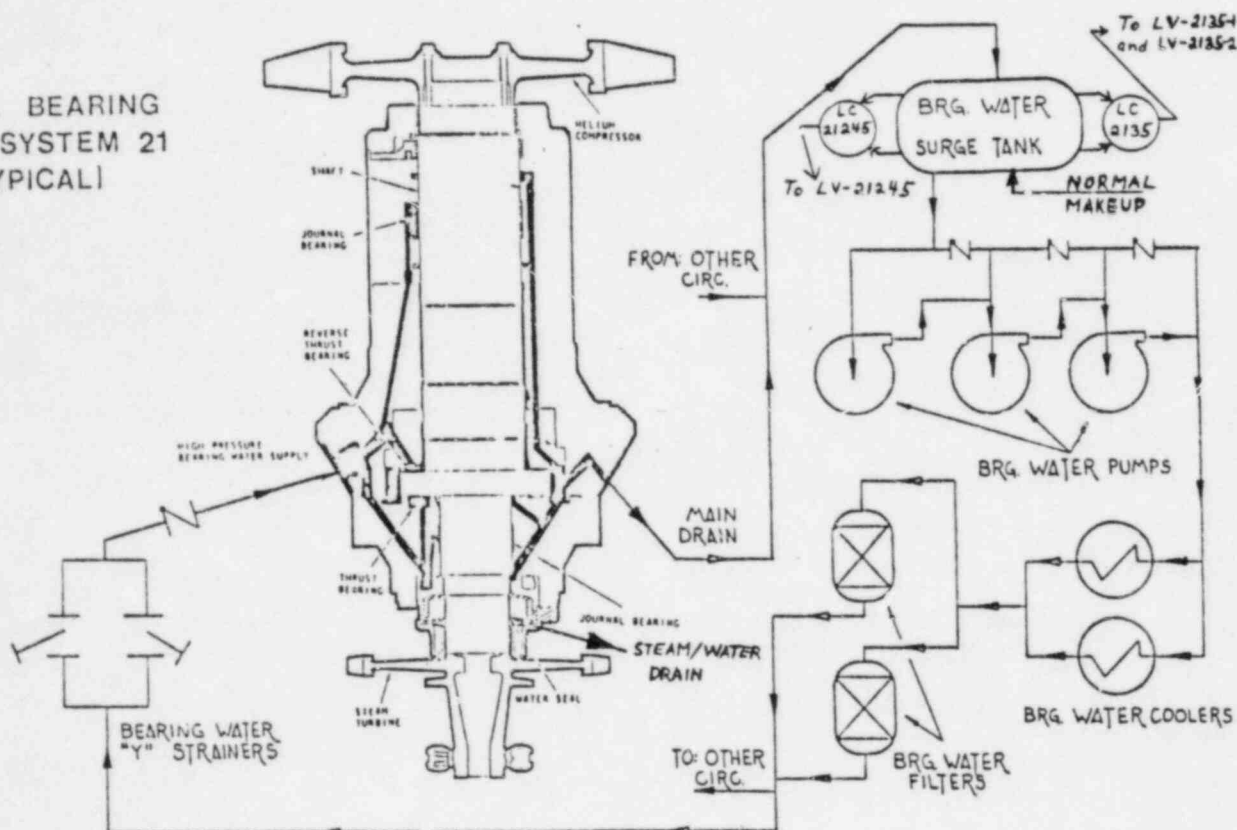
FIGURE 1

A Results (Instrumentation) Engineer assisting with a scheduled surveillance test (SR 5.3.4b1-A) inadvertently exercised the wrong level controller (LC-2135) on the Loop 1 helium circulator bearing water surge tank (T-2104). See Figure 1. The level in T-2104 dropped below the set point of low level switch LSL-2137 which tripped the Loop 1 bearing water pumps and closed the pump suction block valve LV-2137. This action prevents pump damage by cavitation. The pump shutdown was sensed by PDT-2133 on low differential pressure across the pumps. An alarm (PDAL-2133) was sounded in the control room when the differential pressure dropped below approximately 800 psi. Differential pressure switches (PDIS-21179, -21181, and -21183) between the bearing water supply cavity and the main drain of "B" helium circulator actuated at approximately 475 psid as designed, supplying an input to the PPS to initiate the isolation of the Loop 1 helium circulator auxiliary water system due to loss of circulator bearing water. The "B" helium circulator steam turbine was tripped, and the bearing water accumulator supplied bearing water as the circulator slowed down. When the circulator had slowed sufficiently, the brake and seal were automatically set and all Loop 1 bearing water supply and return lines were isolated. The Loop 2 "C" circulator and steam generator EES section continued to operate providing core cooling during this event. The reactor power was reduced to approximately 0.06%, and Loop 1 was restored to operation in approximately one hour. The helium circulators, their auxiliary systems, and the PPS system responded as designed to the low surge tank water level. The surveillance test was successfully completed after restoring Loop 1 to operation.

The cause of the Loop 1 shutdown on July 22, 1985 was the mistaken operation of the bearing water surge tank level controller, LC-2135, instead of the correct level controller, LC-21245, by a Results Engineer while performing the scheduled surveillance test SR 5.3.4b1-A. This lowered the level in the Loop 1 bearing water surge tank to the point where the Loop 1 bearing water pumps were automatically shutdown, and the loss of bearing water resulted in the PPS action Loop 1 Shutdown.

The surveillance test procedure SR 5.3.4b1-A involved in this event was reviewed with regard to human factors. It was found that the root cause of the event was that the location of the proper controller is not specified in the procedure. There are two level controllers on the bearing water surge tank. Each controller is only accessible from a different level in the reactor building, and cannot be seen from the other controller because of intervening piping and equipment. Also contributing to the event was the relative inexperience of the person involved. The surveillance test is being revised to improve human factors considerations, and the personnel will be retrained.
