Department of Energy
Albuquerque Operations Office
P.O. Box 5400
Albuquerque, New Mexico 87185-5400

This concerns the Department of Energy (DOE) Uranium Mill Tailings Remedial Action Green River, Utah, disposal site ground water compliance strategy. As a follow-up to the discussions on July 25 and August 8, 1996, and the Nuclear Regulatory Commission (NRC) letter dated August 29, 1996, enclosed are the "Analysis and Discussion of the Original Ground Water Protection Strategy" and the "Green River Neutron Probe History."

ANALYSIS AND DISCUSSION OF THE ORIGINAL GROUND WATER PROTECTION STRATEGY (MCLs/BACKGROUND), GREEN RIVER SITE, UTAH

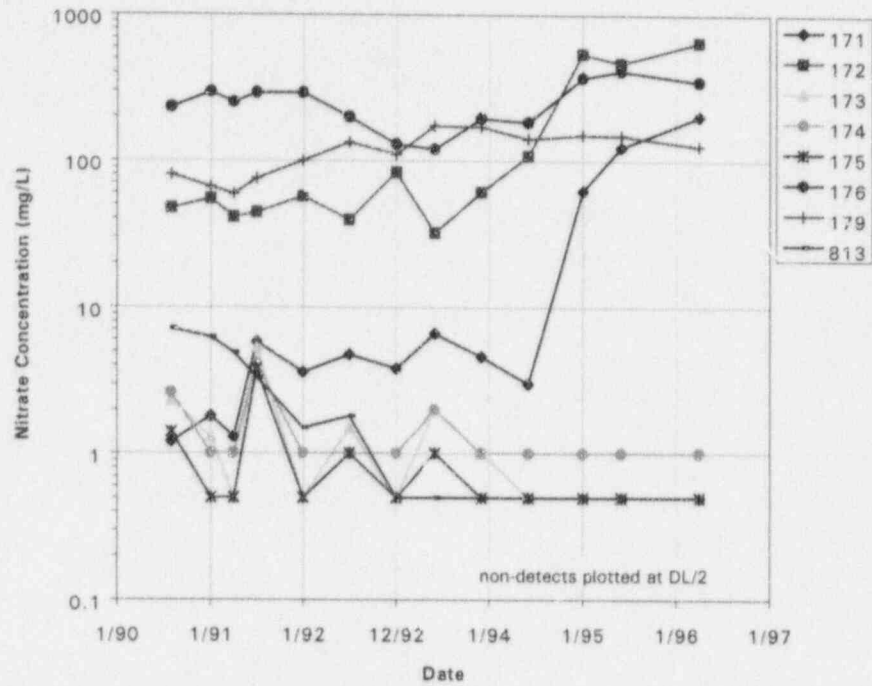
FIGURE 2.
NITRATE AT DISPOSAL SITE MONITOR WELLS, GREEN RIVER, UTAH

Nitrate distribution patterns (Figure 2) are quite striking, with concentrations in well 0171 increasing from nearly uncontaminated values to over 100 milligrams per liter (mg/L) over the course of two sampling rounds. Monitor well 0171 is now part of a group of four wells that are affected by a high-nitrate source. Sulfate and TDS patterns (Figures 3 and 4 respectively) have recently shown a significant increase in another well (0172) and are now higher than all of the other wells, which are closely clustered. (TDS tracks sulfate because sulfate and its counter-ion sodium are the dominant constituents in ground water at this site). Uranium trends (Figure 5) are somewhat less coherent. Well 0179 consistently exhibits high levels, wells 0173 and 0174 have consistently shown very low levels near the detection limit, and several of the remaining wells showed a simultaneous decline of approximately an order of magnitude in late 1994. Selenium concentrations (Figure 6) have been consistently high in two wells (0176 and 0179) and scattered, but low in the remaining wells.

Interpretation of these trends is ambiguous. Nitrate, sulfate, and uranium are potential indicators of tailings-derived moisture, but they have not changed in concert. Nitrate has increased sharply in well 0171, whereas sulfate has increased primarily in well 0172. At the same time uranium has declined in well 0171 and increased slightly in well 0172. Nitrate and uranium changes are synchronous, occurring in the latter half of 1994, but are inversely related. Thus, there is no single source, either preexisting contamination or tailings seepage, that can uniquely explain these trends. These data do not preclude the possibility of significant seepage from the cell, but are more readily explained by migration of preexisting processing-related contamination through the fractured aquifer beneath the disposal cell. Even if tailings seepage were the source, seepage at this stage is most likely related to transient drainage and thus not representative of cell failure.
