LICENSEE EVENT REPORT (LER)

FACILITY NAME (1)
McGuire Nuclear Station - Unit 2

TITLE (4)
Control Rod Drive Mechanism Fabrication Error

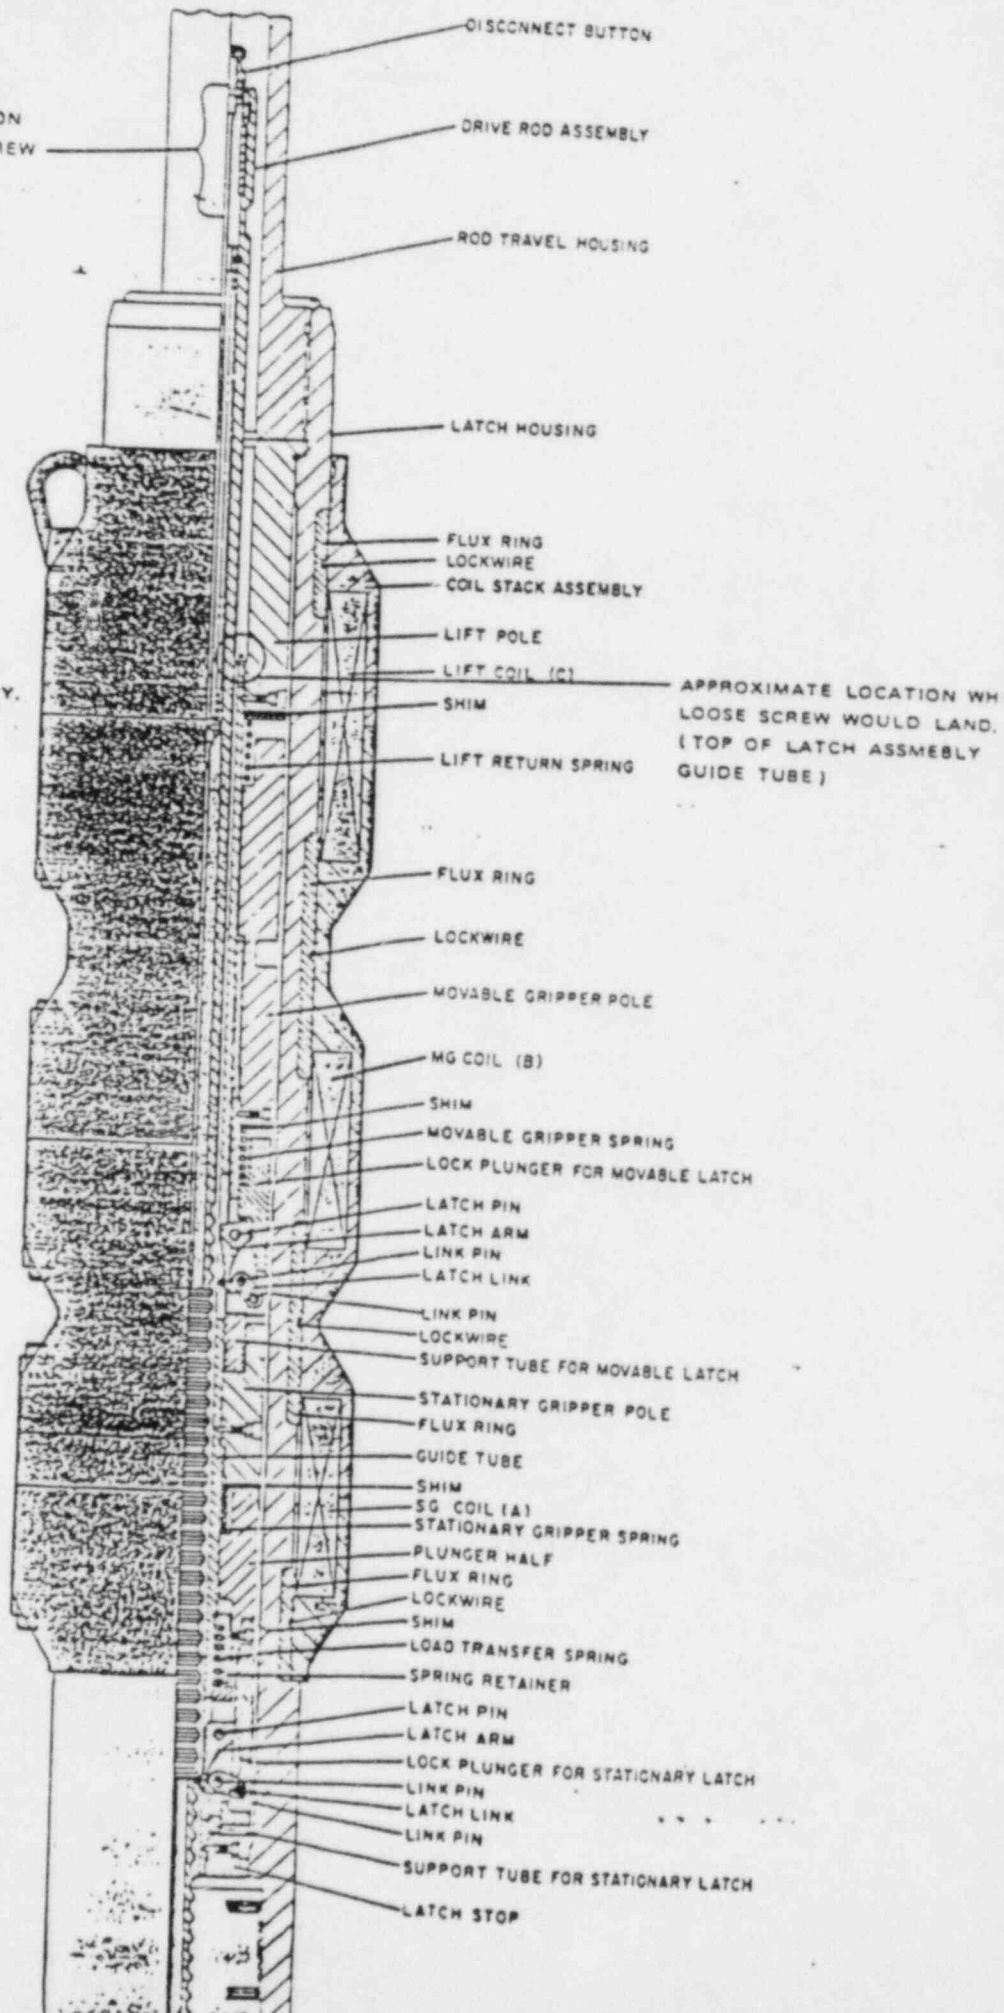
Enclosure 1.0.

APPROXIMATE LOCATION
OF BREECH GUIDE SCREW

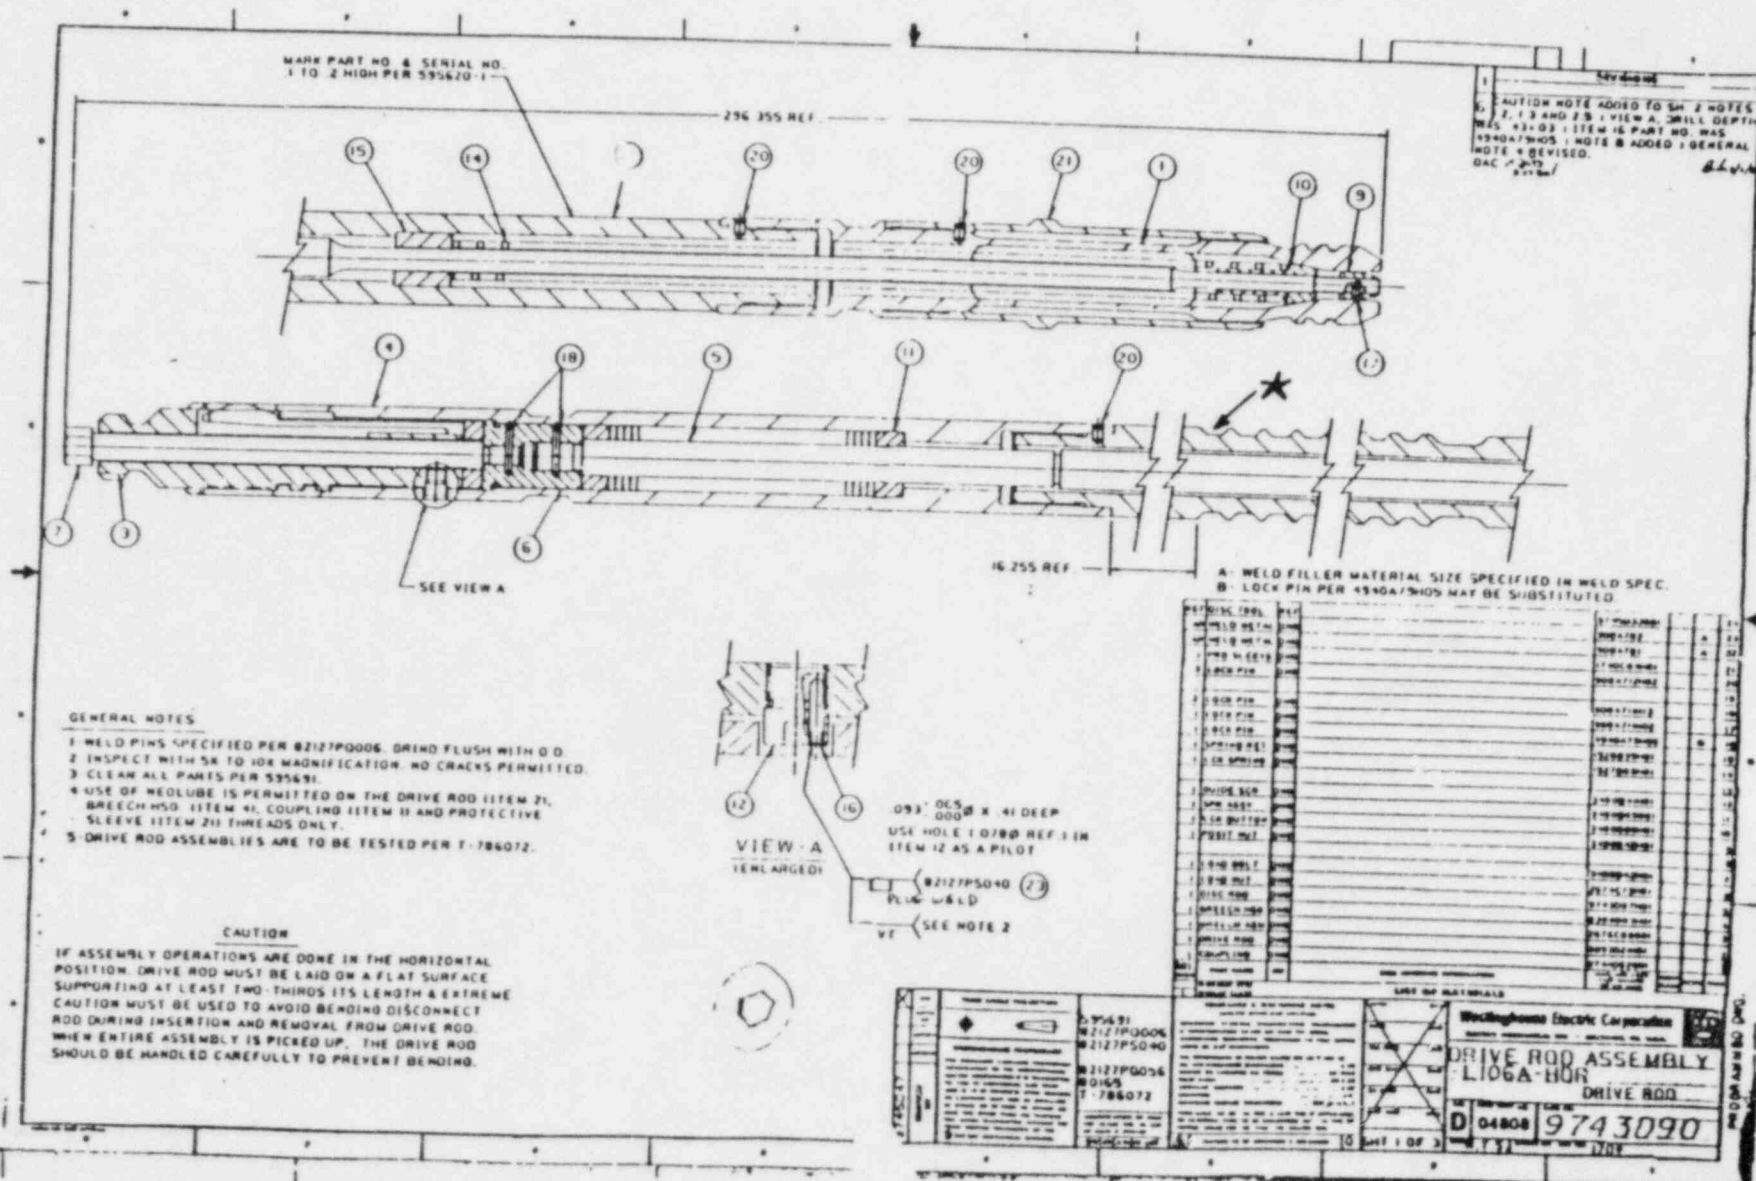
ENCLOSURE 2.0

On November 29, 1984, the on-site investigation had determined that the control rod drive mechanism (CRDM) heavy drive rod assembly guide screw rotated out of position, fell from the drive rod and landed on top of the CRDM latch assembly where it became lodged and prevented driveline motion. The guide screw is normally locked into position by a welded-in pin that intersects the mating threads thus preventing the guide screw from rotating out of position. (See enclosures)

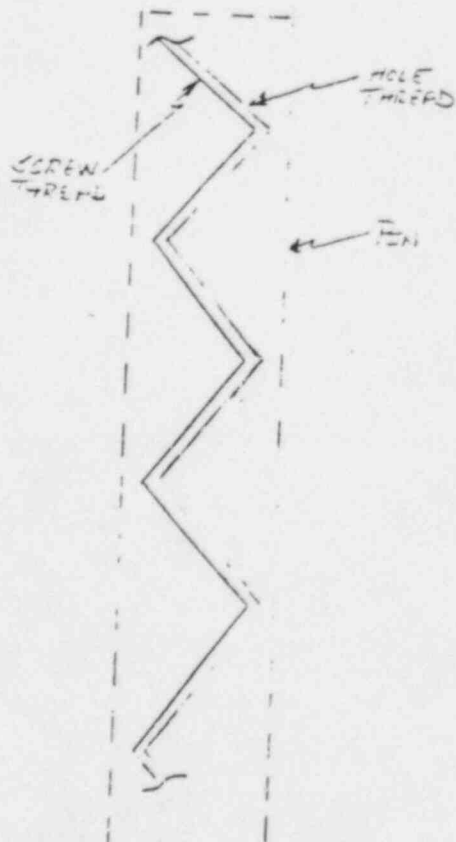
CORRECT PLACEMENT
OF LOCK PIN

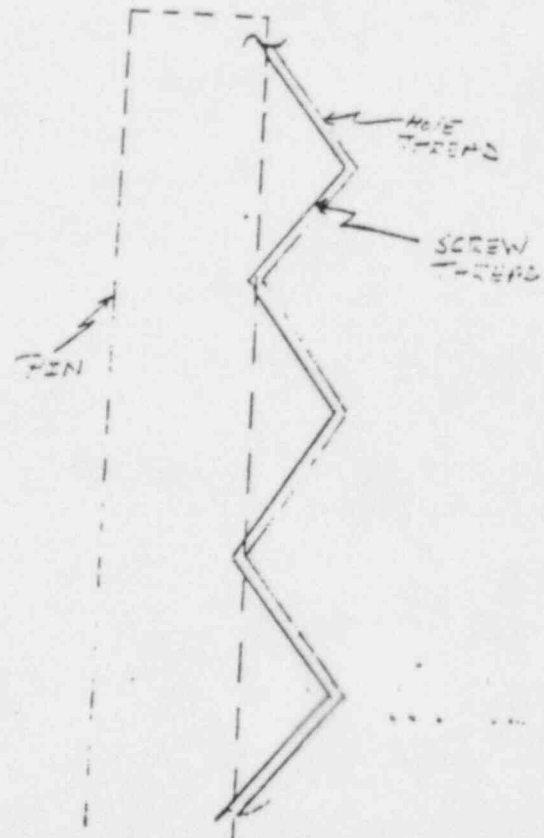
PLACEMENT OF LOCK PIN
IN DEFECTIVE CORDING

Four of the five drive rods were redrilled and repinned.
