SUBJECT: SUMMARY OF THE OPERATING REACTORS EVENTS
MEETING ON AUGUST 13, 1985 - MEETING 85-13

OPERATING REACTORS EVENTS BRIEFING (85-13)

AUGUST 13, 1985

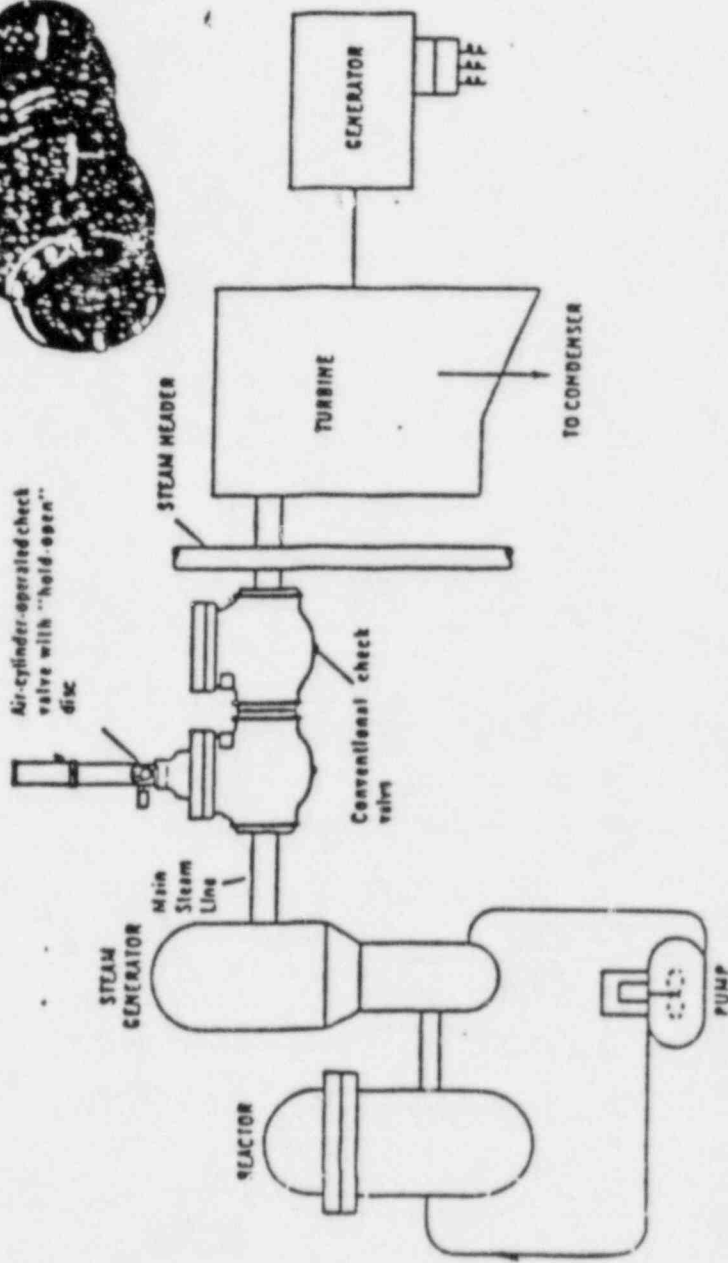
TURKEY POINT
MSIV

- PLANT STATUS
 - UNIT 4 AT POWER, UNIT 3 STARTUP FROM 100 DAY REFUELING
- DEFICIENCY
 - INADEQUATE STORED CLASS 1 AIR SUPPLY TO CLOSE MSIVs AT LOW OR NO STEAM FLOW

- RE-EVALUATED ACCIDENTS MSIVs TAKEN CREDIT FOR
 - MSLB COULD RESULT IN CONTINUED BLOWDOWN AND LOSS OF MOTIVE POWER FOR STEAM DRIVEN AUX FEED PUMPS
- IDENTIFICATION AND NOTIFICATION

- CORRECTIVE ACTIONS
 - PROCEDURES REQUIRING PLANT SHUTDOWN ON LOSS OF PLANT AIR
 - BACKUP DIESEL DRIVEN AIR COMPRESSOR AVAILABLE
 - DESIGN MODIFICATION
- GENERIC IMPLICATIONS

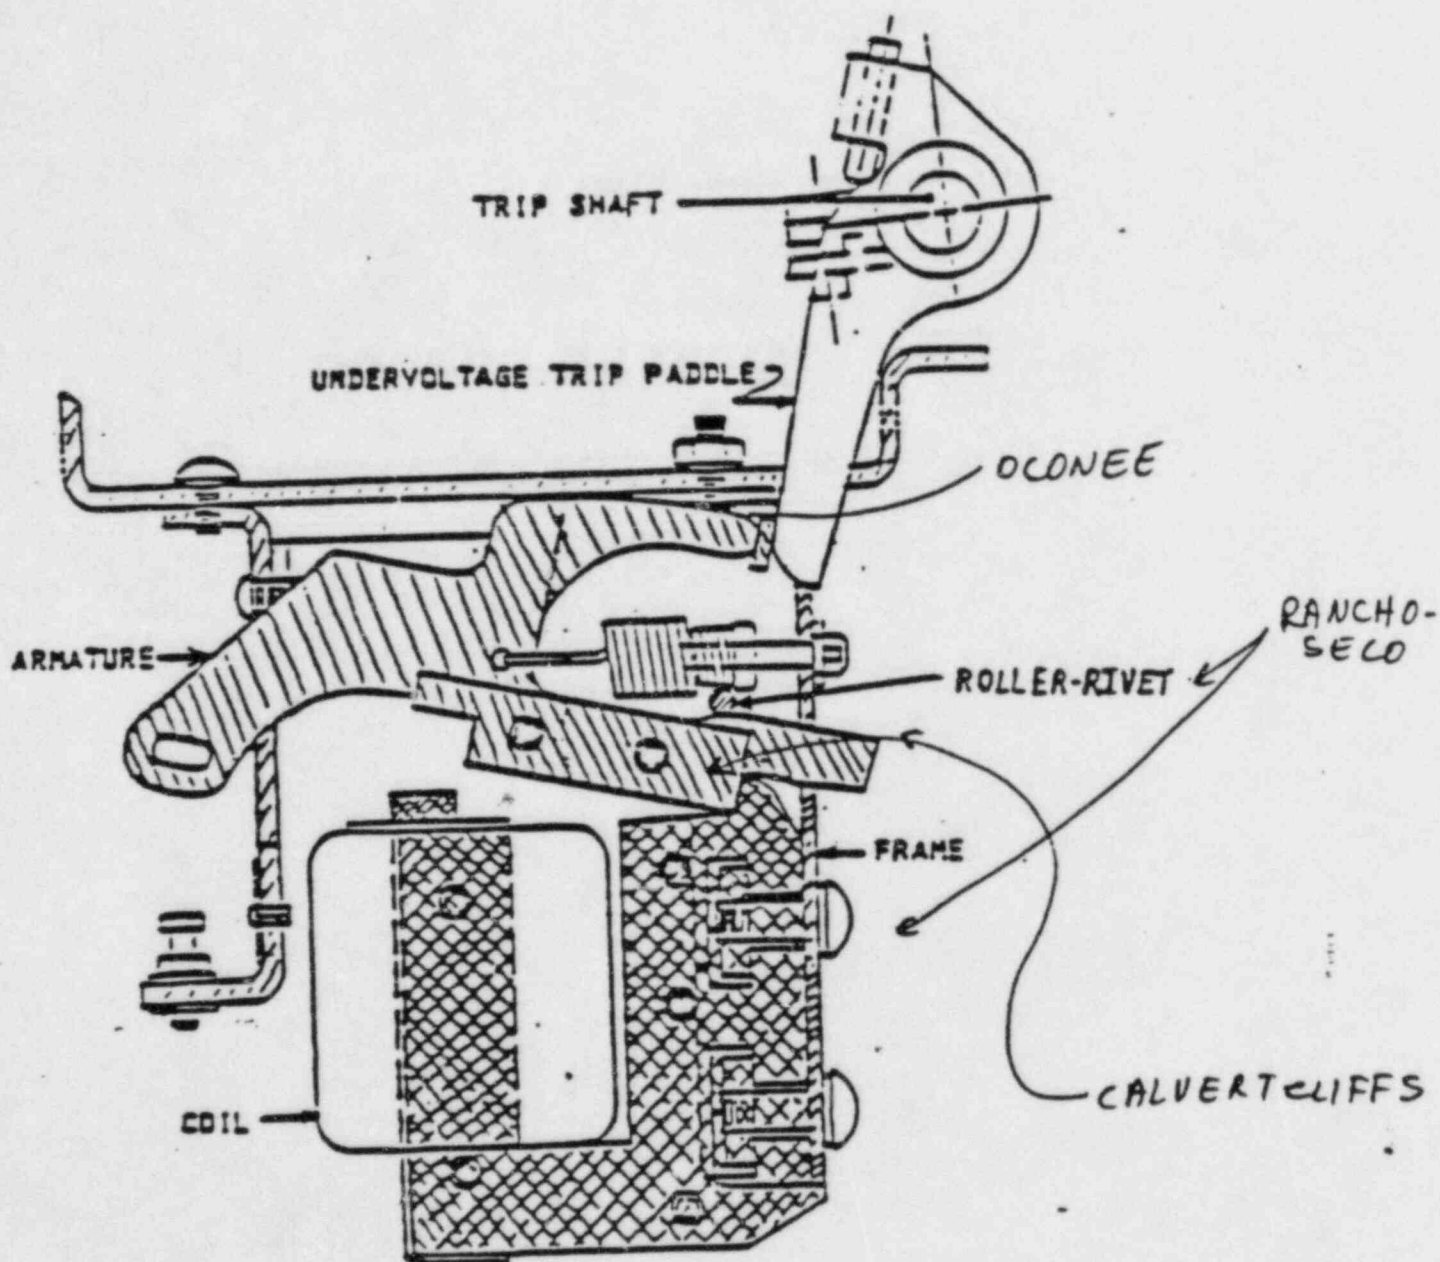
UNDervOLTAGE TRIP DEVICE
COIL DE-ENERGIZED

- UNIT 1 AT 100% POWER, UNDERVOLTAGE TRIP ATTACHMENT (UVTA) OF GE REACTOR TRIP BREAKER RESPONDED SLOW DURING SURVEILLANCE TESTING.
- UVTA TRIPPED IN 1738 MSEC VS. 80 MSEC REQUIREMENT. (40 MSEC, NOMINAL)

- SIMILAR EVENT OCCURRED AT OCCONEE 1 ON APRIL 30, 1985. (1530 MSEC RESPONSE TIME). (PAINT CHIPS)
- REACTOR TRIP BREAKER (RTB) HAD PASSED THE 13 POINT TEST (PERFORMED BY DUKE POWER COMPANY) FOR NUCLEAR SAFETY GRADE CERTIFICATION.

- ORIGINALLY DUKE STATED THAT SMALLER TOLERANCES BETWEEN THE ARMATURE AND MOUNTING NUTS COULD BE CAUSE OF DELAYED TRIPPING.
- LICENSEE CORRECTIVE ACTION - DUKE HAS PUT THE INTERNALS OF THE NEW UVTA INTO OLD HOUSING. DEVICE IS BACK IN-SERVICE ON LINE. FAILURE MECHANISM MAY NEVER BE KNOWN-ALL EVIDENCE LOST.
