Northern States Power Company

MONTICELLO NUCLEAR GENERATING PLANT  
Docket No. 50-263 License No. DPR-22

LER 96-010  
Panel Fire Barrier Not in Correct Position

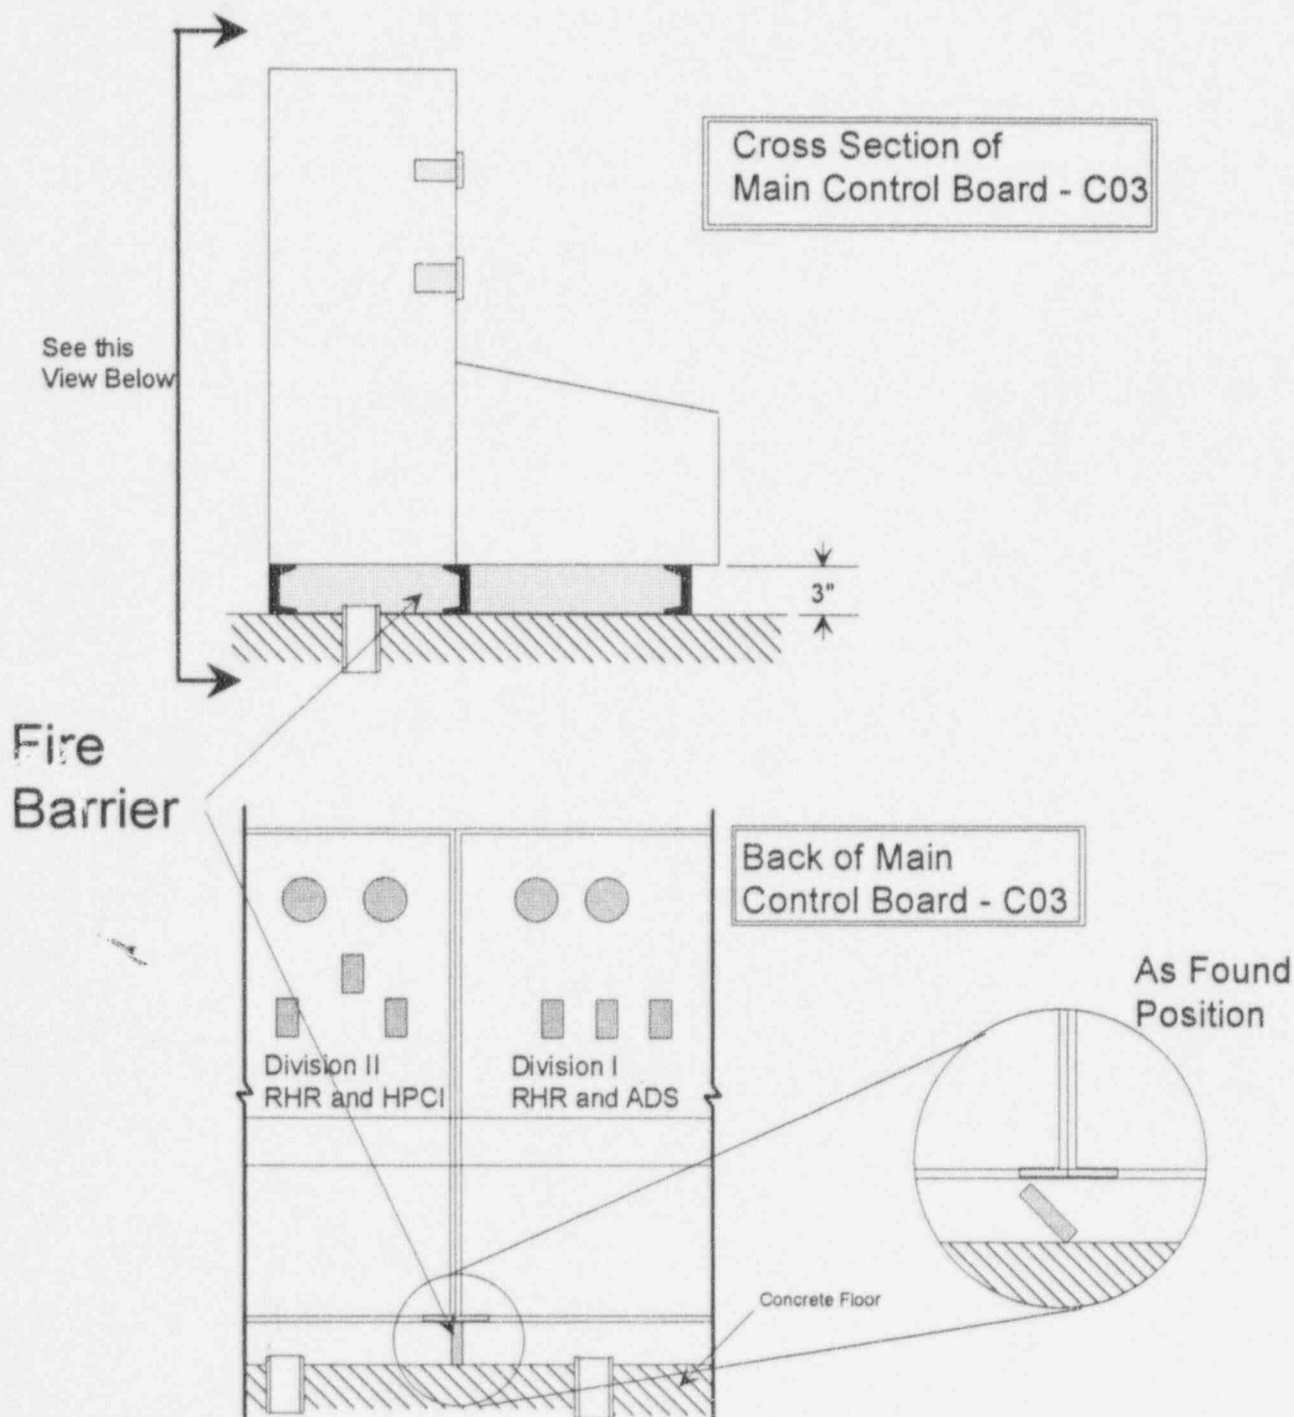
## Location of Misplaced Fire Barrier

On October 16, 1996, at approximately 1030 with the plant at full power, it was determined that a reportable condition existed. One of the fiberboards separating two panels<sup>1</sup> (EIS Component Code: PL) of main control board section CO3 was out of place (see attached figure). This was discovered during a plant walkdown. The main control board consists of several panels. Each panel sets on steel channels. Each control board panel is open at the bottom and the back. Ends of the panels are solid, where divisional separation is required. A fiberboard provides divisional separation between the floor and the bottom of the ends of the panels. One of these fiberboards was found out of position in the main control board panels. It was found at approximately a 45 degree angle to vertical (see attached figure).

The fiberboard barrier used to provide separation in CO3 was found out of position.

During modifications, or other work, the fiberboard barrier may have been bumped or moved. The fiberboard is located below the flange of the panel (see attached figure) and not easily identifiable. It is not known how long this barrier was out of place.

The control board panels do not contain unnecessary combustible materials. In the event of a fault or electrical fire which could affect divisional separation, the fiberboard would inhibit the material or flames from entering the adjacent panel. With the panel fire barrier out of position, both divisions on CO3 could have been affected by the fire. This is a very unlikely scenario due to the lack of combustibles and due to the location and size of the opening. The opening is located at the bottom of the panel side. The height of the opening is 3 inches.

1. The barrier was restored to its proper position (Work Order # 9602694).
2. Other barriers in C04 and C08 in the control room were checked. All of these barriers were found in the proper position (Work Order # 9602695).

Panel fire barriers like the one found out of position will be periodically verified to be in the proper position.
