**Florida
Power**

CORPORATION
Crystal River Unit 3
Docket No. 50-302

Subject: Licensee Event Report (LER) 96-024-01

FACILITY NAME (1) CRYSTAL RIVER UNIT 3 (CR-3)										DOCKET NUMBER (2) 0 5 0 0 0 3 0 2 1 OF 0 9					PAGE (3) 1 OF 0 9									
TITLE (4) Plant Modification Creates Unanalyzed Condition Regarding Emergency Feedwater Availability																								
EVENT DATE (5)			LER NUMBER (6)				REPORT DATE (7)			OTHER FACILITIES INVOLVED (8)														
MONTH	DAY	YEAR	YEAR	SEQUENTIAL NUMBER	REVISION NUMBER	MONTH	DAY	YEAR	FACILITY NAMES N/A				DOCKET NUMBER(S) 0 5 0 0 0											
1	0	1	1	9	6	9	6	0	2	4	0	1	0	2	1	4	9	7	N/A	0	5	0	0	0
OPERATING MODE (9) 5		THIS REPORT IS SUBMITTED PURSUANT TO THE REQUIREMENTS OF 10 CFR 5: (CHECK ONE OR MORE OF THE FOLLOWING) (11)																						
POWER LEVEL (10) 0 0 0 0		20.402(b)				20.405(c)				50.73(a)(2)(iv)				73.71(b)

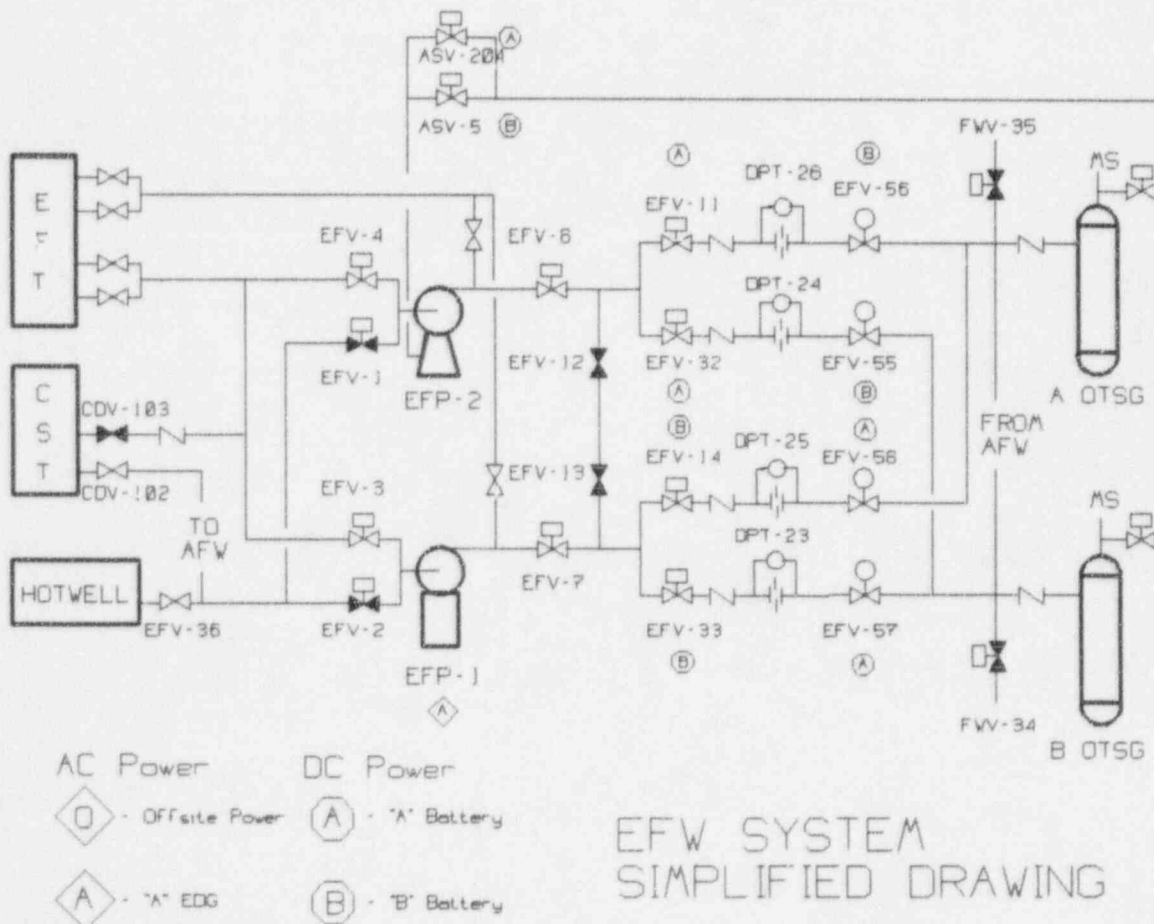
Figure 1

The Emergency Feedwater (EFW) system provides secondary coolant to the Once Through Steam Generators (OTSG) in the event the Main Feedwater System [SJ] is rendered inoperable and is unable to perform this function. The EFW system has two equipment trains (See Figure 1). Each train is capable of feeding both Steam Generators. The two trains take suction from a common line. The flow control valves associated with each pump operate on DC power. The valves are normally open, and require power to close. The valves remain open when the EFW system is in the standby mode. The "A" train pump is EFP-1 and is aligned to the "A" Emergency Diesel Generator during LOOP conditions. The "B" train pump is EFP-2. Motive Steam for the EFP-2 turbine is supplied from the Main Steam [SA](MS) header. The system includes two valves, ASV-5 and ASV-204, which open to admit steam to EFP-2 when the Emergency Feedwater system actuates. The valves are installed in parallel with one another. Only one of the valves must open in order to start the pump. Valve ASV-5 receives an OPEN command from an actuation of the "B" Emergency Feedwater Initiation and Control (EFIC) train. When ASV-204 was installed in 1985, the valve was powered from "B" Class 1E power sources and received its OPEN command from the "B" EFIC train. In 1987, FPC moved the ASV-204 power supply and OPEN command to the "A" side Class 1E sources so the valve opened on the "A" EFIC actuation train signal thus allowing use of EFP-2 for "A" EDG load reduction.
