Subject: Licensee Event Report 96-009 Revision 0 for the Fort Calhoun
Station

Fort Calhoun Station Unit No. 1

Pressurizer Safety Valves As-Found Lift Appears Outside Acceptance Criteria

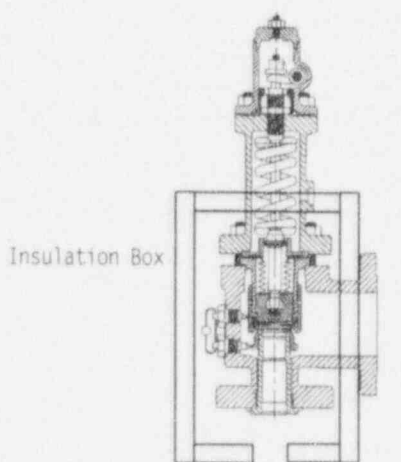
The FCS valve insulation configuration places an insulated box around the inlet flange, body and lower half of the bonnet (see figure 1). This is to ensure that loop seal water temperature remains near the flash point to minimize the formation of water slugs in the discharge piping. Analysis has demonstrated that an insulated valve minimizes the shift in setpoint which occurs between steam inlet conditions and those for a loop seal. Therefore, it is essential to maintain the current valve insulation configuration.

Correct Installation

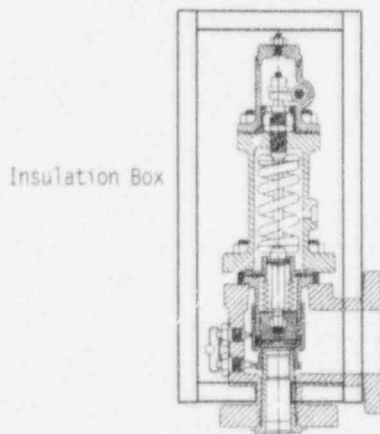
Figure 1

An inspection of the new insulation box, used for initial "As-Found" tests, revealed that the insulation box was too long and caused the bottom of the box to contact the lower spool piece flange. This flange is much larger than the inlet flange and resulted in the two halves of the box being splayed out from top to bottom. The Wyle technicians concluded that the box was intended to go on the valve with the long end up which produced a better fit but entirely enclosed the valve and bonnet within the box (see Figure 1). There are no markings on the box or sketches in the test procedure to indicate the correct orientation of the insulation box. In addition, the thickness of insulation within the new box is 1" compared to the 2" batting used for the in-plant boxes. The clearance between the valve body and insulation permitted hot convective currents to carry heat from the body to the bonnet which was enclosed within the inverted box. This caused the elevated temperatures, which in turn caused the setpoint to shift downward about 1.5% from the as-left settings from previous testing in 1995. These elevated temperatures are an upper bound on what the valve could experience and the resulting downward setpoint shift is therefore a lower bound.

Valve bonnet upper temperature limits were not specified in the vendor test procedure and the test insulation box was improperly constructed and installed.

Incorrect Installation

The vendor test procedure will be revised to specify acceptable upper limits on valve bonnet temperatures used prior to testing, and to ensure that either a correctly modified test insulation box or the plant insulation box is used and properly installed on the safety valve to be tested. These procedure revisions will be completed by December 31, 1997.
