Commonwealth Edison Company
LaSalle Generating Station
2601 North 21st Road
Marseilles, IL 61341-9757
Tel 815-357-6761

Licensee Event Report #96-021-01, Docket #050-373 is being submitted to your office in accordance with 10 CFR 50.73(a)(2)(i) and (ii).

FACILITY NAME (1): LaSalle County Station Unit One										DOCKET NUMBER (2) 05000373		PAGE (3) 1 of 9		
TITLE (4) Inadequate Review of Modification of Main Control Room Atmospheric Control System Radiation Monitoring Logic Results in an Unreviewed Safety Question														
EVENT DATE (5)			LER NUMBER (6)			REPORT DATE (7)			OTHER FACILITIES INVOLVED (8)					
MONTH	DAY	YEAR	YEAR	SEQUENTIAL NUMBER	REVISION NUMBER	MONTH	DAY	YEAR	FACILITY NAME LaSalle County Station Unit Two			DOCKET NUMBER 05000374		
12	17	96	96	021	01	02	14	97	FACILITY NAME			DOCKET NUMBER		
OPERATING MODE (9)		4		THIS REPORT IS SUBMITTED PURSUANT TO THE REQUIREMENTS OF 10 CFR §: (Check one or more) (11)										
POWER LEVEL (10)		000												
			<input type="checkbox"/> 20.2201(b)			<input type="checkbox"/> 20.2203(a)(3)(i)			<input type="checkbox"/> 50.73(a)(2)(iii)			<input type="checkbox"/> 73.71(b)		
			<input type="checkbox"/> 20.2203(a)(1)			<input

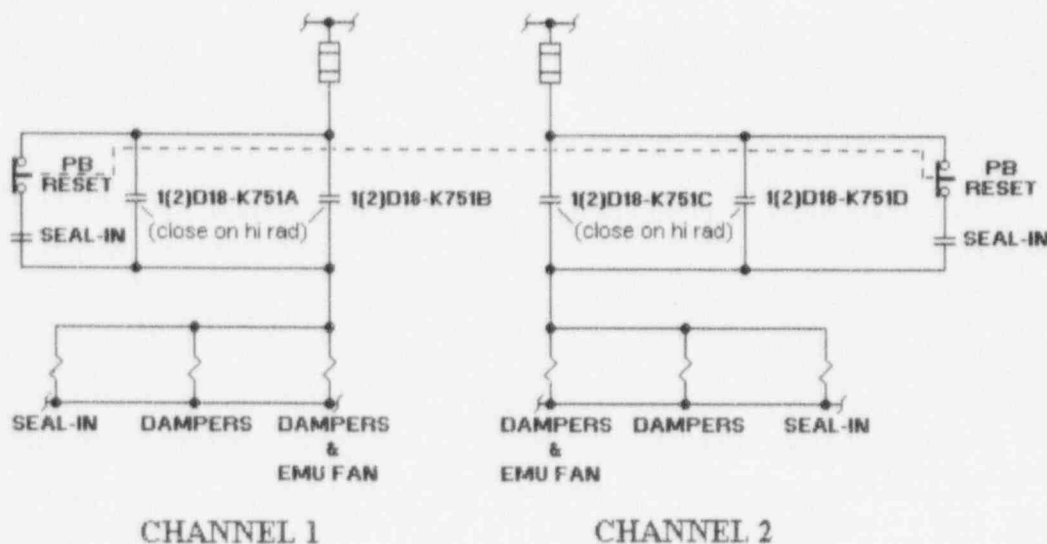
**UNIT 1(2) MCRACS RADIATION MONITOR TRIP LOGIC PRIOR TO INSTALLATION OF
MODIFICATION M01-88-003A(B)**

For the purpose of identifying the planned corrective actions, the following historical background is provided. The MCRACS consists of two 100% capacity redundant HVAC trains. Each train is supplied through its' own ventilation intake. Each ventilation intake is equipped with four radiation monitors installed and oriented approximately 90 degrees apart around the perimeter of each intake. Normal operating mode is for one of the two trains to be in operation. In the original design, a high radiation signal from any one of the four radiation monitors in an intake resulted in an automatic isolation of the normal outside air and actuation of the Emergency Makeup Filtration mode of the operating train.

Due to the one-out-of-four logic and the very low setpoint (2.5 mR/hr), the system was subject to spurious actuations. In 1989, LaSalle County Station investigated several modifications to the system to reduce the occurrence of spurious actuations. One proposal was to revise the actuation logic to require a signal from minimum of two radiation monitors in order to actuate the emergency mode.

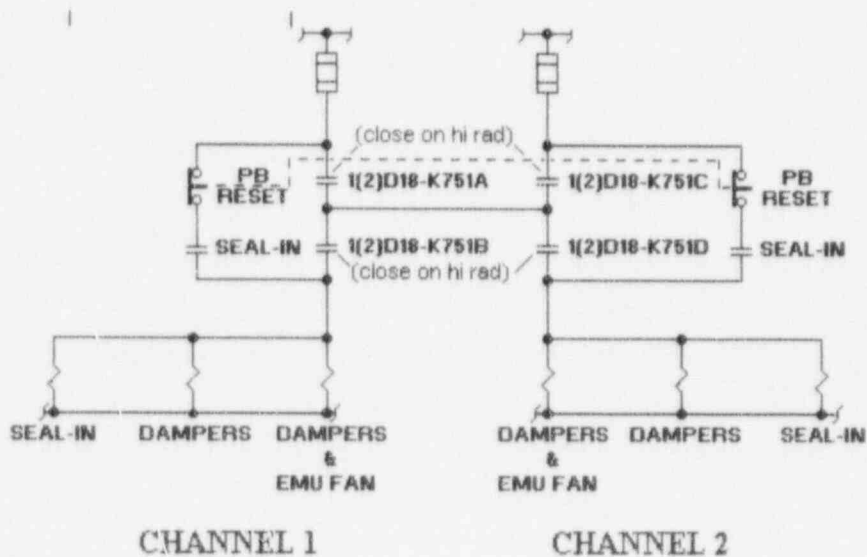
ATTACHMENT B**UNIT 1(2) MCRACS RADIATION MONITOR TRIP LOGIC AFTER INSTALLATION OF
MODIFICATION M01-0-88-003A(B)**

On July 13, 1993, and July 26, 1993, modification of Unit 1 and Unit 2 Main Control Room Atmosphere Control System (MCRACS) Radiation Monitoring System (PR/VC) [IL] logic was made to prevent spurious Engineered Safety Features (ESF) actuations. Prior to installation of the modifications, the logic for initiation of the Emergency Makeup Mode due to High Radiation levels in the ventilation intakes consisted of four radiation monitors per intake divided into two channels to provide a one out of two taken once trip logic. See Attachment A. Due to this trip logic, a spurious trip of any one of the radiation monitors caused an ESF actuation. To eliminate spurious ESF actuations the modifications changed the trip logic for each Unit to require actuation of two monitors per channel to initiate the ESF actuation. See Attachment B.

The root cause of the inadequate safety evaluation for the modifications performed in 1993 was that LaSalle County Station failed to recognize that damper isolation for the control room ventilation air intakes is not functionally redundant. Hence, the modified design would have allowed a single failure to result in the failure to isolate one train.

The AE incorporated the request and the revised design was issued in September, 1992. This design no longer met the channel redundancy requirements in the design basis. This was not recognized during the review and approval process as the new design appeared to be a basic simplification of the design change which had been proposed and reviewed numerous times since 1990.

1. A modification will be developed to correct the installed design. The original channel separation and redundancy will be restored. The revised design will meet the single failure criterion of the design basis.
2. The Technical Specifications will be revised to conform to the design and to eliminate confusion in the wording of the action statement.
3. An ongoing detailed system design review of the MCRACS is already in progress as a result of previous concerns as identified in LER 96017.
4. A review of other modifications to the MCR Ventilation System which could affect the single failure criteria as it applies to the MCR Isolation Dampers and Control Circuitry will be conducted.
5. A review of the changes which removed FSAR drawings from the UFSAR to ensure that the information contained on the drawings is adequately referenced in the UFSAR for subsequent Safety Reviews.
