U.S. NUCLEAR REGULATORY COMMISSION
REGION I

REPORT NUMBER: 50-309/96-09

FACILITY: Maine Yankee Atomic Power Station

Maine Yankee Atomic Power Station NRC Inspection Report 50-309/96-09

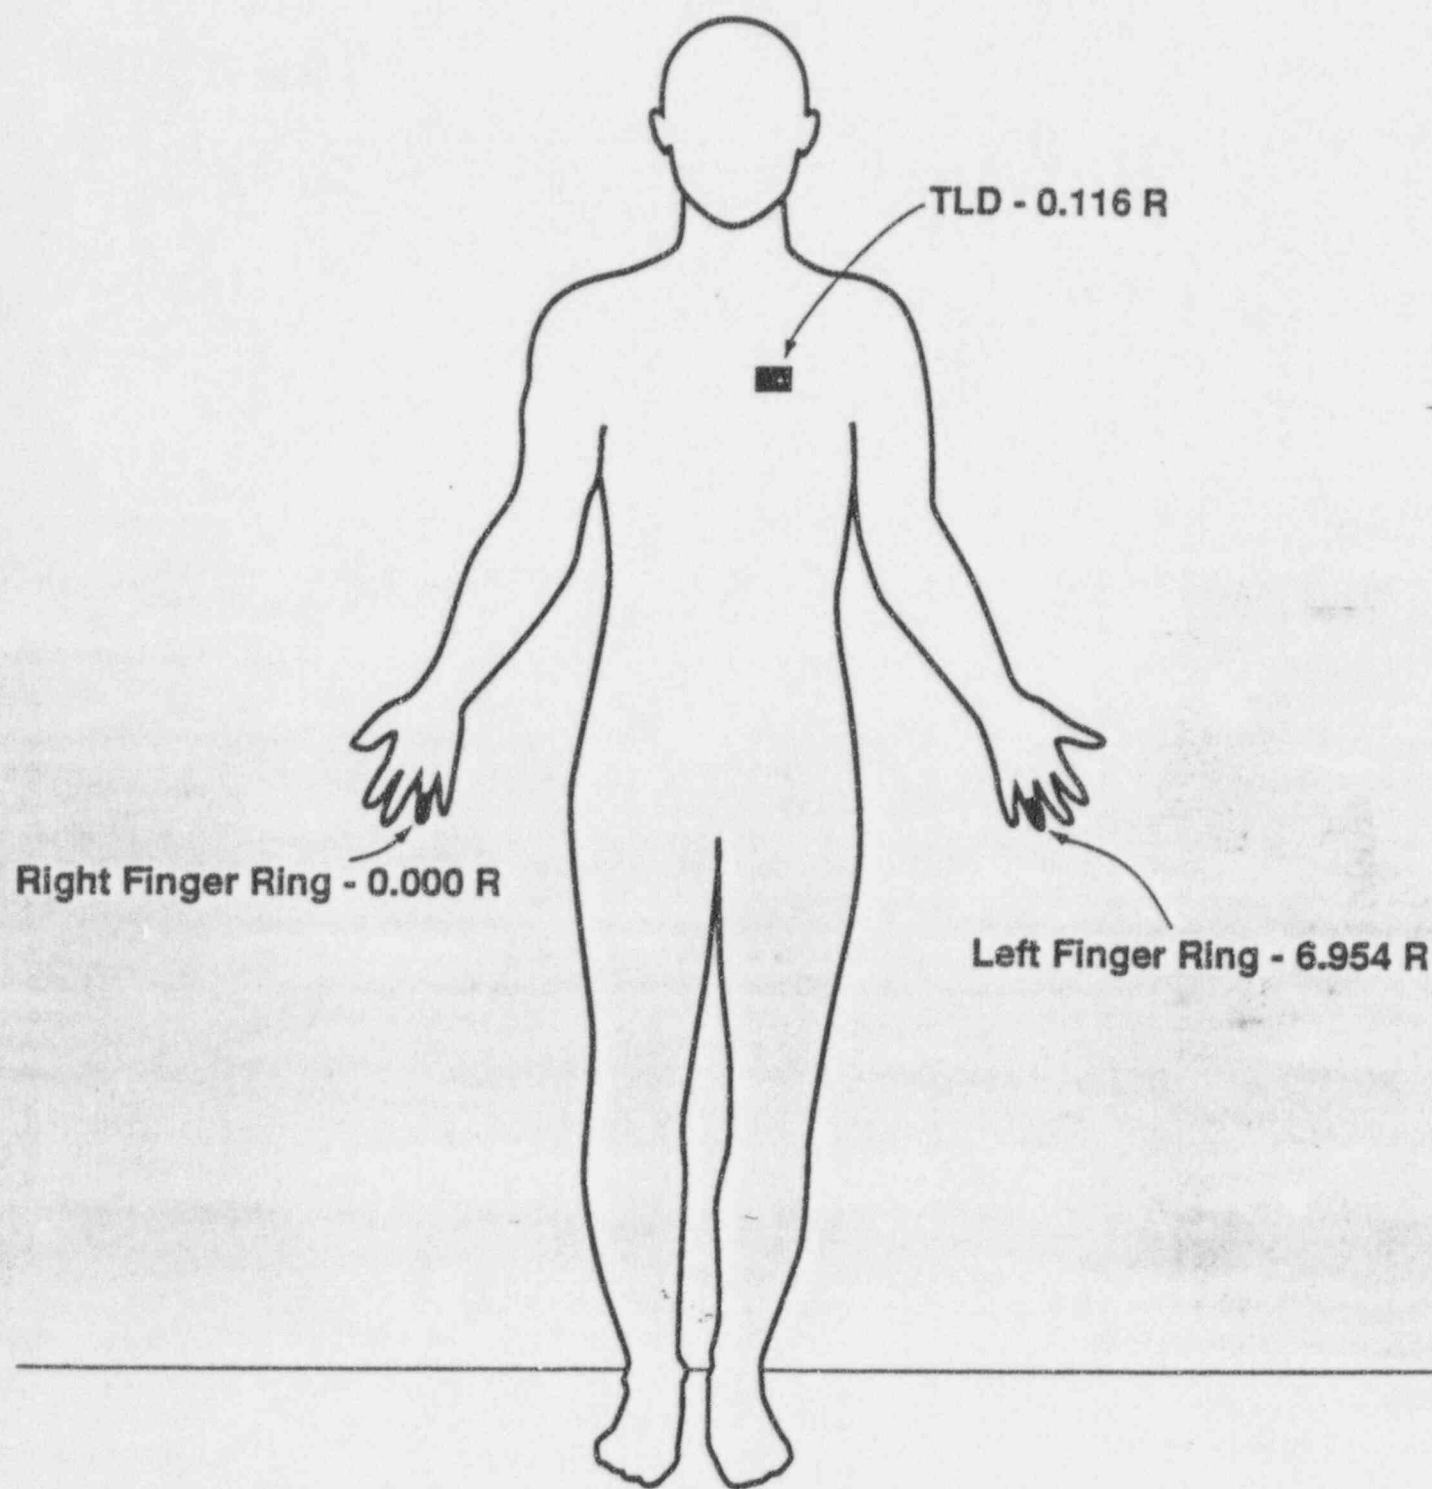
7-11-96 Data Available From 2nd Quarter Read

- July 11, 1996 Quarterly TLD Read Data Resulted in 6.954 rem to Workers Left Hand, 0.000 rem to the Right Hand, and 0.116 rem to Whole Body for Quarter. (Worker is Right Handed)
- July 12, 1996, RIR-96-010 Initiated. Worker and His Supervisor were immediately informed of concern. Worker was immediately restricted from RA. Suspended all primary liquid filter change outs.
