U.S. NUCLEAR REGULATORY COMMISSION
REGION IV

Docket No.: 50-483
License No.: NPF-30
Report No.: 50-483/96-10
Licensee: Union Electric Company
Facility: Callaway Plant
Location: Junction Hwy. CC and Hwy. O
Fulton, Missouri
Dates: October 21 through December 9, 1996
Inspectors: I. Barnes, Technical Assistant
C. Beardslee, Materials Engineer
D. Graves, Senior Project Engineer
W. McNeill, Reactor Inspector
P. Rush, Materials Engineer
C. Dodd, NRC Consultant
Approved By: Kenneth E. Brockman, Deputy Director
Division of Reactor Safety

Callaway Plant NRC Inspection Report 50-483/96-10

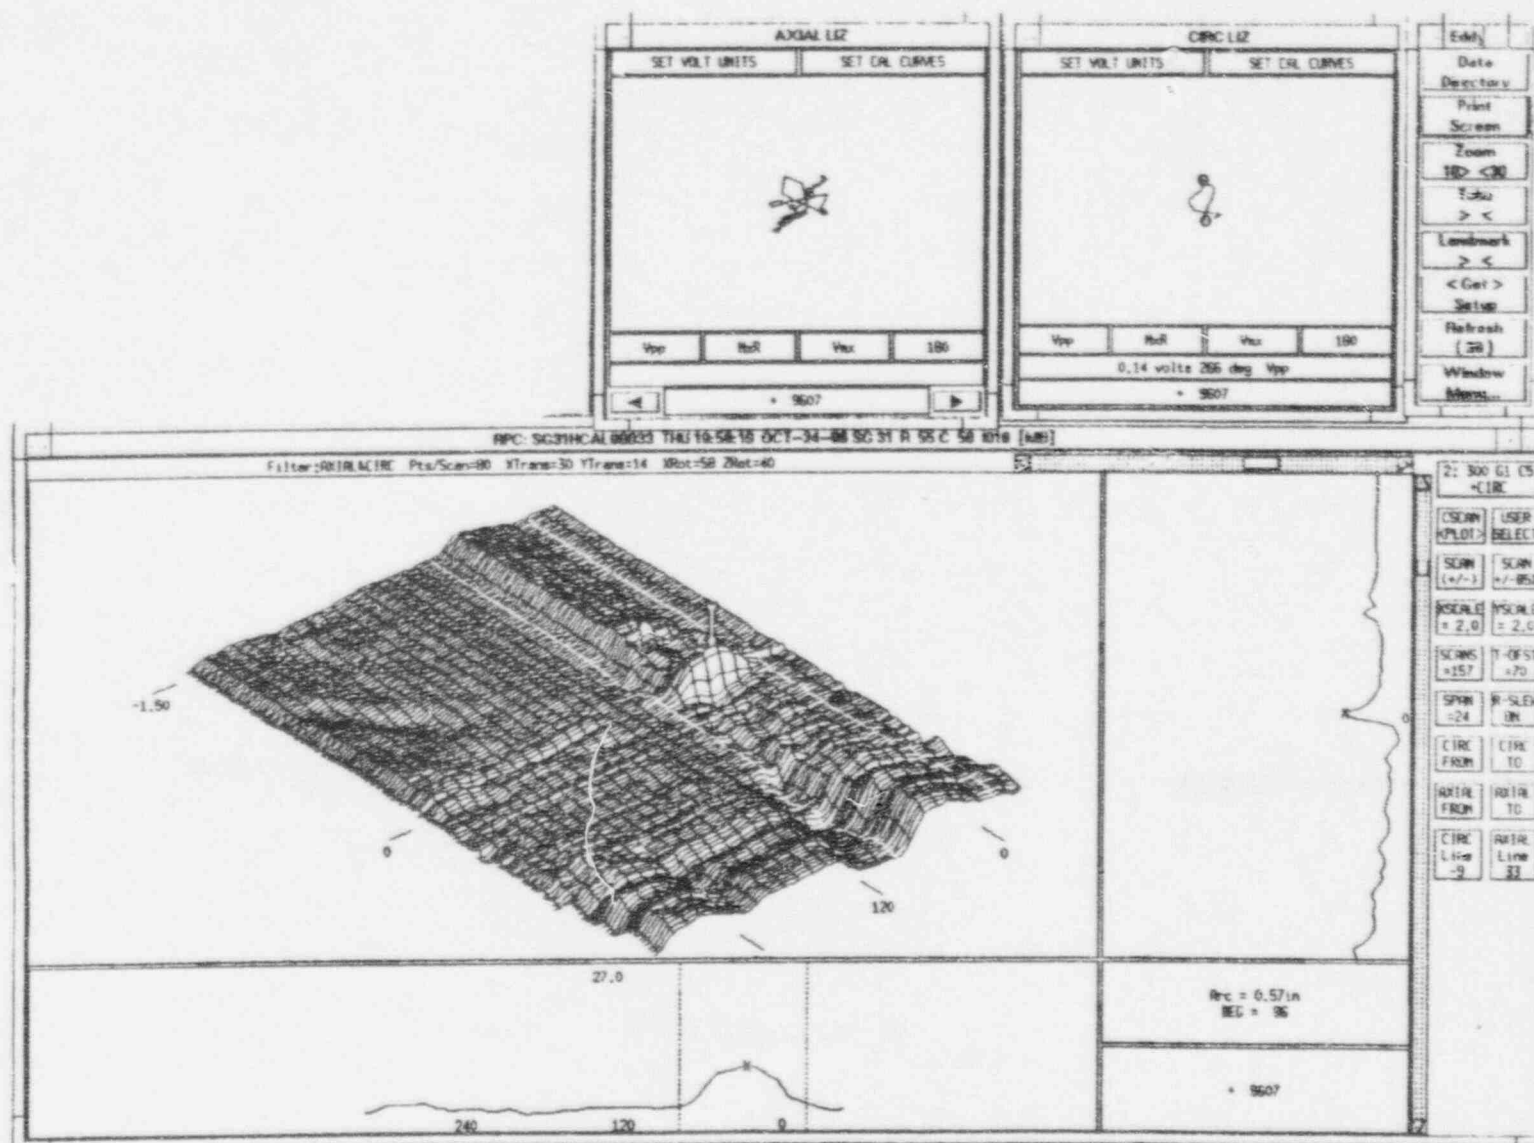
Figure 1: Apparent circumferential defect on the 300 kHz plus point channel

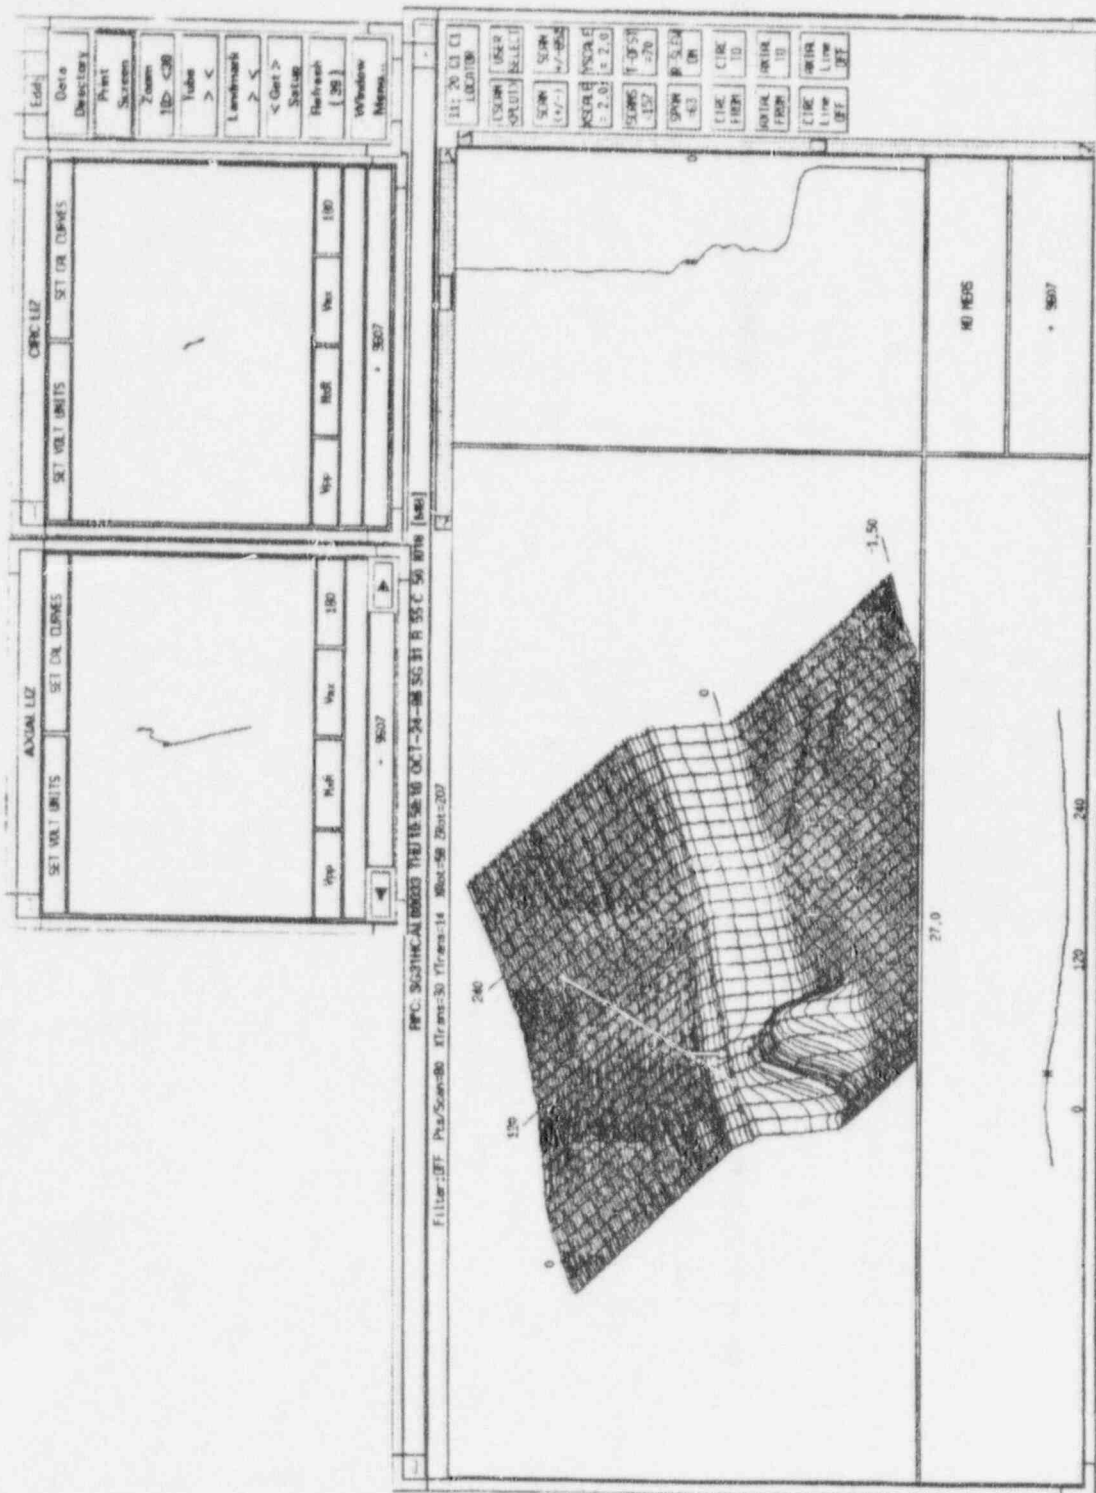
Figure 2: Ferromagnetic indication at the tubesheet secondary face on the locator channel.

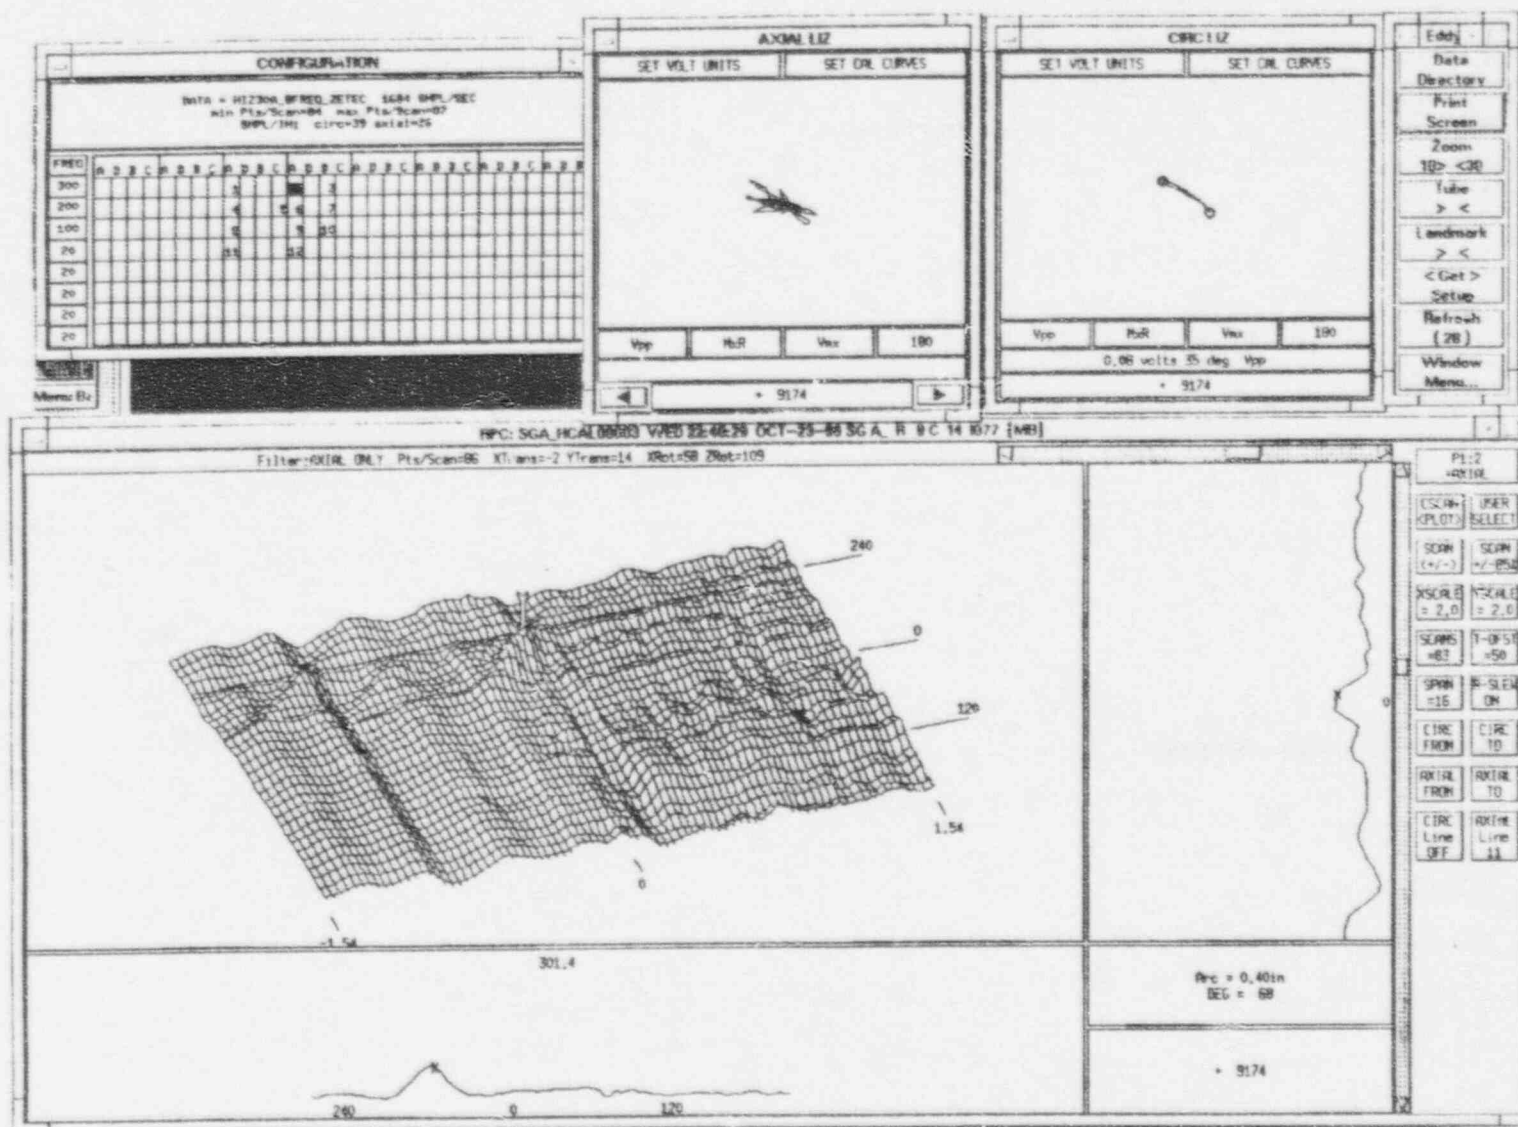
Figure 3: Small axial indication at the top of the tubesheet in tube R9/C14 (SG-A)

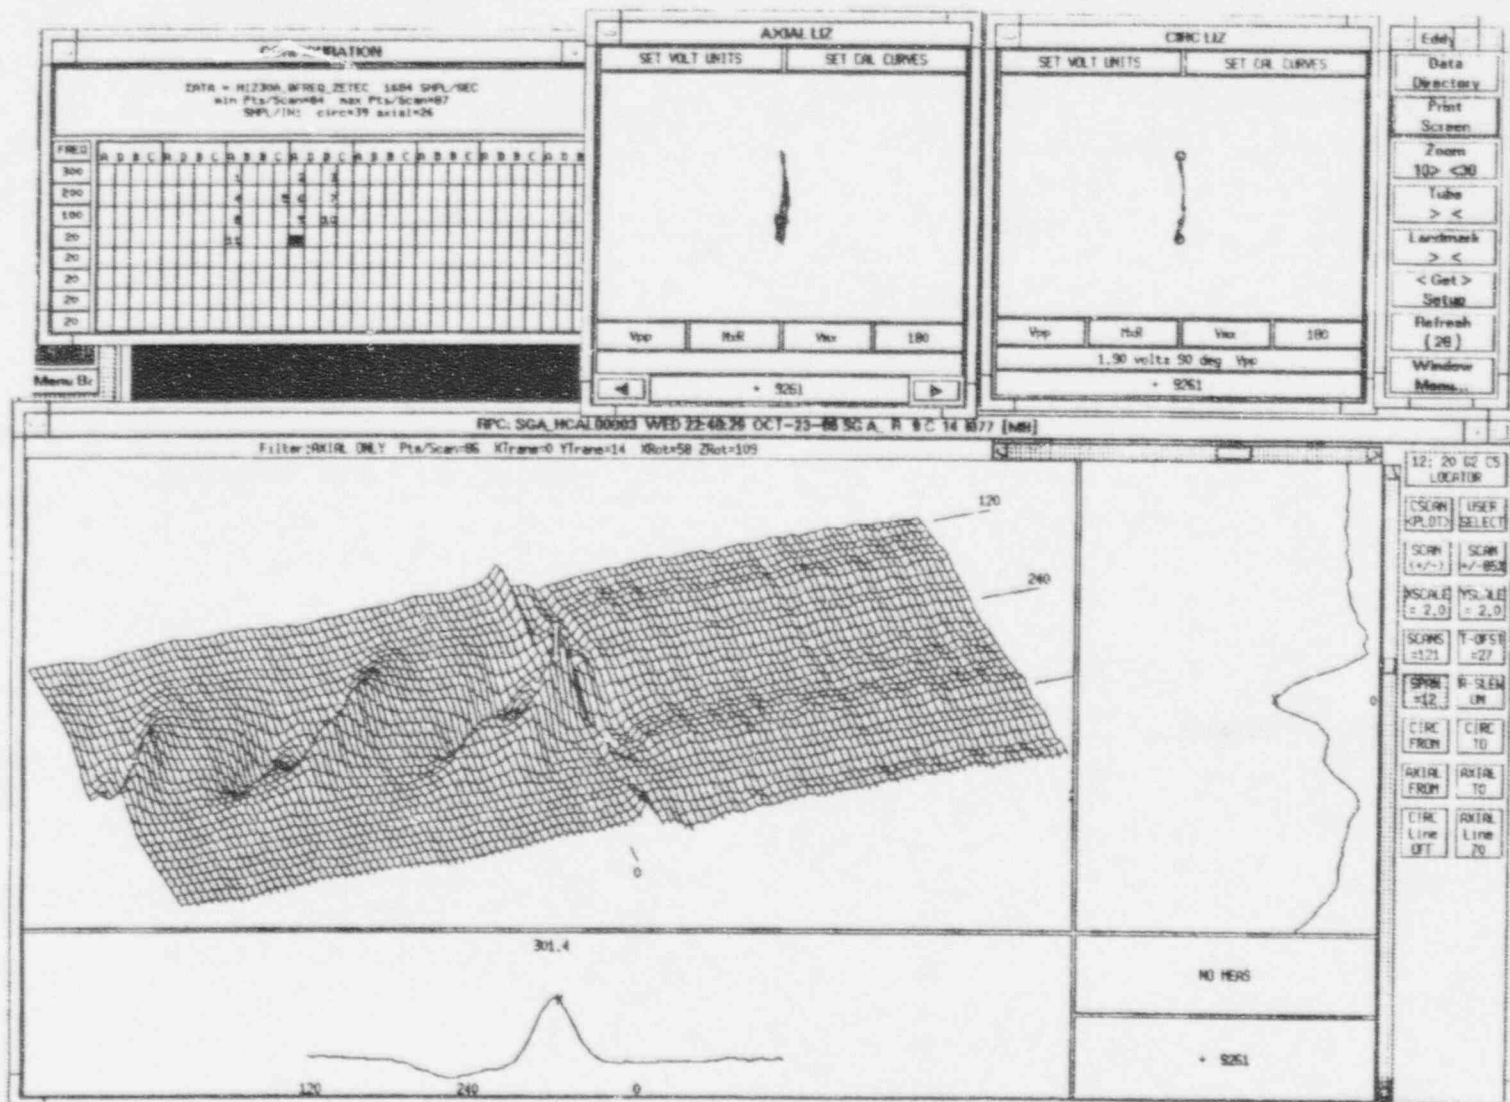
Figure 4: "Ripple" associated with indication in Figure 3 as seen on the locator channel

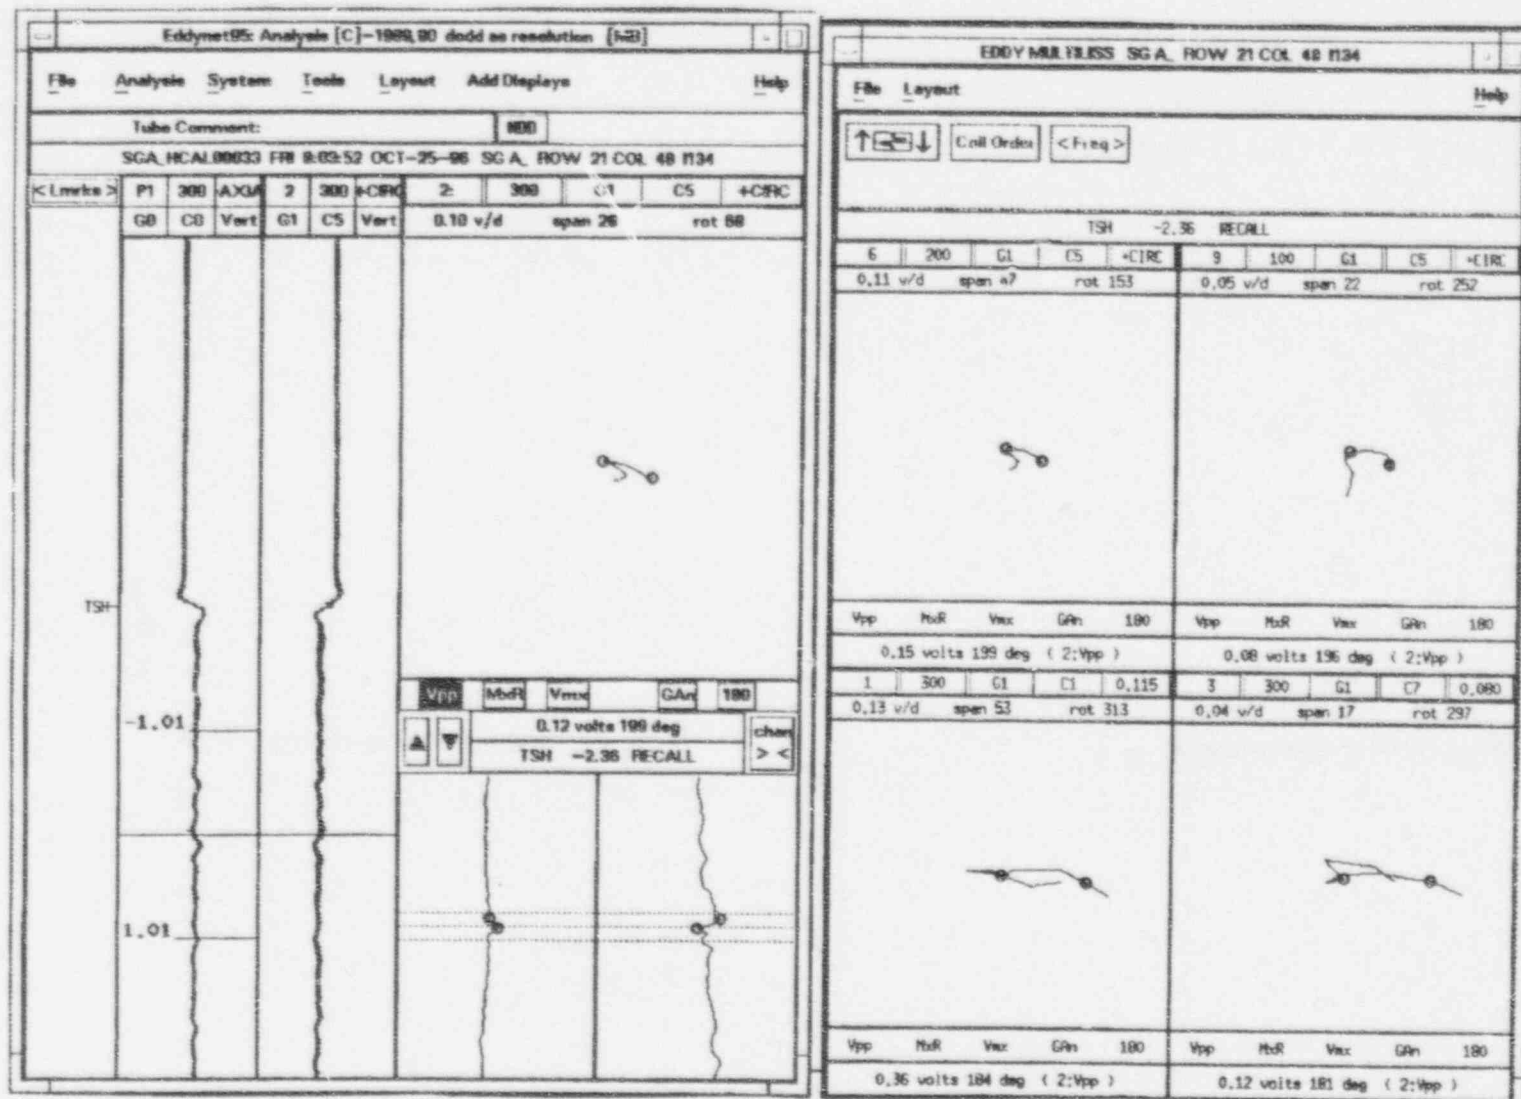
Figure 5: Lissajous signals for tubesheet expansion circumferential indication in tube R21/C48 (SG-A)

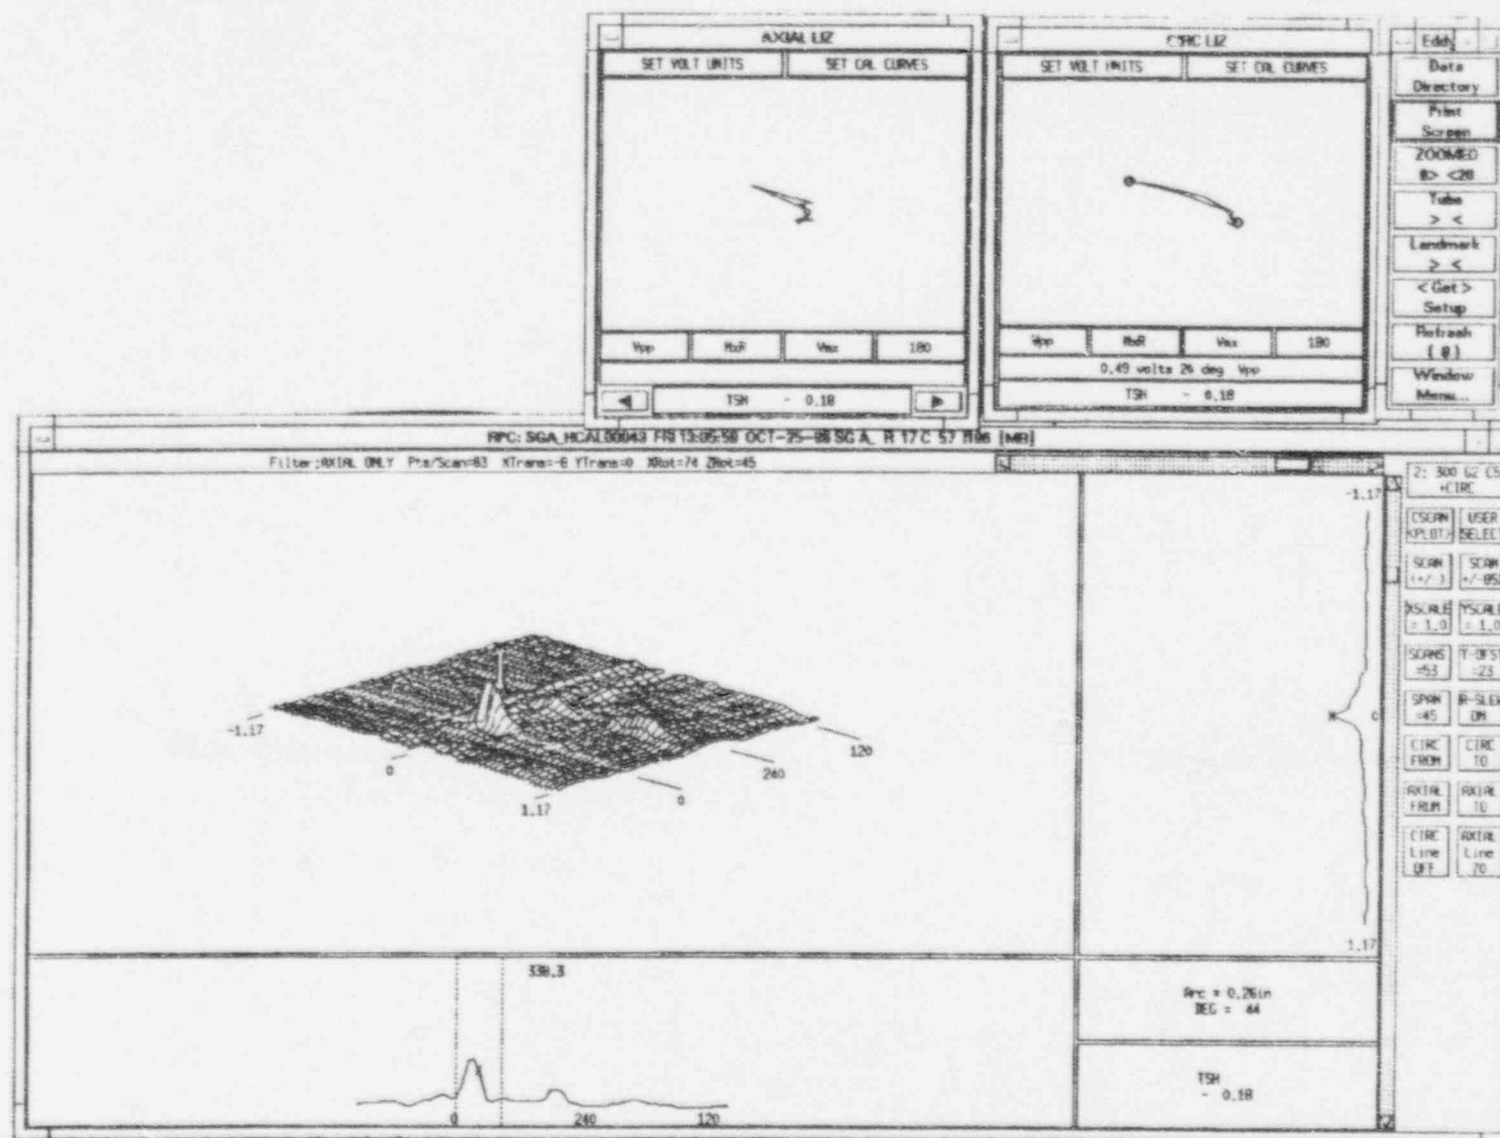
One of the larger indications reviewed during the data assessment was in the Steam Generator A tube located at Row 17, Column 57. Figure 6 shows data obtained from this tube which was called as containing multiple circumferential indications at the top of the tube sheet. As shown in Figure 7, the phase of the signal is consistent with defects for the plus point at 300 kHz, 200 kHz, and 100 kHz. Although the indications was one of the larger signals seen with the plus point coil, this indication was only marginally detectable on the 300 kHz frequencies for the 0.115-inch pancake and the 0.080-inch pancake coils. The licensee declared this tube defective, and elected to sleeve the tube.

Figure 6: Multiple circumferential indication at the top of the tubesheet in tube R17/C57 (SG-A)

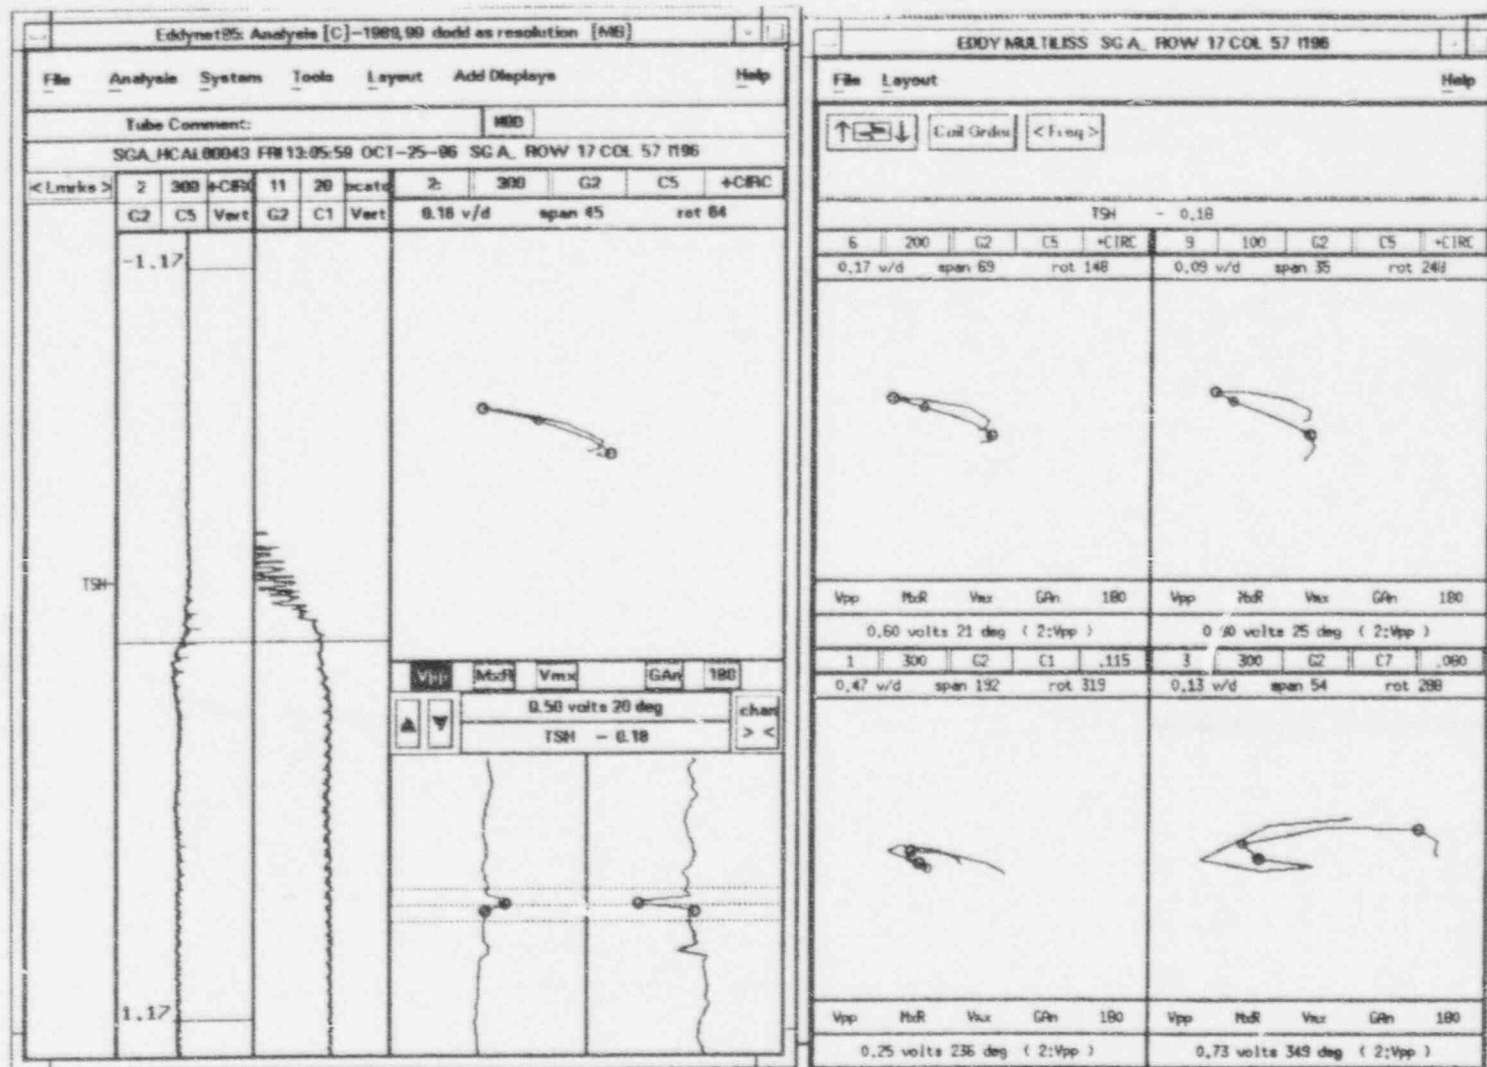
Figure 7: Lissajous signals for circumferential indication in tube R17/C57 (SG-A)
