WATERFORD SES - UNIT3

**Predecisional Enforcement
Conference**

November 20, 1996

Entergy Operations, Inc.

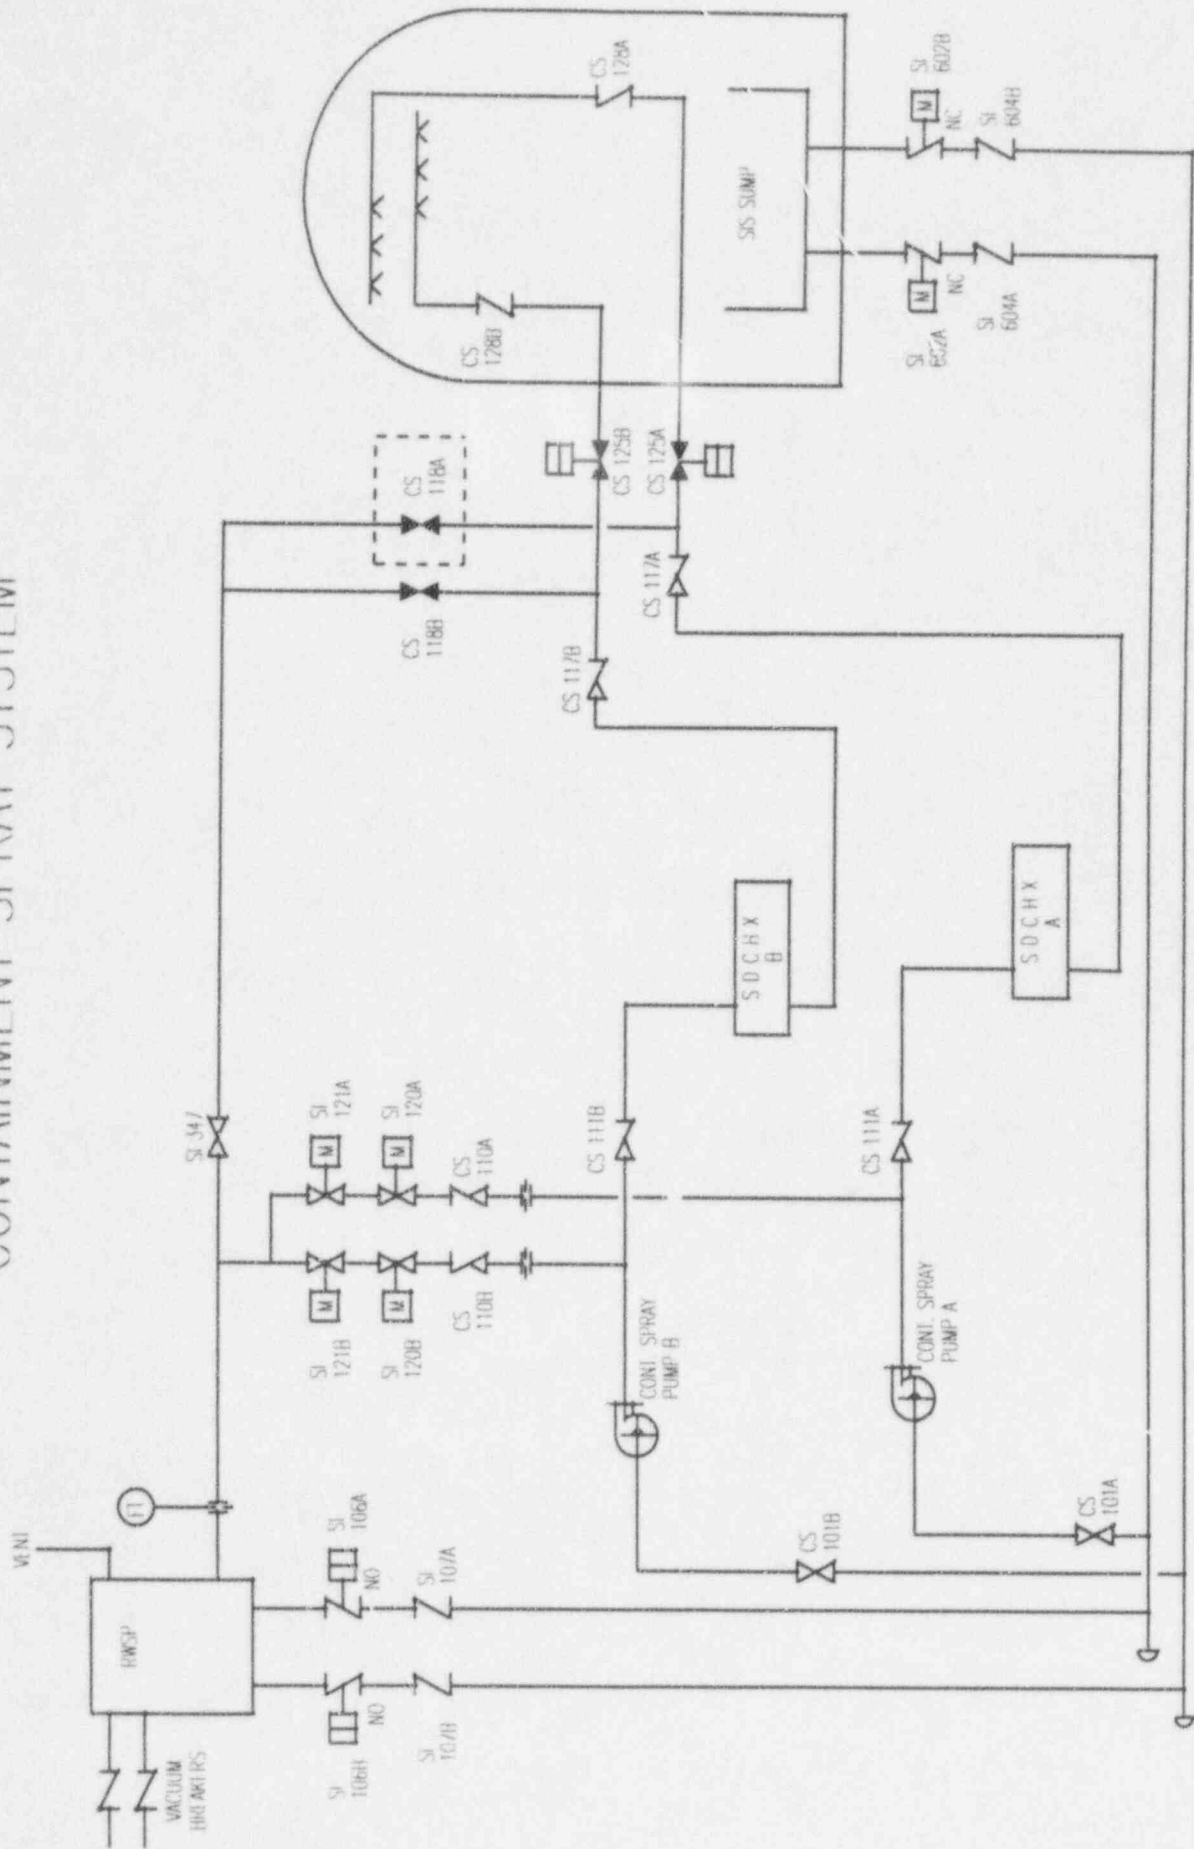
CONTAINMENT SPRAY SYSTEM

Valve CS-118A was found to be 1 & 1/2 turns open following a surveillance test. Excessive post accident leakage past this valve to the RWSP could affect control room dose limits.

- CS-118A was immediately closed
- CS-118A will be repaired/refurbished to ensure ease of operation during the next refueling outage
- Caution tag hung on CS-118A
- Inspected CS-118B valve and no problems were found
- Operators were interviewed to determine what valves were hard to operate
- Caution tags were hung on hard to operate valves and will remain until they are fixed
- Management expectations regarding difficult to operate valves were reinforced
- Design Engineering, Licensing, Safety Analysis and IHEA supervisors reviewed the RCA with appropriate personnel
