MEMORANDUM TO: PD IV-1 File February 24, 1997
FROM: Tom Alexion ORIGINAL SIGNED BY:
SUBJECT: LICENSEE'S UNIT 2 CYCLE 6 ROD CLUSTER CONTROL ASSEMBLY
(RCCA) EVALUATION AND LICENSEE'S UNIT 2 STEAM GENERATOR (SG)
INSPECTION RESULTS

SUBJECT: LICENSEE'S UNIT 2 CYCLE 6 ROD CLUSTER CONTROL ASSEMBLY
(RCCA) EVALUATION AND LICENSEE'S UNIT 2 STEAM GENERATOR (SG)
INSPECTION RESULTS

Originating Document No. USQE 97-0102 Revision No. 0
TITLE ST-4B-HL-1683, Unit 2 Cycle 6 RCCA Evaluation

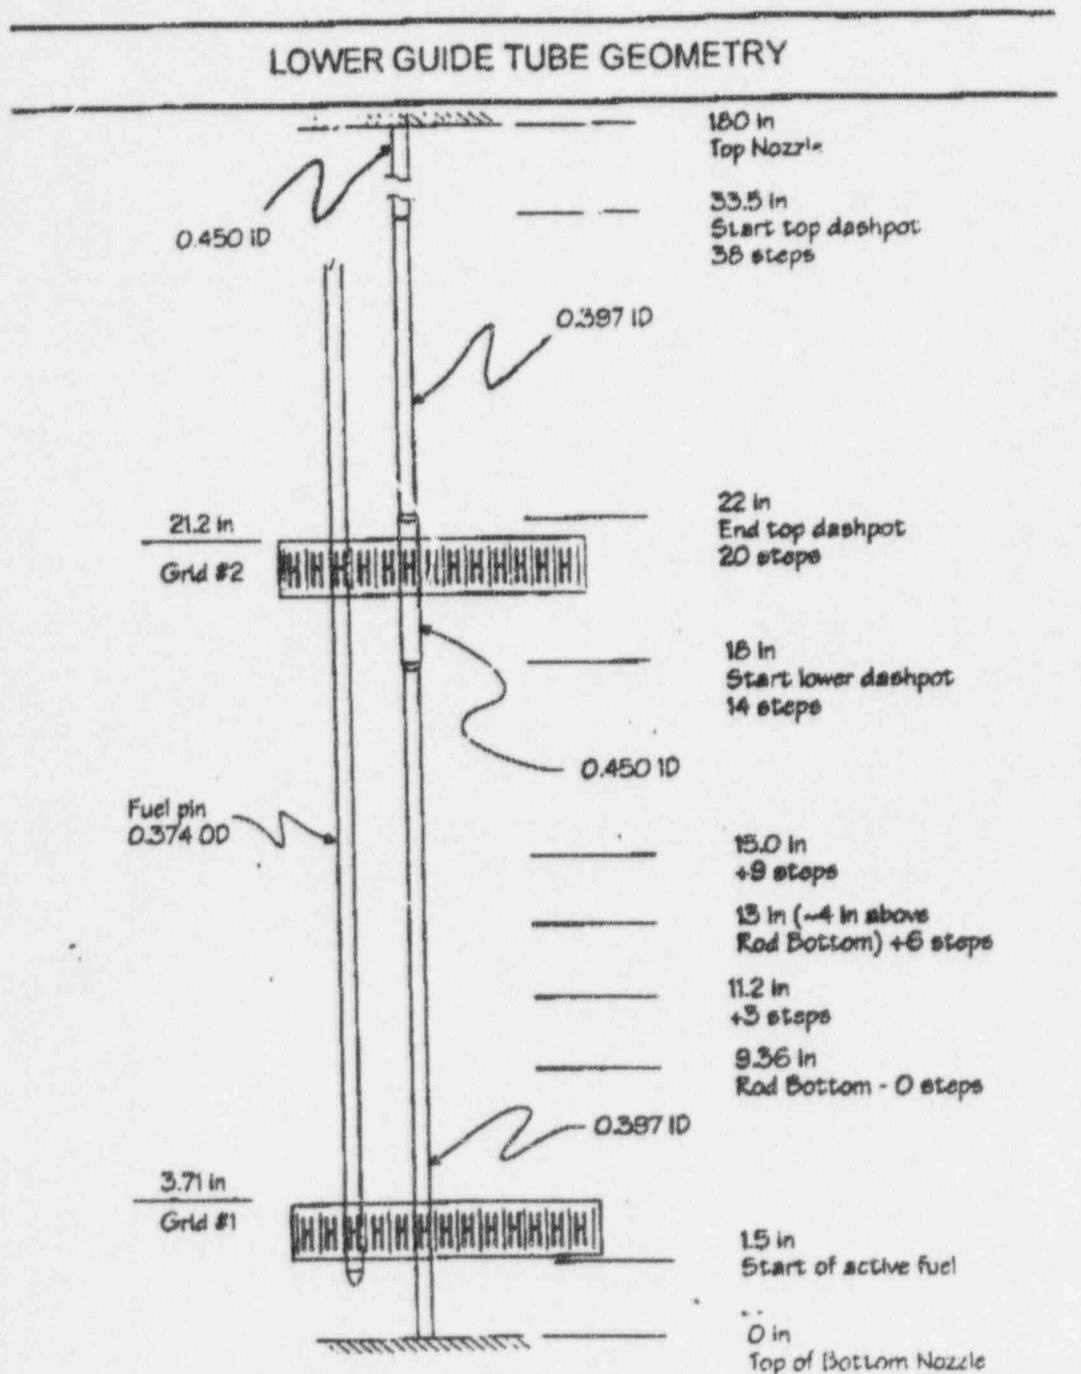
8.2 Figure 1, Fuel Assembly Dashpot Region

assemblies that stuck on 5/18/96 had become deformed. Based on the Spent Fuel Pool IRI testing results the root cause of the U1C6 incomplete rod insertion problem was determined to be guide tube distortion in the dashpot due to the in-vessel axial compressive load. The "most likely" cause for the excessive distortion was determined to be inadequate resistance to mechanical buckling in the fuel assembly design. Contributing factors included "irradiation effects and thermal creep at higher burnup levels".

The upper guide tube clearance with the RCCA is more than 5 times that of the 6 mil diametral dashpot clearance. Any interference within the guide tubes in the high burnup assemblies is likely to be limited to the lower dashpot area, i.e., in the region from 0 to 14 steps withdrawn (Figure 1). This is supported by the test results performed on South Texas Units 1 and 2.

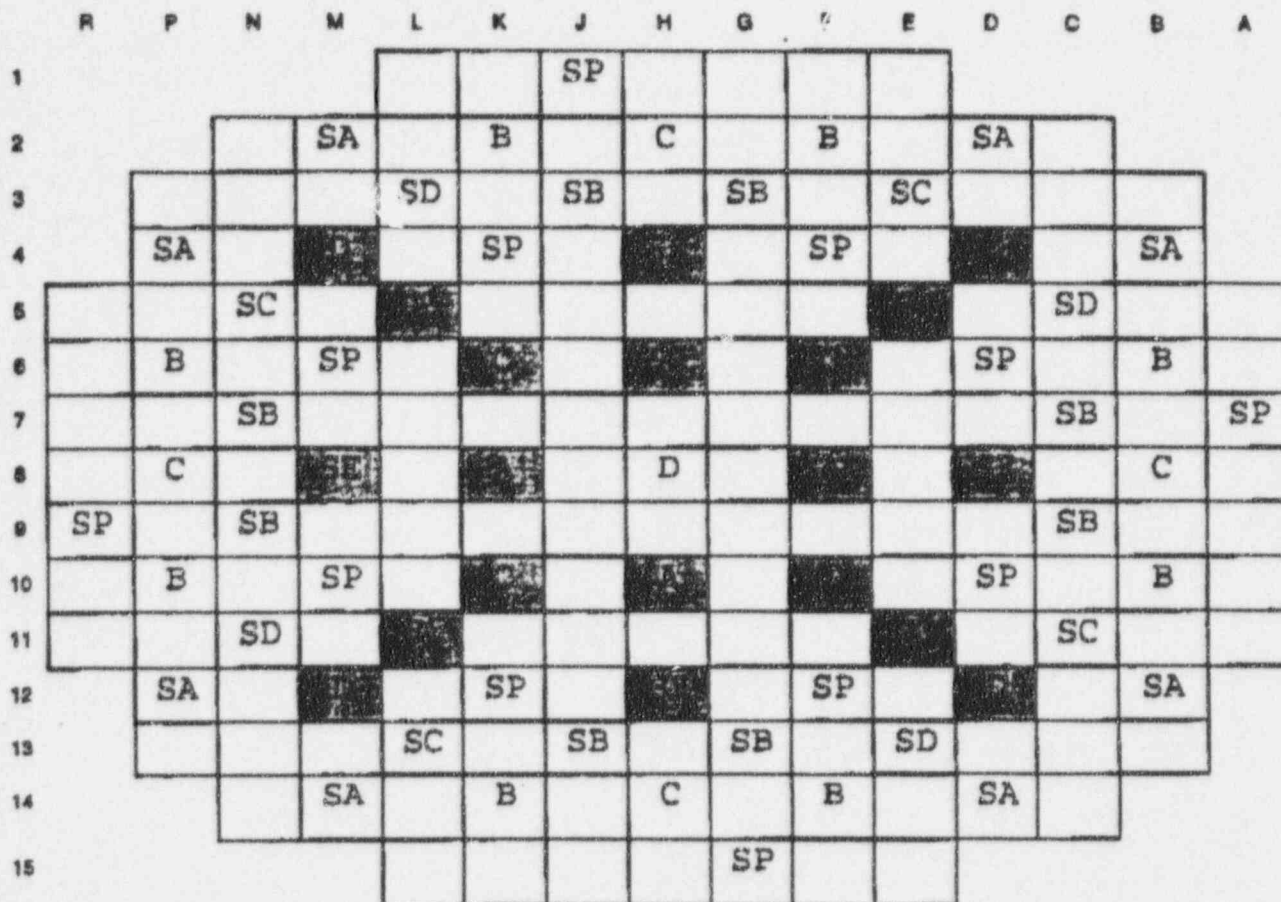
8.3 Figure 2, 20 RCCAs Stuck at 16 Steps

Shaded locations indicate stuck RCCAs at 16 steps; RCCA H8 is assumed to be stuck fully withdrawn.
