U.S. NUCLEAR REGULATORY COMMISSION

Report: 030-17304/96001(DNMS)

Licensee: H. C. Nutting Company

Dates of Inspection: November 6 and 7 (on site) with continuing in  
office review through November 18, 1996

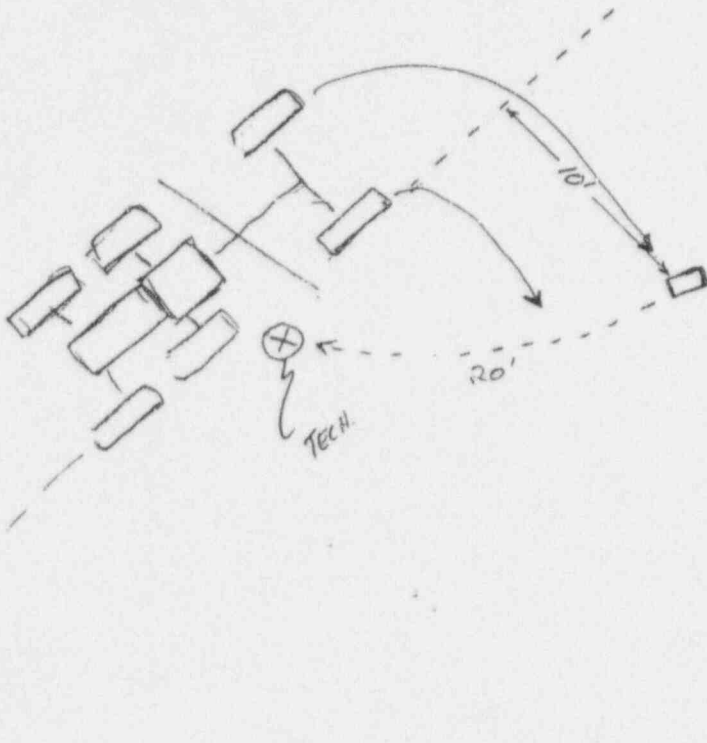
PLAY NORTH

The accident occurred when a piece of rubber-tired construction equipment (road grader) struck the gauge. It is my understanding, prior to the accident, our technician had finished a field density test and was to inform the operator of the test results. To do so, he left the meter in place and walked to the right side of the unit to discuss the test results with the operator. Upon completion of the discussion, the operator resumed grading operations. When he turned to the left, he struck and damaged the gauge. A diagram of the accident scene is attached.

Following the accident, the instrument and the affected area was isolated, after which our field technician notified our Columbus, Ohio, office. Upon receipt of the notification, our Columbus advisor, Mr. John F. Enderle, was dispatched to the project to supervise the recovery of the instrument. This examination revealed the damage had been limited to the face of the gauge, breaking the

index rod, and a slight bending of the source rod. With the source rod in a stored position, a radiation survey of the instrument revealed radiation levels in the range of two to three MR.

As previously indicated, the accident was the result of our technician's failure to keep immediate control of the gauge. In an effort to eliminate this type of accident, each division will hold a safety meeting for the sole purpose of re-familiarizing all field technicians regarding the direct control of surveillance and proper storage of nuclear gauges on field projects. These retraining classes will be completed within 45 days of the date of this letter.
