South Texas Project

Unit 1

Results of Fuel Assembly Testing in Response to NRC Bulletin 96-01

Attachment 1
Summary of Unit 1 July 1996 Fuel Assembly Testing In SFP

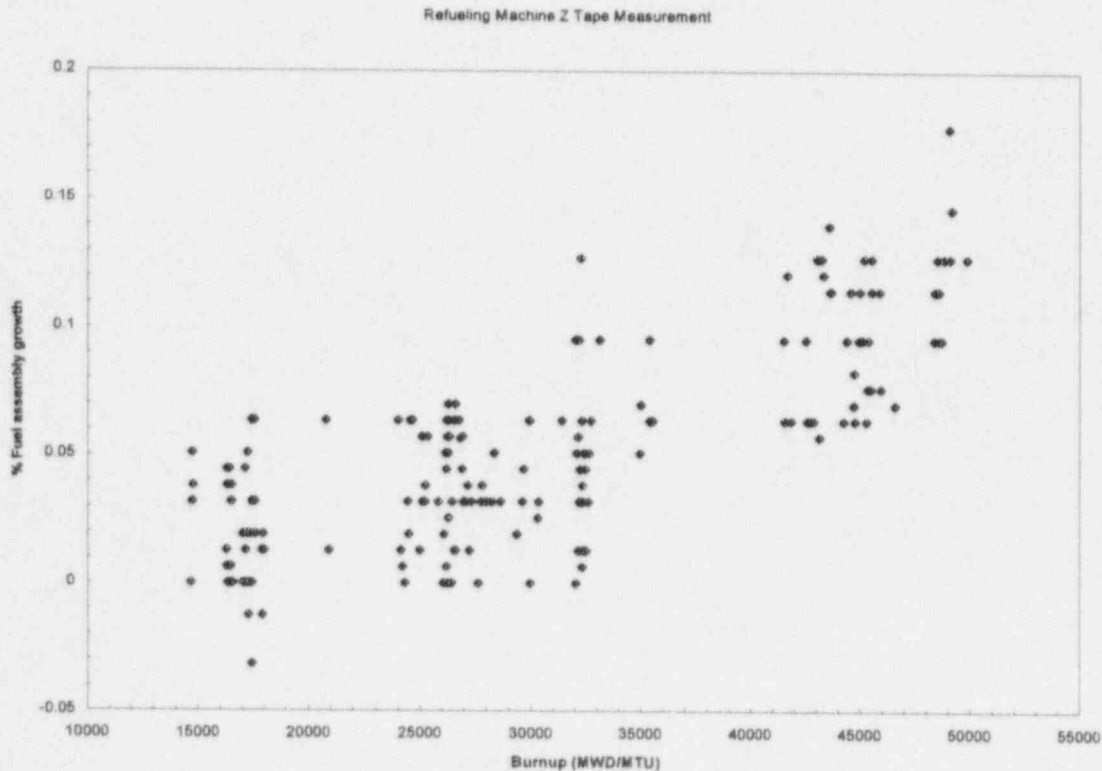
In addition to the tests performed in the SFP, relative fuel assembly lengths of all fuel in the core were measured in the reactor building upender during the 1RE06 outage core offload. These measurements were shown to correlate well with the SFP length measurements made in the July 1996 campaign. As shown in the figure below, the upender measurement shows normal growth for all fuel in the Unit 1 Cycle 6 core. Fuel growth is expected to be less than 0.27% fuel growth, which is the maximum design fuel growth at end of cycle.

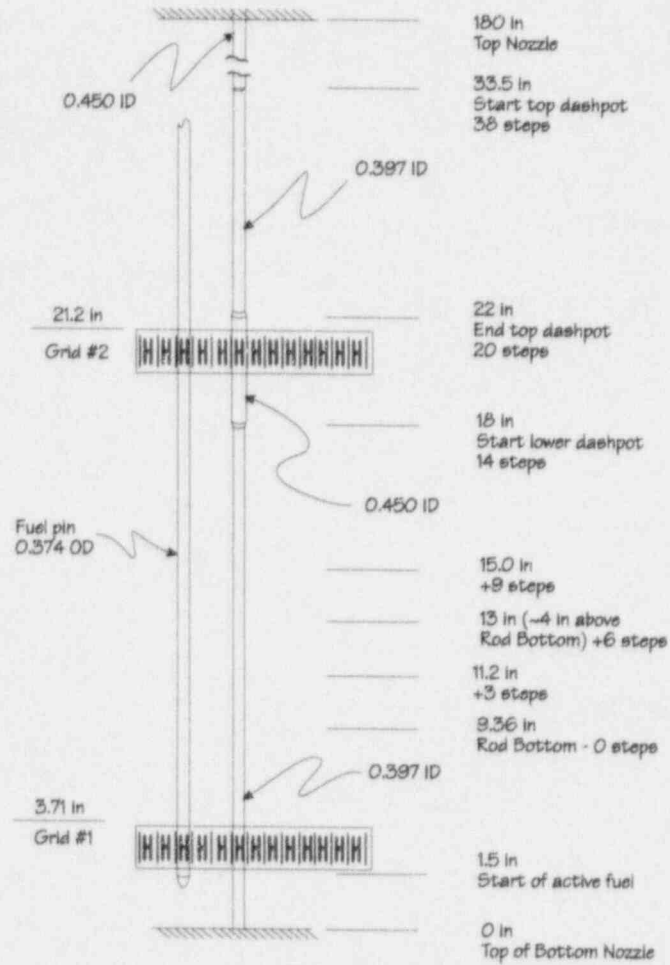
Schematic Diagram of South Texas Project Fuel Dashpot Geometry

In summary, the July 1996 test campaign showed that South Texas Project fuel assemblies are generally prone to increasing guide tube distortion in the dashpot as burnup and core residency time increases with the greatest amount of drag and distortion in the lower dashpot region. This distortion leads to high RCCA drag. The tests show that the distortion is occurring with normal fuel assembly and fuel pin growth. The geometry of the guide tube dashpot is shown in the figure on the following page.
