Commonwealth Edison Company
LaSalle Generating Station
2601 North 21st Road
Marseilles, IL 61341-9757
Tel 815-357-6761

LICENSEE EVENT REPORT (LER)

FACILITY NAME (1): LaSalle County Station Unit One

TITLE (4) Foreign Material Injected Into Service Water Tunnel Causes Dual Unit Shutdown Due to Inadequate Work Control

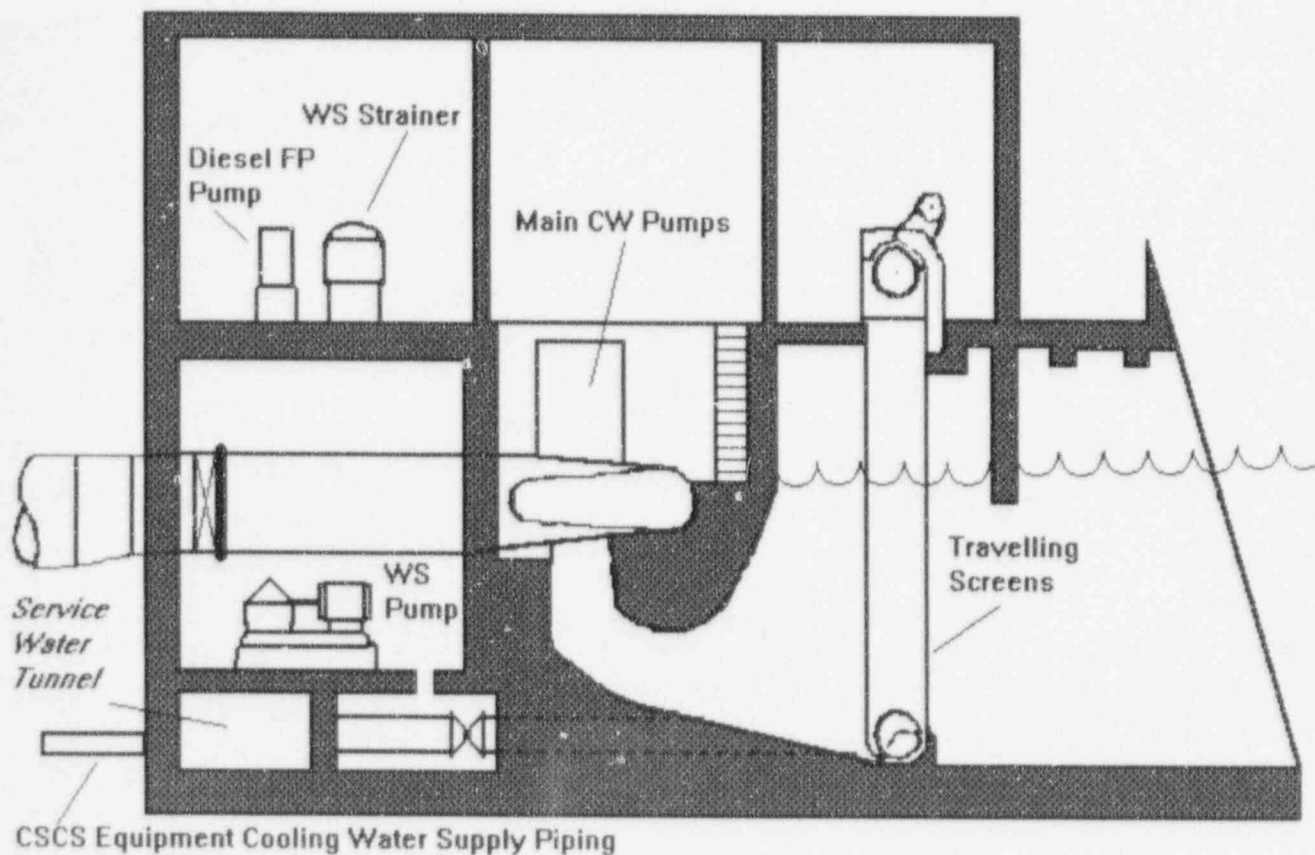
Lake Screen House Cross-section View

While doing floor repairs, the workers started fixing cracks on the top or ceiling of a service water tunnel which runs the length of the building approximately 20 feet below lake level (see sketch). This tunnel supplies cooling water to both the non-essential and essential (safety-related) cooling water pumps at the plant. As they repaired these cracks, the large amount of water at pressure indicated to the workers that a large void was present. The workers believed that they were working on a concrete floor laid over soil. They proceeded to drill five holes through the ceiling of the service water tunnel and inject sealant. Instead of being injected into a void under the building floor, the material was injected into the tunnel accumulating on the ceiling and floor or dispersing into the cooling water.
