RADIOLOGIC AND ENGINEERING ASSESSMENT

DOE ID NO.: GJ-00154-CS
ADDRESS: 1121 NORTH AVENUE

AUGUST 1985

BENDIX FIELD ENGINEERING CORPORATION
P.O. Box 1569
Grand Junction, Colorado 81502

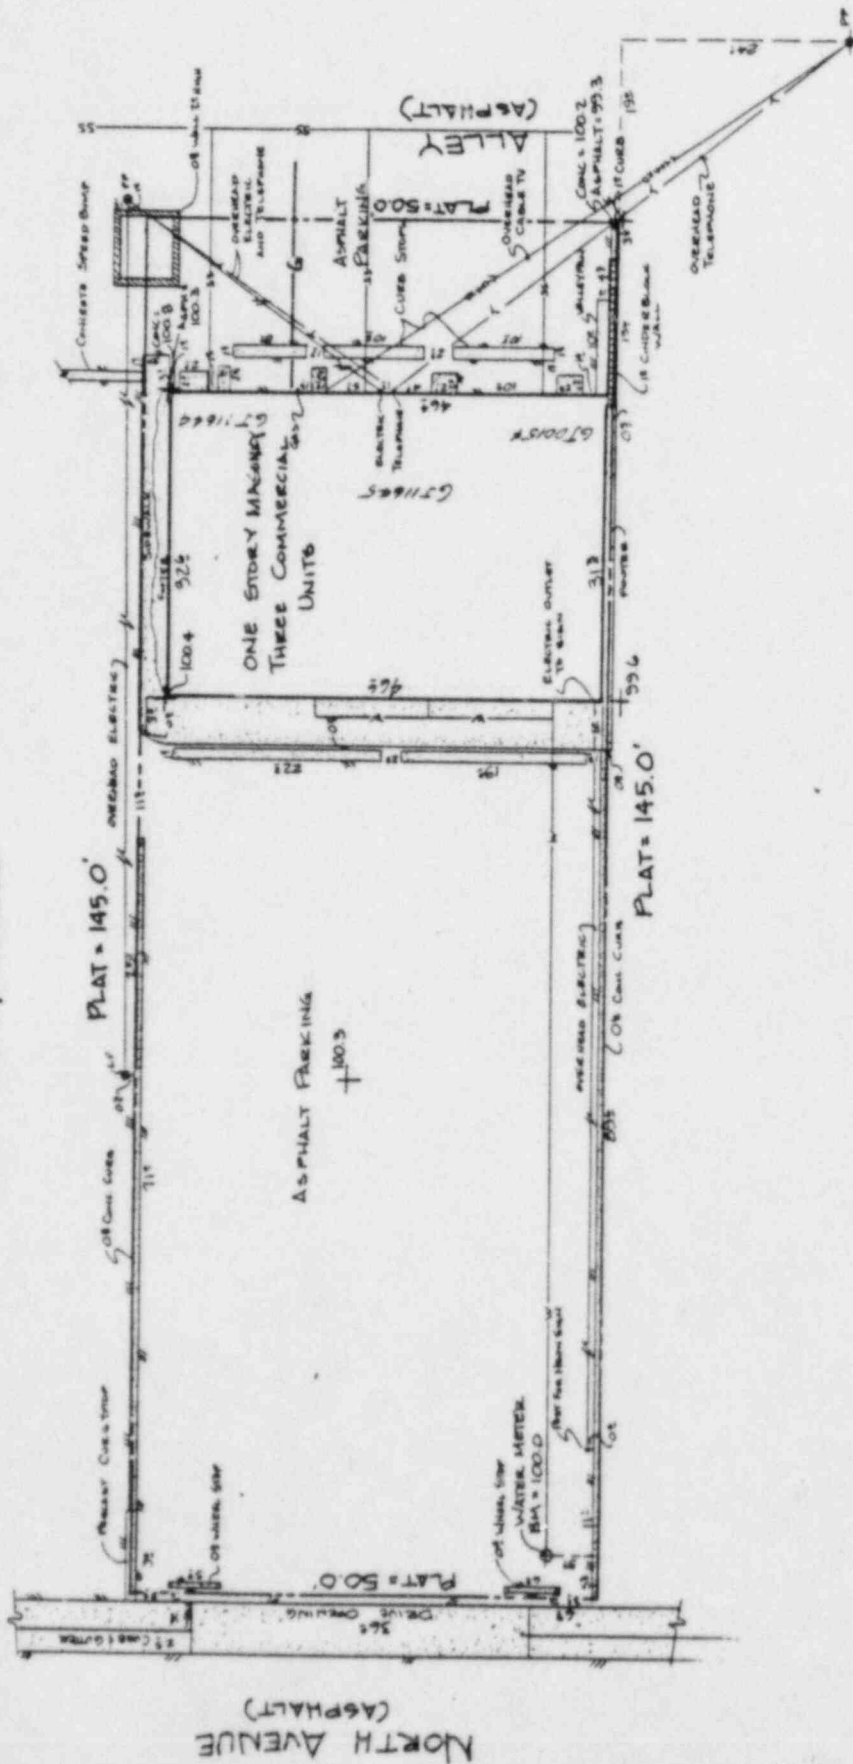
FIGURE 2.2 SITE PLAN

Structures, utilities, landscaping, and other special features of this property are included in Appendix Figure 2.2.

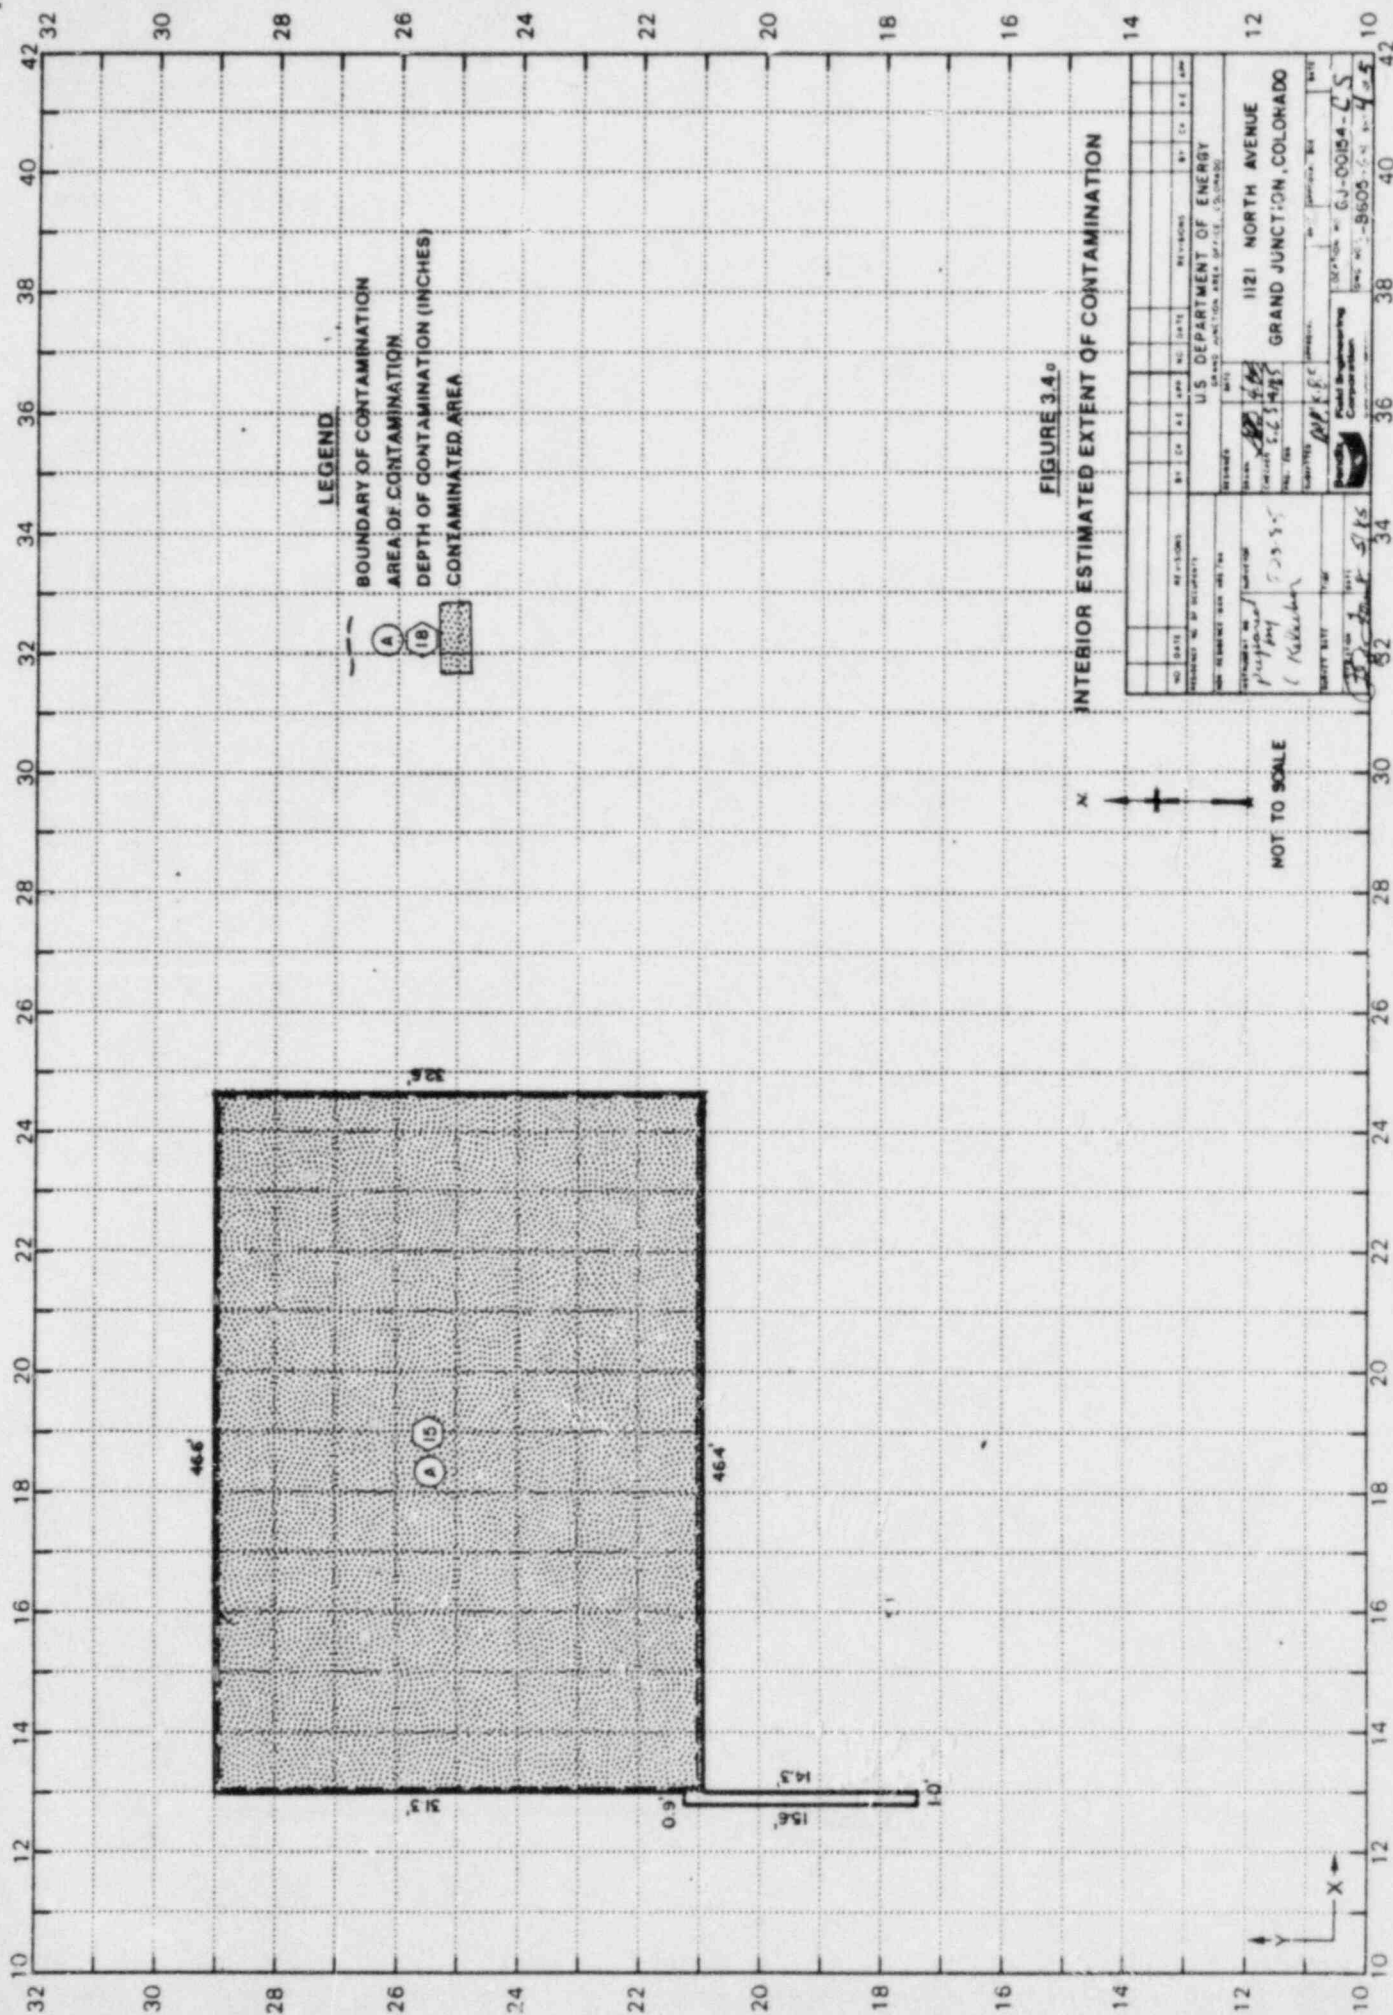
FIGURE 3.40

- (AREA A) The floor of the primary structure is underlaid by tailings. The floor is a 4-inch-thick concrete pad. The total depth of contamination is 15 inches, based on the visible tailings/soil interface under the floor (approximately 1,364 sf).
- (AREA B) The sidewalk adjacent to the primary structure on the north and east is underlaid by contamination. The total depth of contamination is estimated at 15 inches, based on the footing depth (approximately 358 sf).
- (AREA C) The asphalt parking area south of the primary structure is underlaid by contamination to a total depth of 12 inches (approximately 184 sf).
- (AREA D) Five small concrete pads adjacent to the south side of the primary structure are underlaid by contamination. The total depth of contamination is estimated at 12 inches, based on data collected in Area C (approximately 46 sf).

INTERIOR ESTIMATED EXTENT OF CONTAMINATION

The recommended remedial action for this property, DOE ID No. GJ-00154-CS, includes removal of all areas identified as containing radioactive material (as discussed in Section 3.5 and shown in Appendix Figures 3.4a and 3.4b) and transport of removed material to the disposal site.
