Nebraska Public Power District

LICENSEE EVENT REPORT (LER)

COOPER NUCLEAR STATION

Reactor Water Sample Valves Inoperable Due to Potential for Single Active Failure.

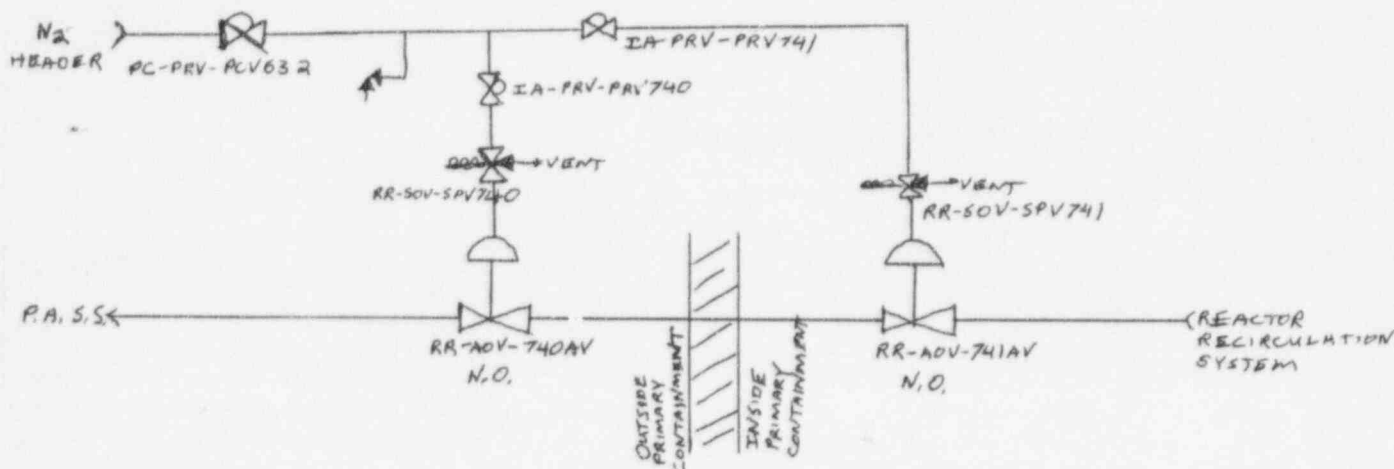
Simplified Sketch

The pneumatic supply lines to the RR-AOV-740AV/741AV air operators diverge from a common nitrogen header. PC-PRV-PCV632 is a safety grade pressure regulator that has an active function of reducing the line pressure for this header from 200 psig to 100 psig. Stemming from this common header are two parallel lines providing nitrogen to the solenoid pilot valves. Each supply line is configured with a nonsafety-related regulator reducing the pneumatic pressure from 100 psig to 90 psig. The manufacturer's Maximum Operating Differential Pressure (MODP) for RR-SOV-SPV740/741 (RR-AOV-740AV/741AV solenoid pilot valves) is 110 psid. A failure of PC-PRV-PVC632 in concert with the assumed failure of both nonsafety-related regulators could result in exceeding the MODP of the solenoids. Accordingly, RR-AOV-740AV/741AV were declared inoperable and repositioned to their isolated condition in accordance with CNS TS 3.7.D.2. A 4-hour non-emergency report was then made to the NRC.¹

SEQUENCE FOR SINGLE ACTIVE FAILURE SCENARIO

- 1) Single active failure of PC-PRV-PCV632 within quarterly surveillance interval.
- 2) Concurrent (or possibly consequent) failure of IA-PRV-PRV740/741 resulting in exceeding MODP of RR-SOV-SPV740/741.
- 3) Loss of Coolant Accident concurrent with Loss of Offsite Power prior to detection of previous failures by Operations.
- 4) Failure of RR-SOV-SPV740/741 to reposition to vent reactor water sample valves' air operators.

Prior to the restoration of RR-AOV-740AV/741AV operability, the pneumatic configuration will be modified to resolve the single failure vulnerability associated with PC-PRV-PCV632. Additionally, this reportable event will be discussed with Engineering personnel to increase their awareness of the subtleties involved in defending against single active failures in the design change process.
