**Re: Freedom of Information Act Request Regarding the Salem Generating
Station, Docket Nos. 50-272 and 50-311**

SALEM U1 REACTOR TRIP/SAFETY INJECTION

**SALEM U1 REACTOR TRIP/SAFETY INJECTION
ROOT CAUSE DETERMINATION PLAN
(TROUBLESHOOTING)**

1. CONDUCT A THOROUGH REVIEW OF THE CIRCUMSTANCES SURROUNDING THE 4/7/94 SALEM UNIT 1 REACTOR TRIP AND SUBSEQUENT LOSS OF THE PRESSURIZER STEAM BUBBLE.
2. ASSESS OPERATORS' ACTIONS PRIOR AND SUBSEQUENT TO THE REACTOR TRIP; DEVELOP A SEQUENCE OF EVENTS AND CAUSAL FACTOR ANALYSIS FOR THE PLANT AND OPERATORS' RESPONSES ASSOCIATED WITH THE EVENT; COMPARE ACTUAL PLANT RESPONSE TO EXPECTED PLANT RESPONSE.
3. REVIEW THE LICENSEE EVENT CLASSIFICATION AND NOTIFICATIONS.
4. ASSESS SAFETY SIGNIFICANCE OF THE EVENT.
5. EXAMINE EQUIPMENT FAILURES AND IDENTIFY ASSOCIATED ROOT CAUSES.
6. DETERMINE IF ANY DESIGN DEFICIENCIES ASSOCIATED WITH THE EVENT EXISTED THAT WARRANTED PROMPT ACTION.

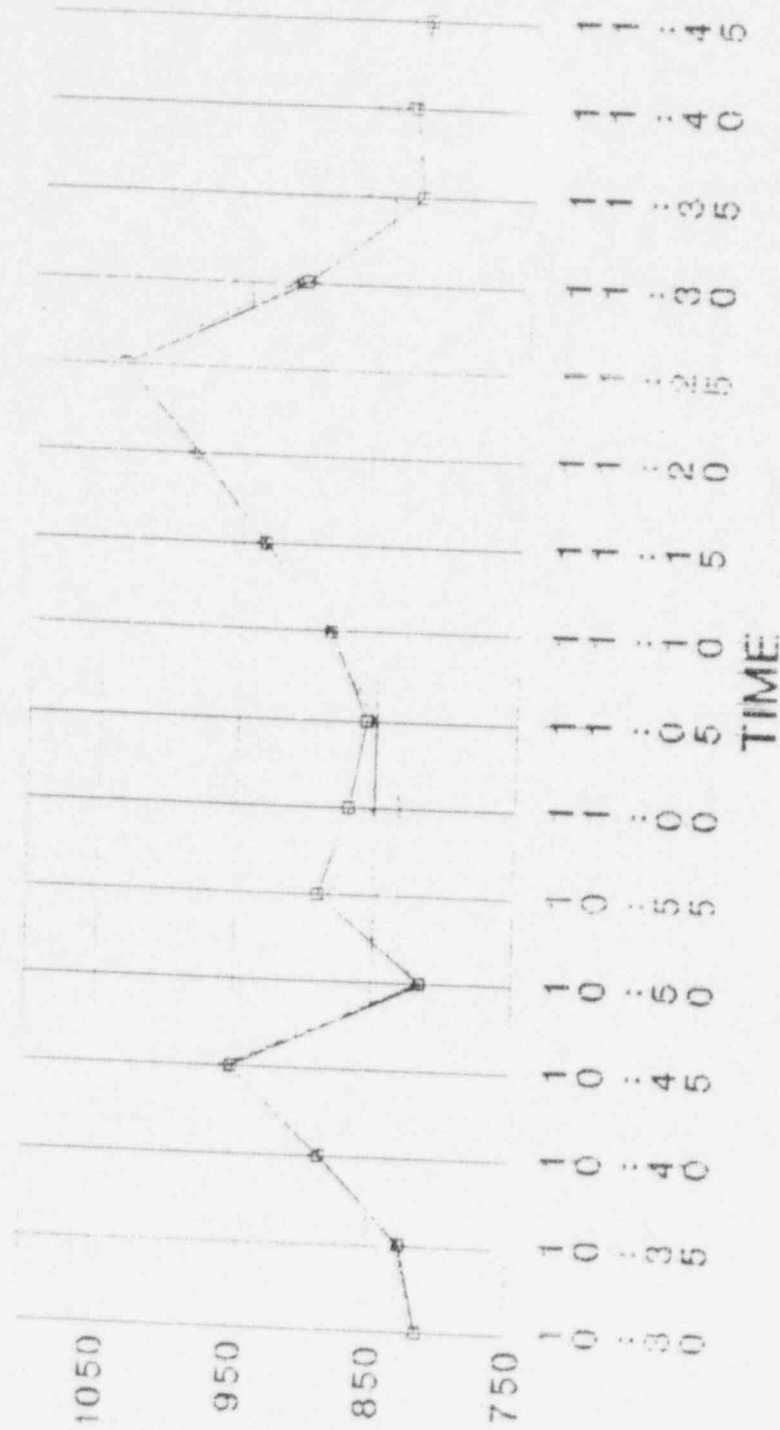
Steam Pressures

Steam Generator Levels(WR) rapidly decreased, then slowly increased during the safety valve lifting
