SUBJECT: COMANCHE PEAK STEAM ELECTRIC STATION
DOCKET NO. 50-445/84-45
SUPPLEMENTAL RESPONSE TO NRC
NOTICE OF VIOLATION 50-445/8445-02

Supplemental Response to NRC Notice of Violation 50-445/8445-02

SUBJECT: COMANCHE PEAK STEAM ELECTRIC STATION
RESPONSE TO NRC NOTICE OF VIOLATION
INSPECTION REPORT NO.: 50-445/84-45

NOTICE OF VIOLATION
445/8445-02

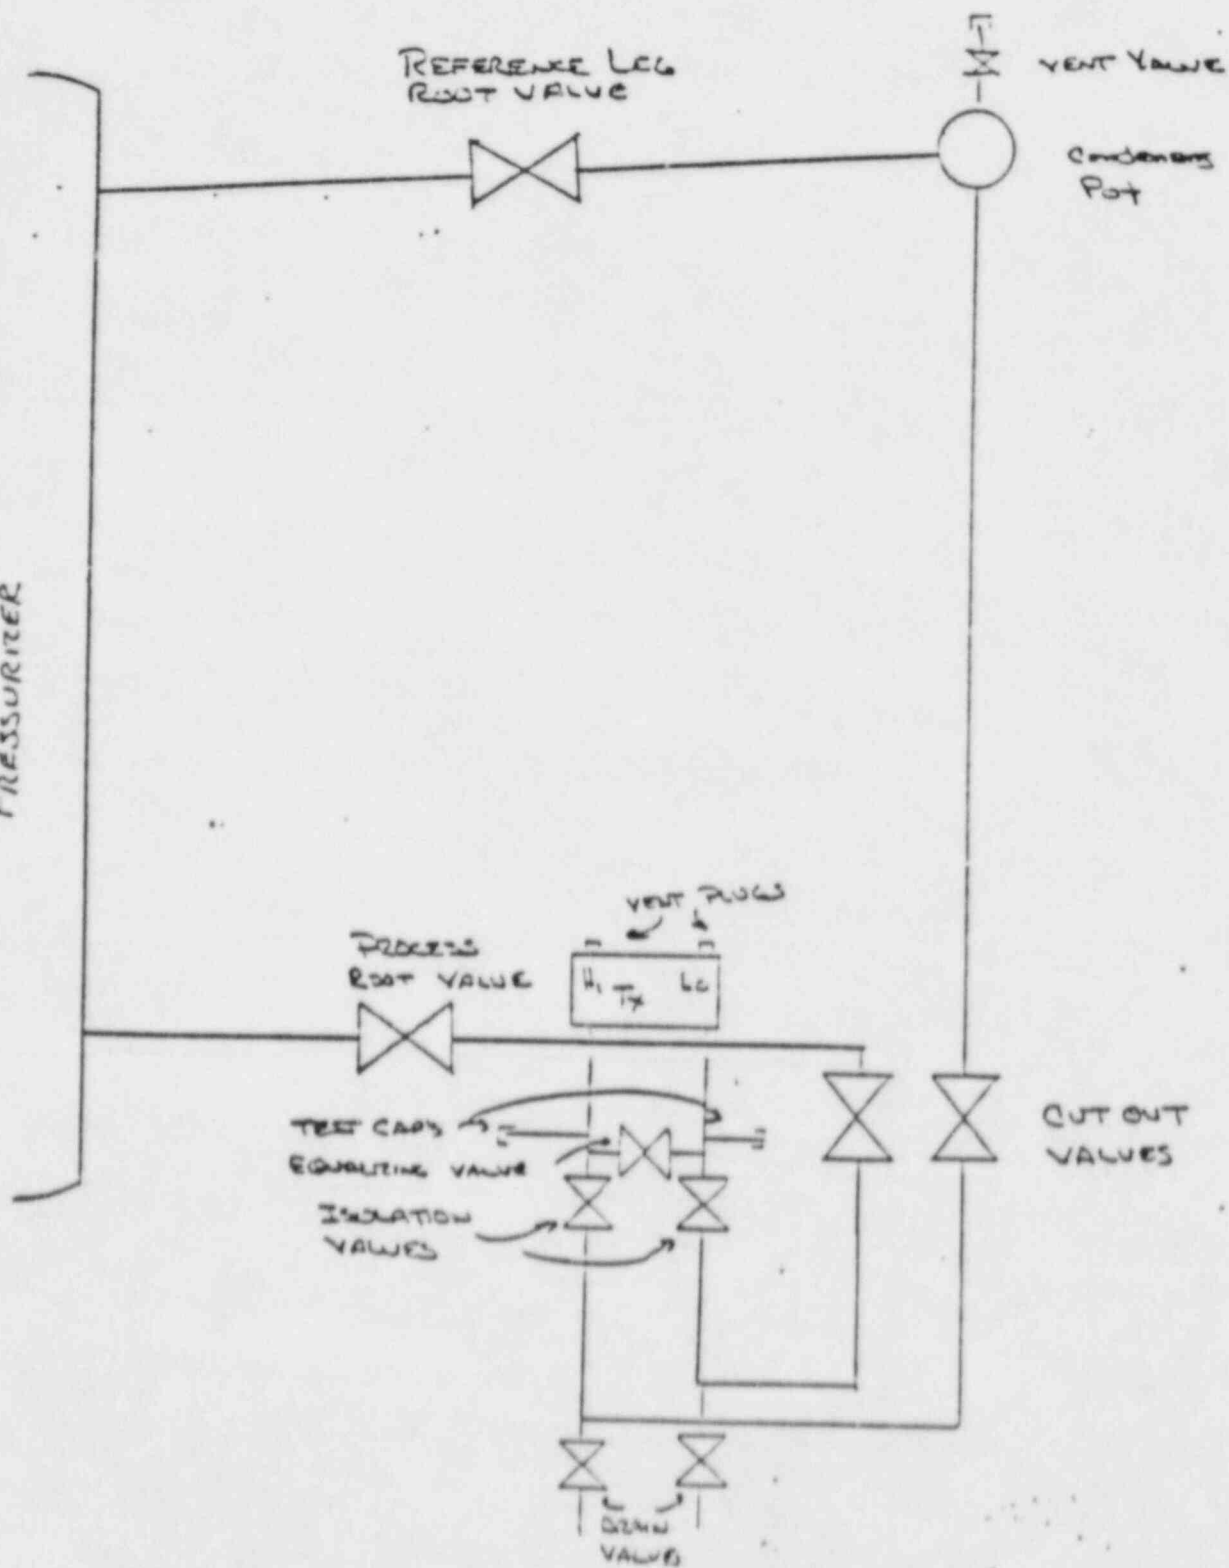
Pressurizer

The I&C technician had Operations close the reference leg root valve again while he isolated the transmitter by shutting both isolation valves and both cutout valves (see attached drawing). The vent valve cap was removed and the vent valve cracked open to depressurize the reference leg and to verify that the reference leg root valve was not leaking. The technician hooked up his low pressure fill rig to the process side test fitting instead of the reference side. The technician opened the process isolation valve instead of the reference isolation valve and was pumping up the fill rig when he noticed pressure was increasing (both cutout valves had been shut in previous steps). The technician then opened the process cutout valve instead of the reference leg cutout valve and the fill hose blew off the test fitting. The hot water struck him on the upper arm causing a minor first degree burn approximately 2" in diameter. The technician shut the process isolation valve and notified the Shift Supervisor of the problem.

The contributing factors to the incident were:

1. The reference leg valves were not adequately identified.
2. The procedure did not require the technician to verify system pressure prior to hooking up the low pressure fill rig.

Positively identify all reference leg instrument valves on Barton and Rosemount non-capillary electronic level transmitters for which normal system operating pressure is greater than 500 psig or normal system operating temperature is greater than 200°F. Specifically, hang metal tags that read "REF LEG" or "REFERENCE LEG" on the applicable valves for the following transmitters:
