Docket 50-305
Operating License DPR-43
Kewaunee Nuclear Power Plant
Reportable Occurrence 96-007-00

Kewaunee Nuclear Power Plant

TITLE (4) Design Deficiency in Containment Isolation Function Found During Operating Experience Assessment

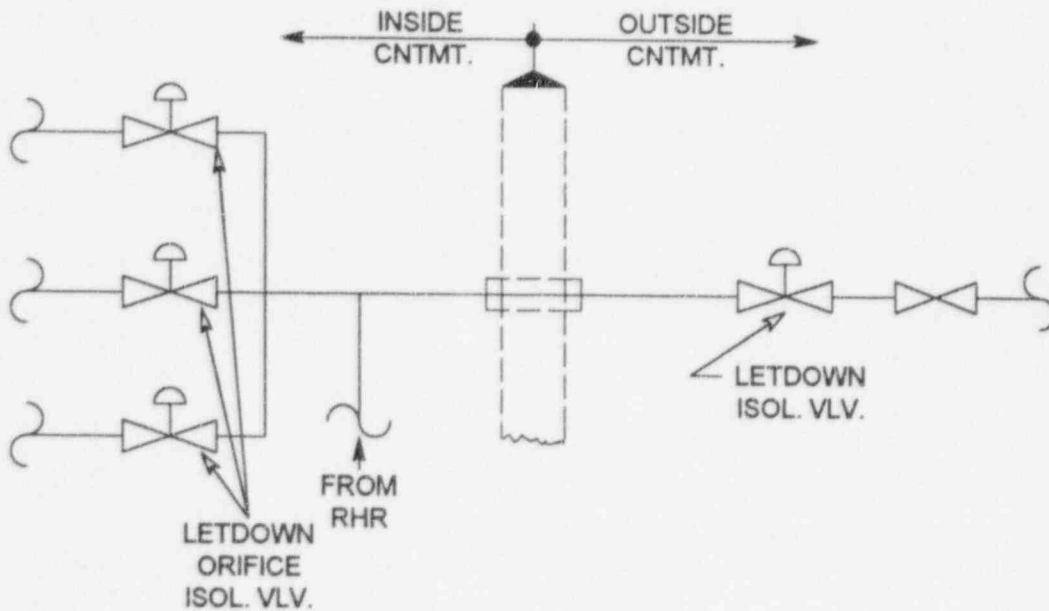
The CVC system letdown line from the reactor coolant system has redundant containment isolation valves. The inboard isolation consists of 3 letdown orifice isolation valves in parallel, and the outboard isolation consists of a single valve. The RHR system is connected to the letdown line between the redundant containment isolation valves. This configuration is used for shutdown purification and overpressure protection of the RHR piping. (See attached figure.)

Failure of the outboard letdown line containment isolation valve in the open position would allow the RHR system to pump postaccident containment sump water to the letdown system outside of containment. Assuming no operator action, there is a potential to exceed the USAR offsite dose calculation values. Additionally, with contaminated water in the auxiliary building in locations other than those evaluated, it may not be possible to fully implement all the emergency procedures within the assumed radiation dose.

The cause of the event is an apparent oversight during original plant design.

Administrative controls will be implemented to preclude the above condition prior to plant start-up.
