RADIOLOGIC AND ENGINEERING ASSESSMENT

DOE ID NO.: GJ-02246-RS
ADDRESS: 1370 NORTH 20TH STREET

AUGUST 1985

BENDIX FIELD ENGINEERING CORPORATION
P.O. Box 1569
Grand Junction, Colorado 81502

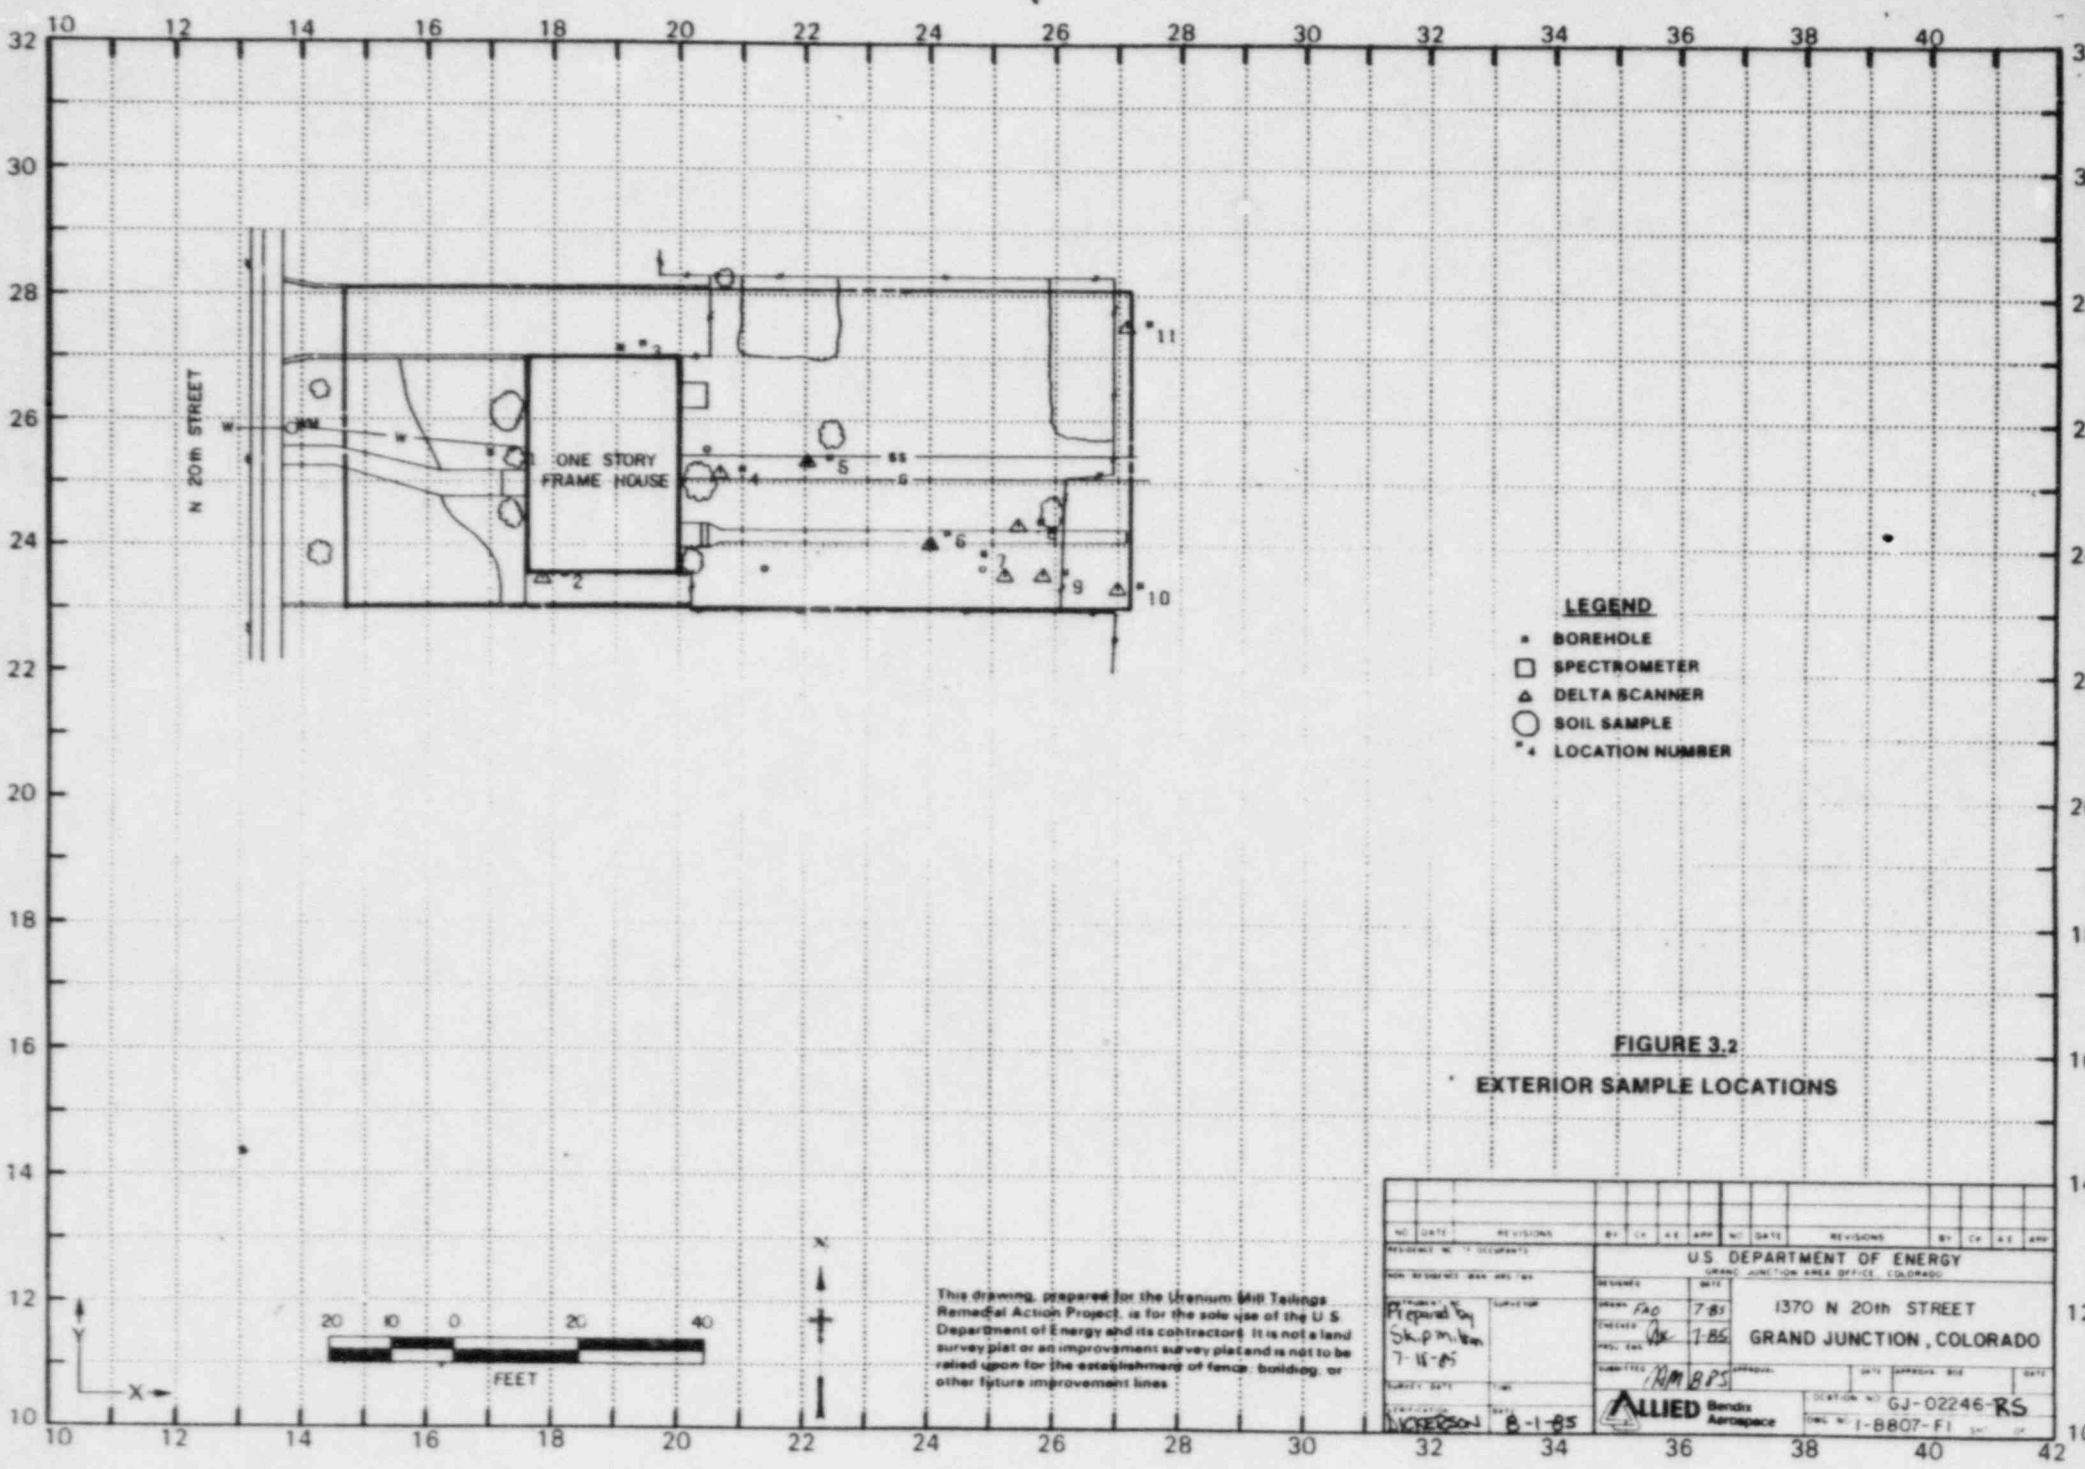
FIGURE 3.2
EXTERIOR SAMPLE LOCATIONS

Areas which displayed elevated gamma levels were further investigated; these areas are shown in Appendix Figure 3.2. Data from these investigations are included in Appendix Table 3.1.

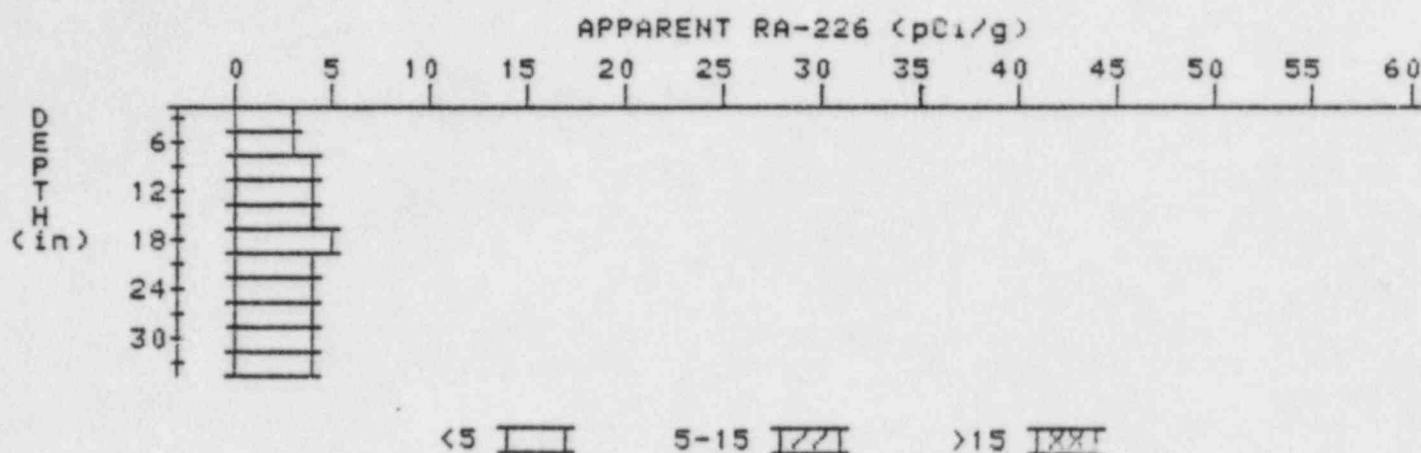
HOLE NUMBER: 1

A borehole was drilled adjacent to the located water line at this property. No contamination was noted.
