RADIOLOGIC AND ENGINEERING ASSESSMENT

DOE ID NO.: GJ-01572-RS
ADDRESS: 1933 ELM AVENUE

AUGUST 1985

BENDIX FIELD ENGINEERING CORPORATION
P.O. Box 1569
Grand Junction, Colorado 81502

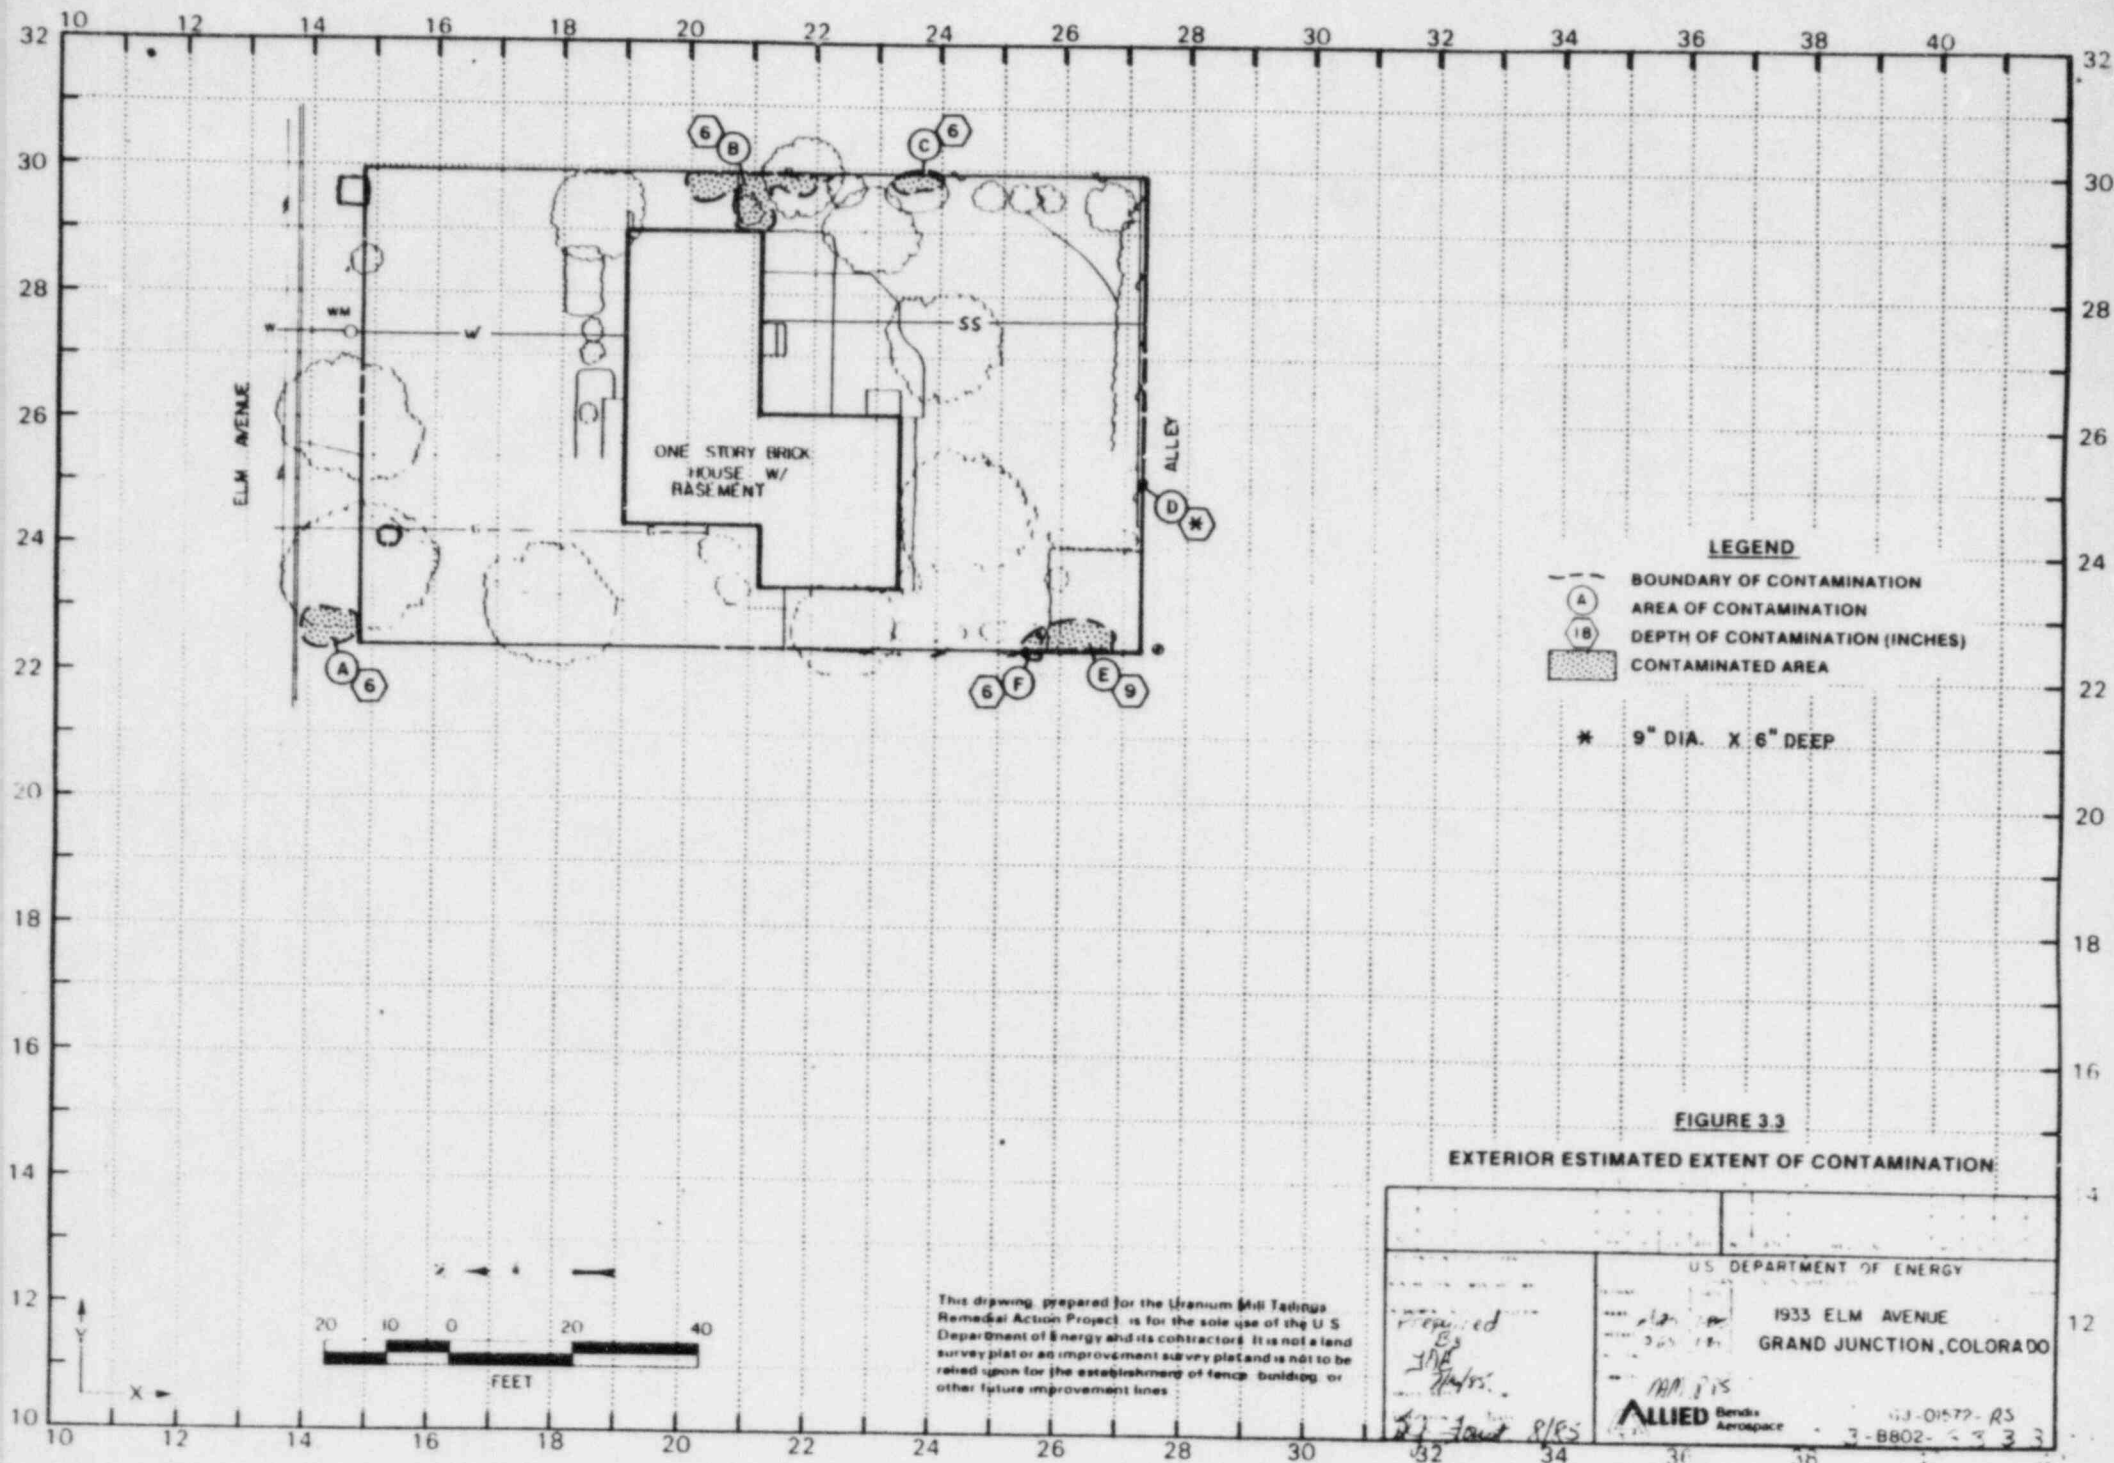
Appendix Figure 3.3 shows identified areas and estimated depths of contamination on this property, based on assessments of all measurements taken. As noted in this figure, areas recommended for remedial action that contain identified residual radioactive materials are:

- (Area A) Surface Material: Lawn
 Direction From Primary Structure: Northwest
 Other Directions: North property boundary
 Total Depth of Contamination: 6 inches
 Approximate Square Footage: 45

- (Area B) Surface Material: Soil
 Direction From Primary Structure: East
 Other Directions: East property boundary
 Total Depth of Contamination: 6 inches
 Approximate Square Footage: 105

- (Area C) Surface Material: Rock
 Direction From Primary Structure: Southeast
 Other Directions: East property boundary
 Total Depth of Contamination: 6 inches
 Comments: Rock garden
 Approximate Square Footage: 21

- (Area D) Surface Material: Concrete
 Direction From Primary Structure: South
 Other Directions: Near alley
 Total Depth of Contamination: 6 inches
 Other (height or thickness): 6-inch-thick by eight-inch-wide concrete.
 Comments: This is a slab of concrete for a fence pole.
 Approximate Square Footage: 0.4

- (Area E) Surface Material: Soil
 Direction From Primary Structure: Southwest
 Other Directions: Next to alley in south yard
 Total Depth of Contamination: 9 inches
 Approximate Square Footage: 52

- (Area F) Surface Material: Soil
 Direction From Primary Structure: Southwest
 Other Direction: West property boundary
 Total Depth of Contamination: 6 inches
 Approximate Square Footage: 2

The recommended remedial action for this property, DOE ID No. GJ-01572-RS, includes removal of all areas identified as containing radioactive material (as discussed in Section 3.5 and shown in Appendix Figure 3.3) and transport of removed material to the disposal site.

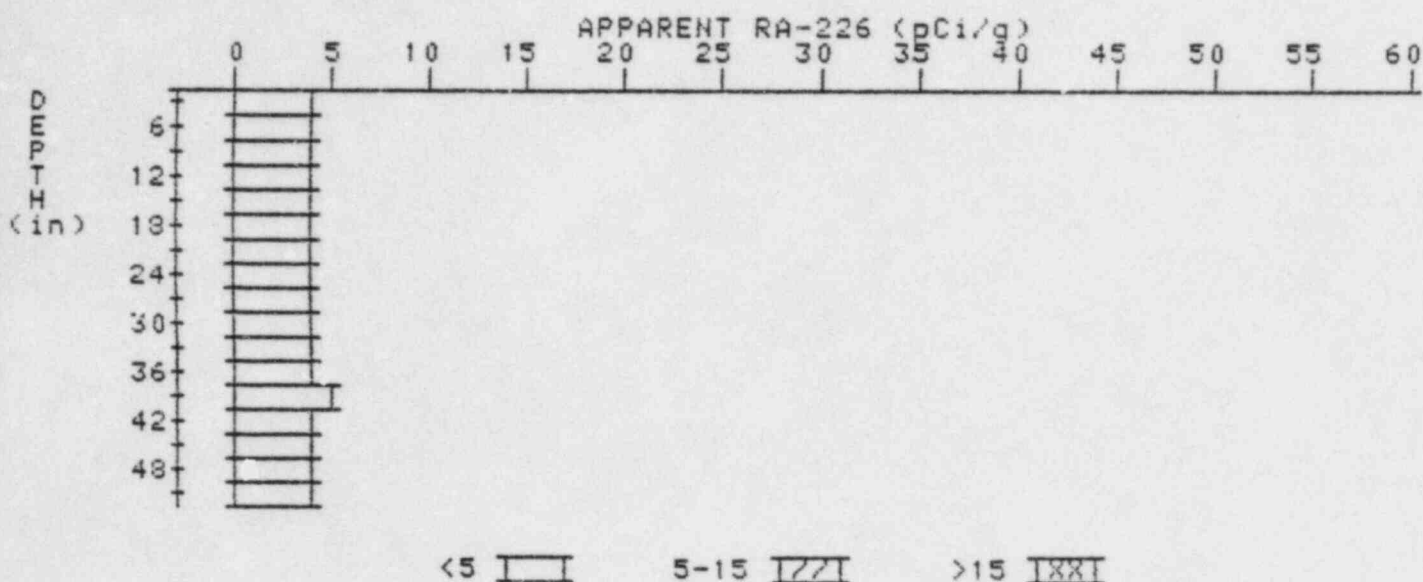
HOLE NUMBER: 2

Depth (in)	Apparent Radium-226 (pCi/g) Undeconvolved	Apparent Radium-226 (pCi/g) Deconvolved
3	3.6	3.6
6	3.9	4.4
9	3.9	3.9
12	3.9	3.9
15	3.9	3.7
18	4.0	4.0
21	4.1	4.3
24	4.1	4.1
27	4.1	3.9
30	4.2	4.4
33	4.2	4.2
36	4.2	4.0
39	4.3	4.7
42	4.2	3.8
45	4.3	4.5
48	4.3	4.3
51	4.3	4.3

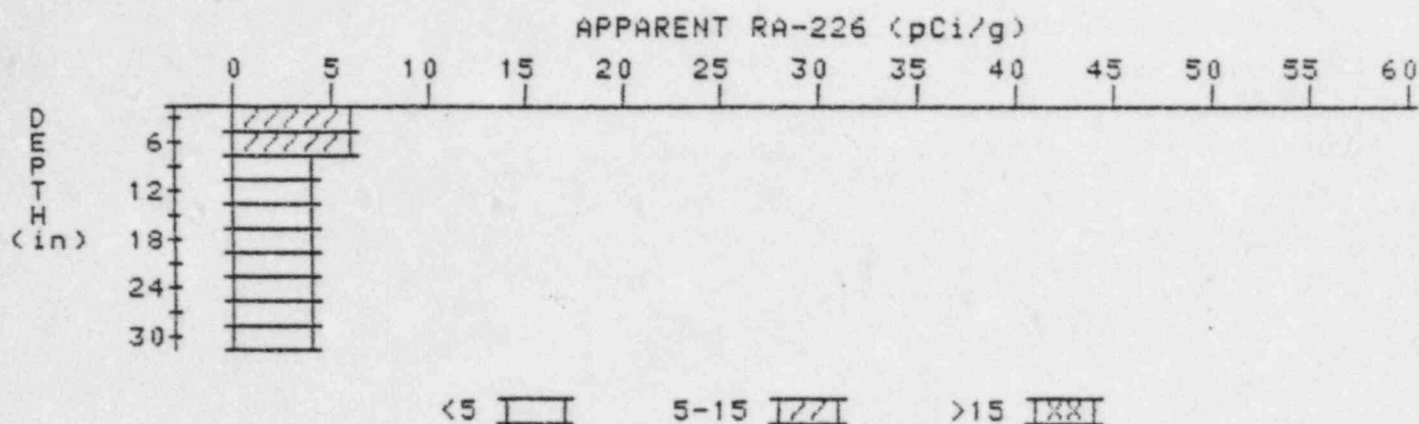
HOLE NUMBER: 17

Depth (in)	Apparent Radium-226 (pCi/g) Undeconvolved	Apparent Radium-226 (pCi/g) Deconvolved
3	6.0	6.0
6	5.6	6.1
9	4.9	4.4
12	4.5	4.1
15	4.3	4.3
18	4.1	3.7
21	4.1	4.1
24	4.1	4.1
27	4.1	4.3
30	4.0	4.0
