RADIOLOGIC AND ENGINEERING ASSESSMENT

DOE ID NO.: GJ-05611-RS  
ADDRESS: 211 COUNTRY CLUB PARK ROAD

AUGUST 1985

BENDIX FIELD ENGINEERING CORPORATION  
P.O. Box 1569  
Grand Junction, Colorado 81502

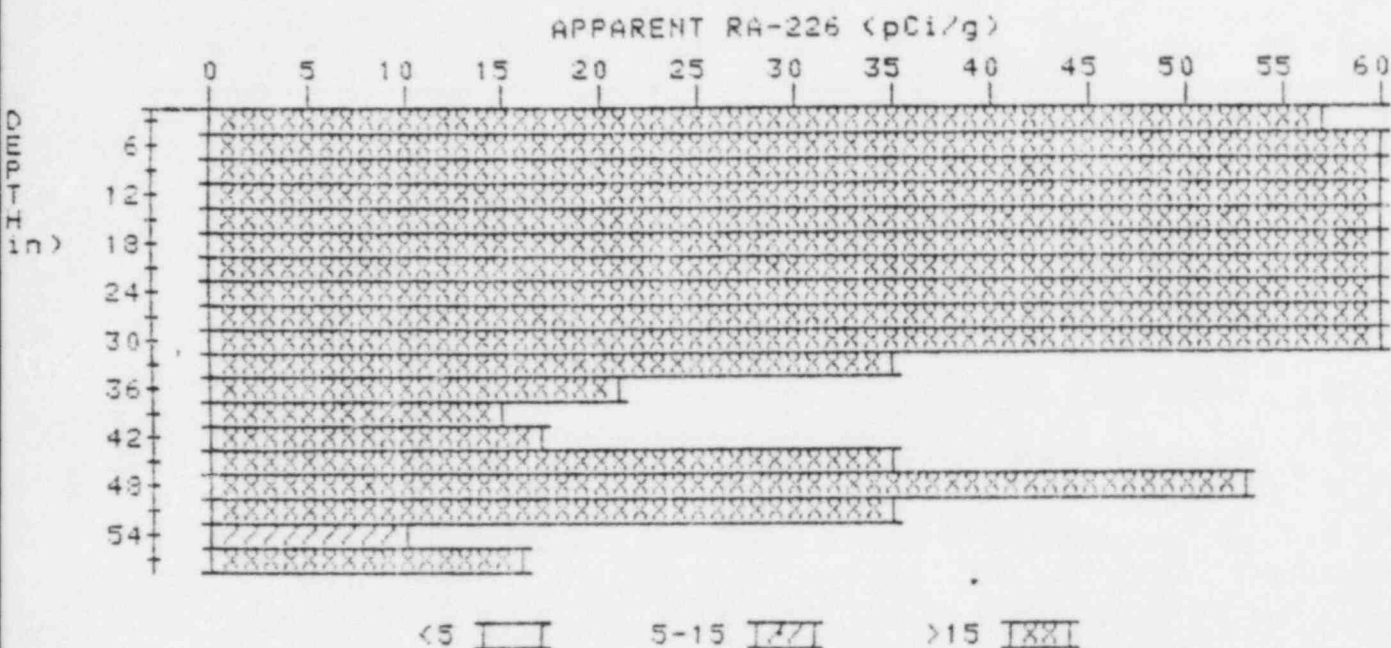
# APPARENT RADIUM-226 CONCENTRATION 22 DECONVOLUTION GRAPH

Loc #	Grid Location	Depth (in.)	Meas. Type	In Situ Ra-226 (pCi/g)		Chem Ra-226 (pCi/g)	Comments
				Tot. Ct	Spectr.		
22	403269	21	TC	131.6		*	
		24	TC	122.6		*	DC = 54 inches
		27	TC	95.1		*	Based on the
		30	TC	72.6		*	deconvolution graph
		33	TC	49.5		*	
		36	TC	34.7		*	
		39	TC	27.4		*	
		42	TC	27.0		*	
		45	TC	32.1		*	
		48	TC	35.7		*	
		51	TC	29.4		*	
		54	TC	19.9		*	
		57	TC	15.7		*	
23	407286	03	TC	109.5		*	Next to street
		06	TC	137.2		*	north of mailboxes
		09	TC	152.3		*	DC = 27 inches
		12	TC	154.5		*	Based on the
		15	TC	146.4		*	deconvolution graph
		18	TC	127.7		*	
		21	TC	96.6		*	
		24	TC	62.0		*	
		27	TC	37.9		*	
		30	TC	25.6		*	
		33	TC	17.3		*	
		36	TC	12.0		*	
		39	TC	8.5		*	
		42	TC	7.3		*	
		45	TC	6.2		*	
		48	TC	5.7		*	
		51	TC	5.4		*	
		54	TC	5.4		*	
		57	TC	5.5		*	
		60	TC	6.1		*	
		63	TC	7.6		*	
24	409309	00	DS	<1.0		*	In trees by road
