RADIOLOGIC AND ENGINEERING ASSESSMENT

DOE ID NO.: GJ-12224-RS
ADDRESS: 1660 ORCHARD AVENUE

AUGUST 1985

BENDIX FIELD ENGINEERING CORPORATION
P.O. Box 1569
Grand Junction, Colorado 81502

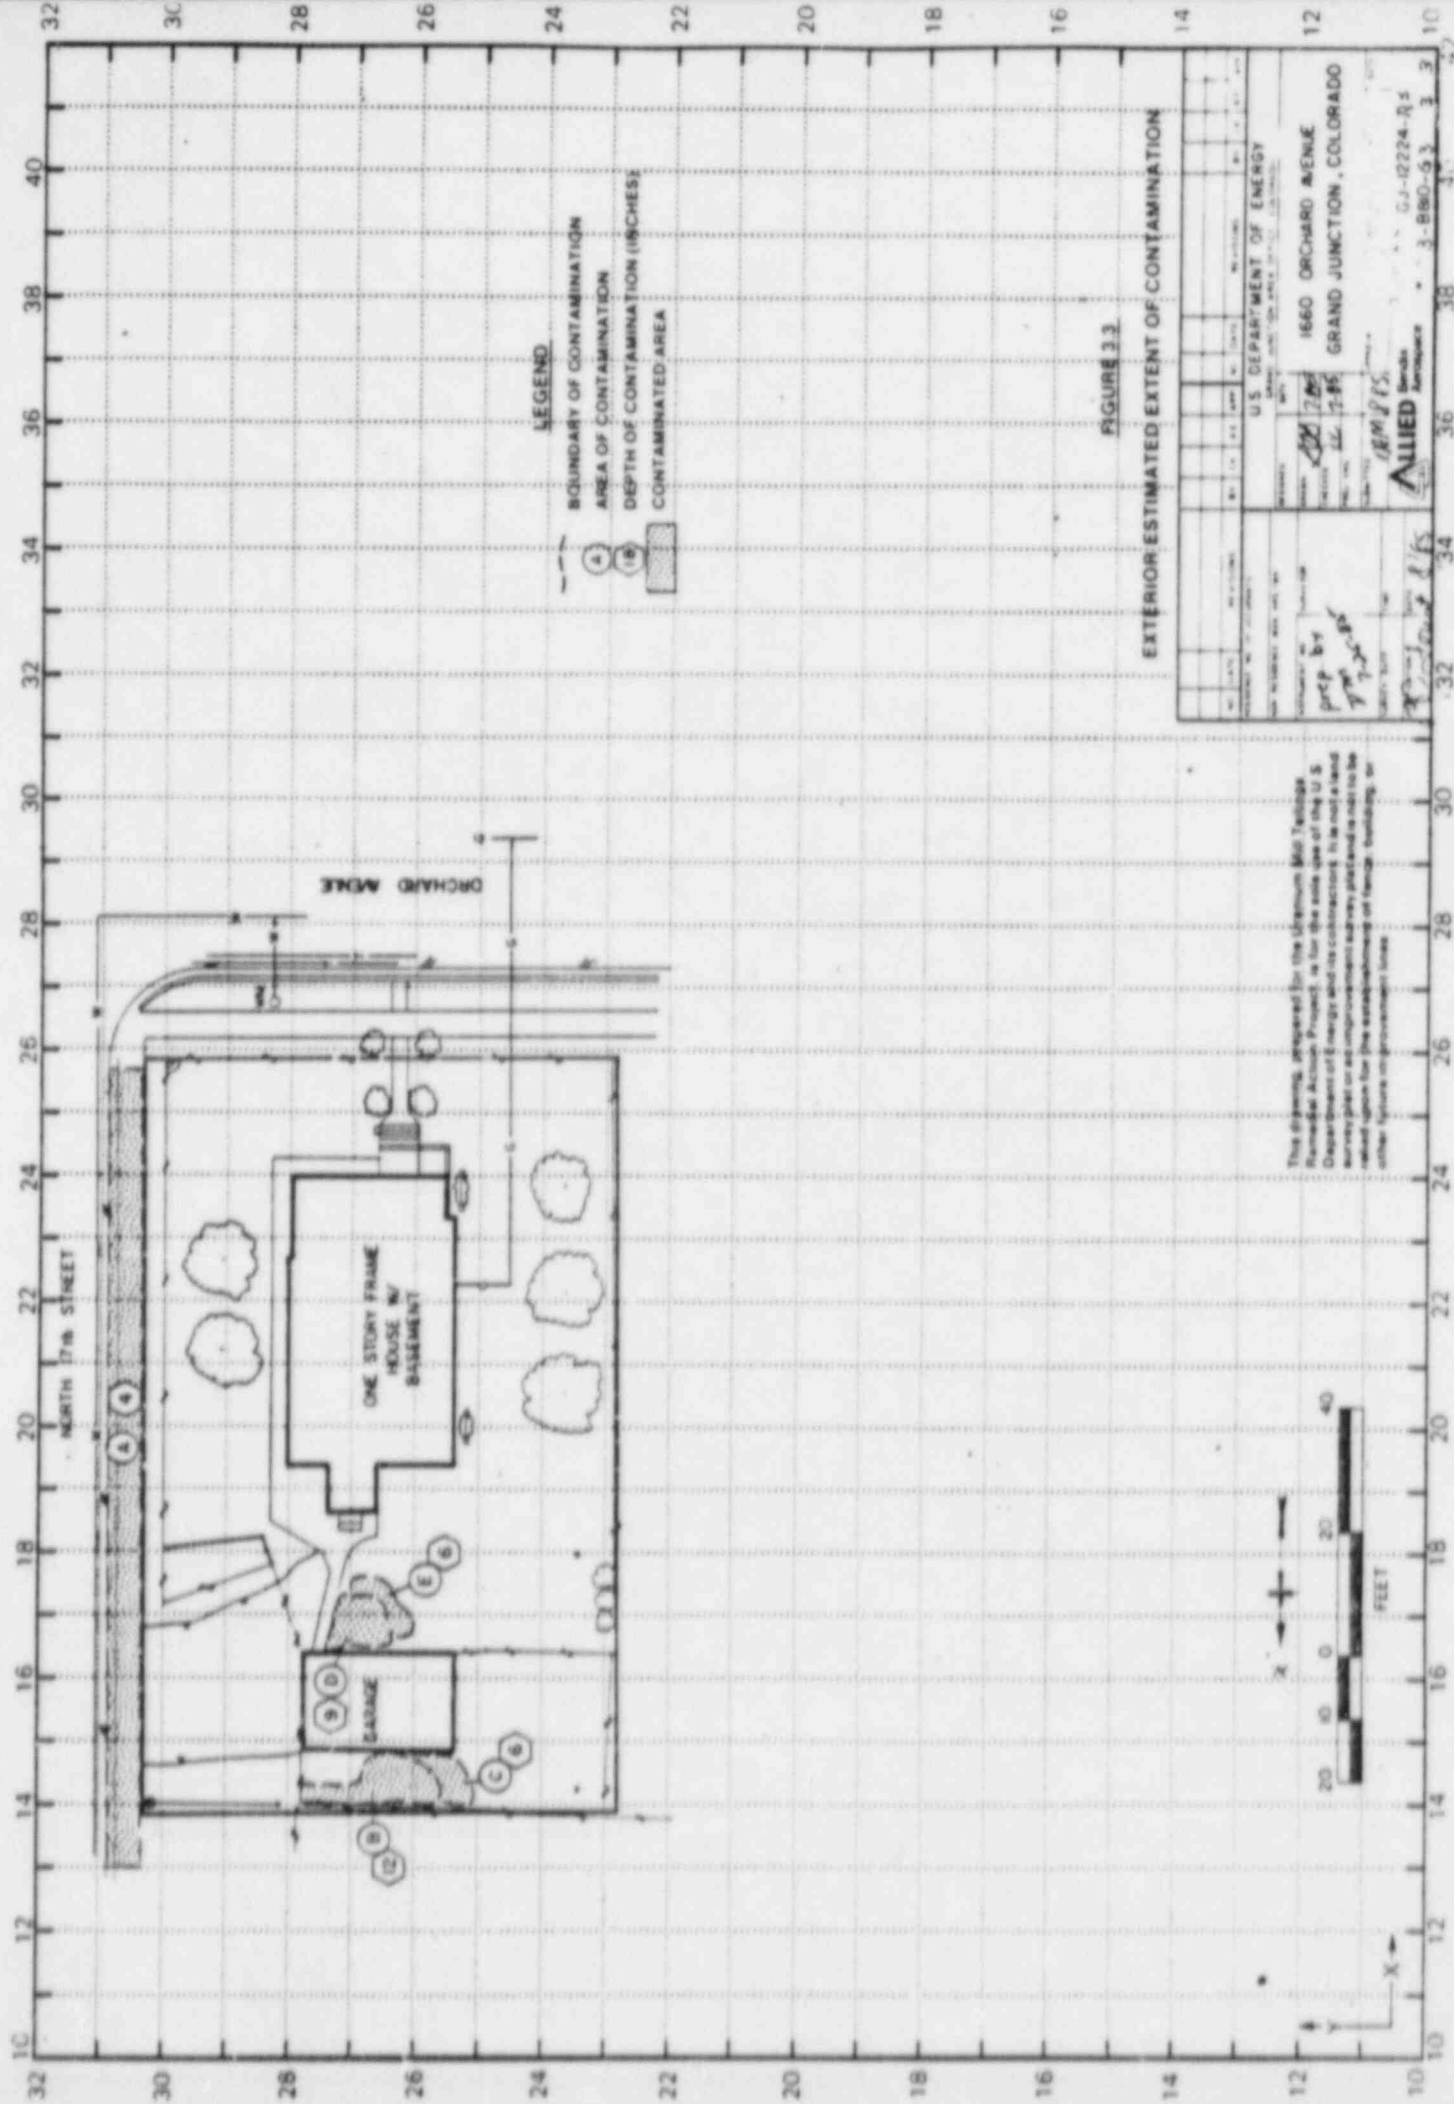
Appendix Figure 3.3 shows identified areas and estimated depths of contamination on this property, based on assessments of all measurements taken. As noted in this figure, areas recommended for remedial action that contain identified residual radioactive materials are:

- (Area A) Surface Material: Concrete
Direction From Primary Structure: East
Total Depth of Contamination: 4 inches
Other (height or thickness): 4-inch-thick concrete
Comments: City sidewalk
Approximate Square Footage: 669

- (Area B) Surface Material: Soil
Direction From Primary Structure: North
Other Directions: North of garage
Total Depth of Contamination: 12 inches
Approximate Square Footage: 136

- (Area C) Surface Material: Soil
Direction From Primary Structure: North
Other Directions: Adjacent to Area B
Total Depth of Contamination: 6 inches
Approximate Square Footage: 40

- (Area D) Surface Material: Soil
Direction From Primary Structure: North
Other Directions: South of garage
Total Depth of Contamination: 9 inches
Approximate Square Footage: 80

- (Area E) Surface Material: Soil
Direction From Primary Structure: North
Other Directions: Adjacent to Area D
Total Depth of Contamination: 6 inches
Approximate Square Footage: 33

The recommended remedial action for this property, DOE ID No. GJ-12224-RS, includes removal of all areas identified as containing radioactive material (as discussed in Section 3.5 and shown in Appendix Figure 3.3) and transport of removed material to the disposal site.

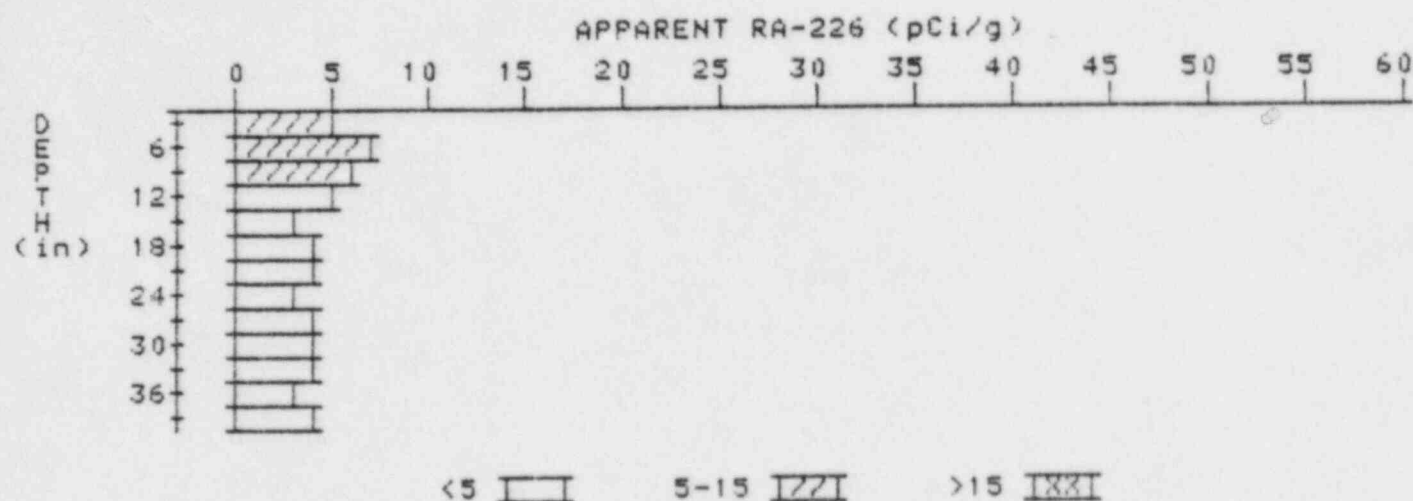
HOLE NUMBER: 4

LOCATION: 145260

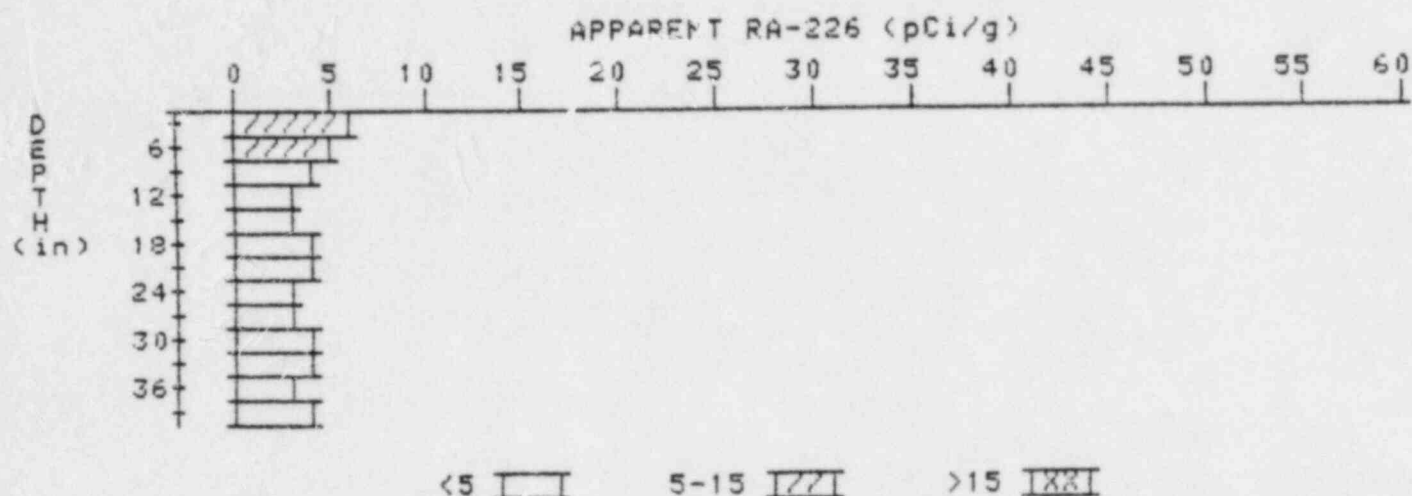
HOLE NUMBER: 7

LOCATION: 170268

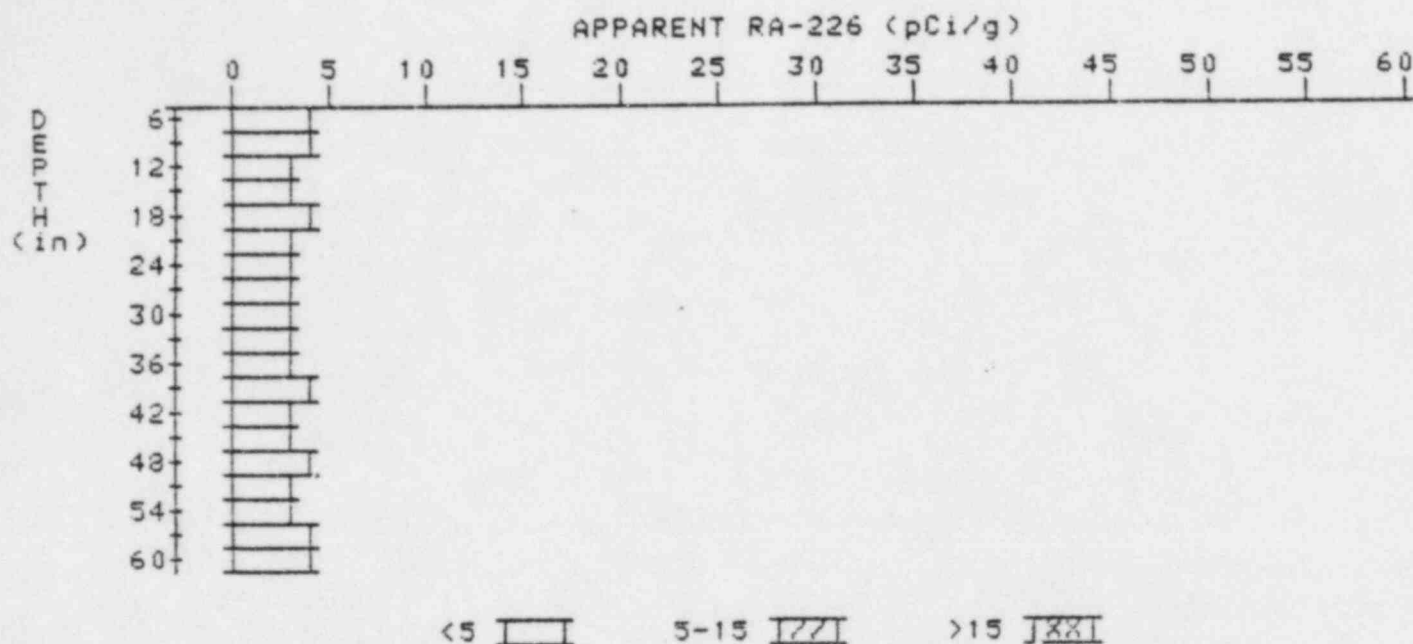
HOLE NUMBER: 10

An abandoned sewer line exiting the primary structure on the north was checked with a borehole at Grid Location 193260. The active sewer line exits on the east side of the primary structure, close to where the water lines comes in.

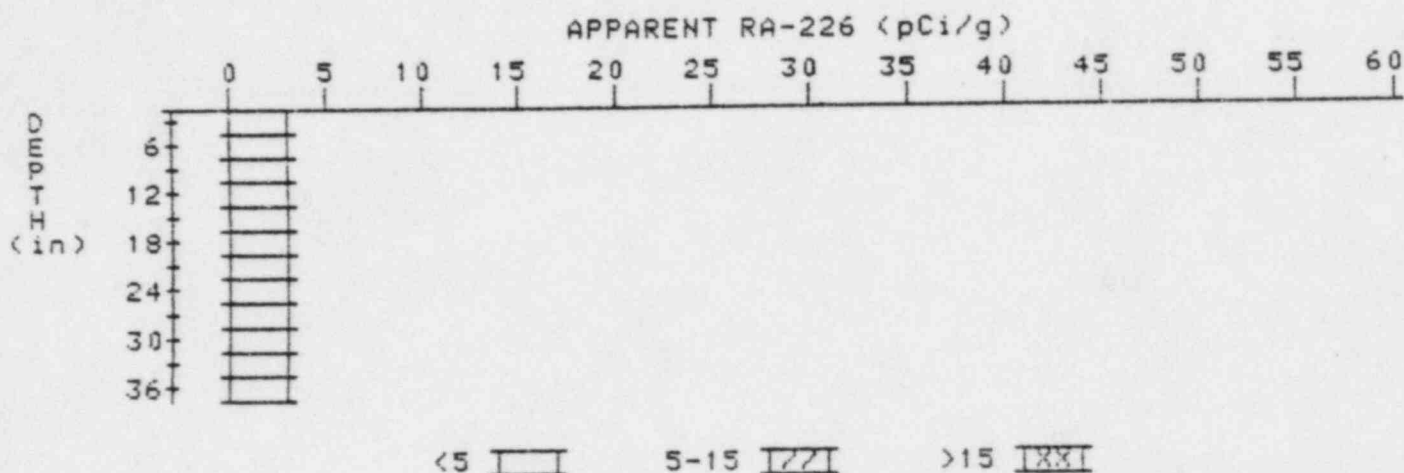
HOLE NUMBER: 13

LOCATION: 210253
