RADIOLOGIC AND ENGINEERING ASSESSMENT

DOE ID NO.: GJ-05828-MR
ADDRESS: 140 MIRIAM AVENUE

AUGUST 1985

BENDIX FIELD ENGINEERING CORPORATION
P.O. Box 1569
Grand Junction, Colorado 81502

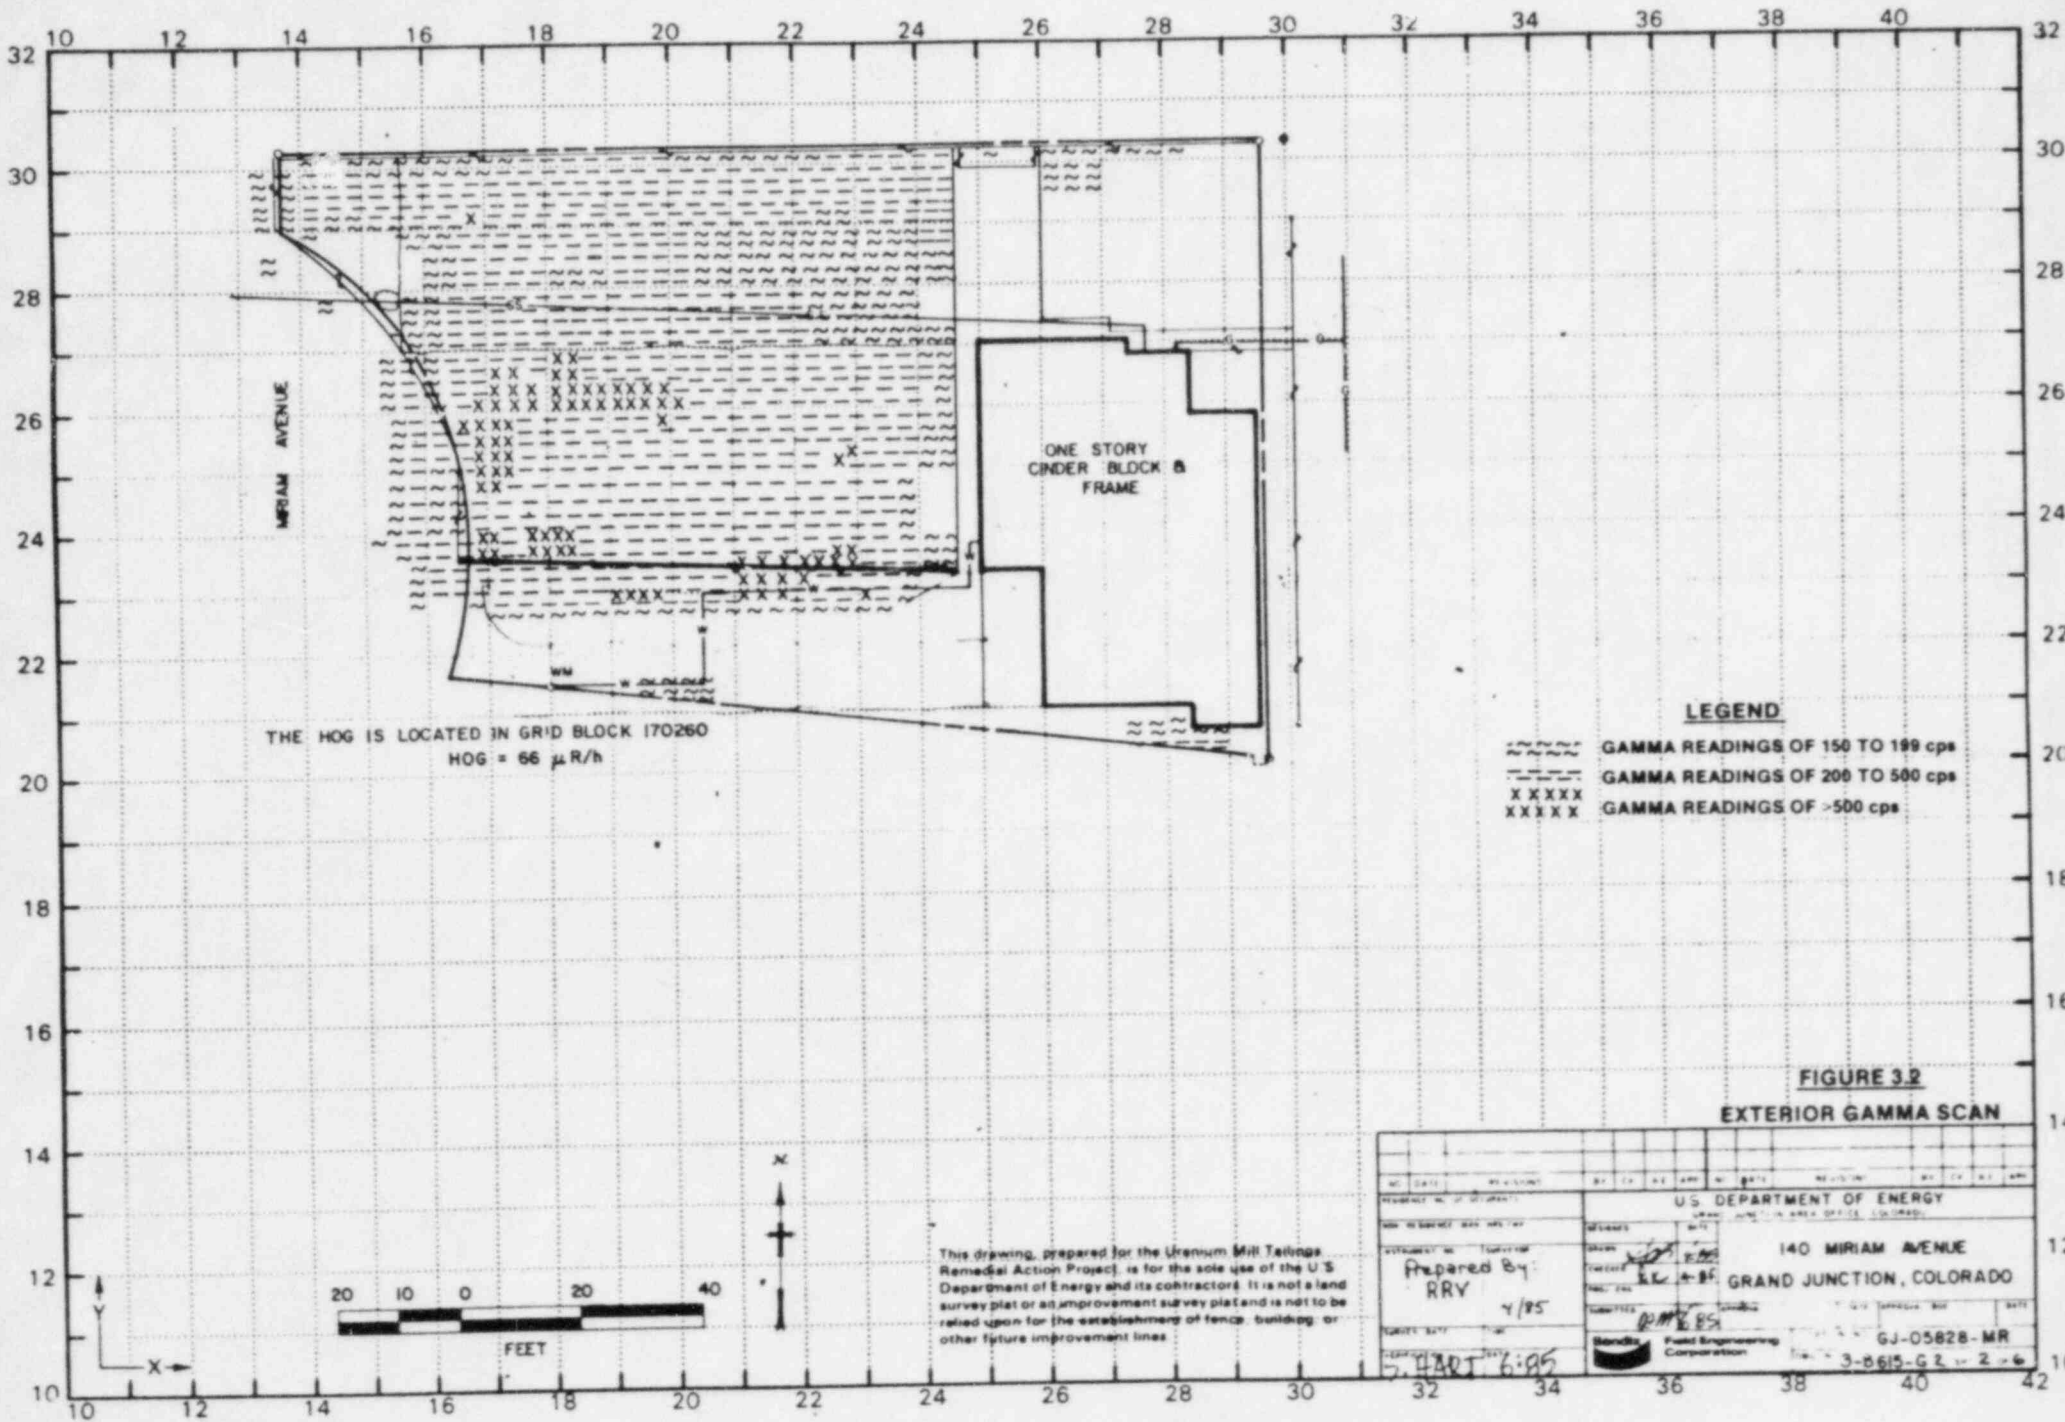
FIGURE 3.2
EXTERIOR GAMMA SCAN

Background Readings: 15 to 17 uR/h
Highest Outside Gamma Reading (HOG): 66 uR/h

Exterior radium-concentration measurements are presented in Appendix Table 3.1. Grid-point survey results are shown in Appendix Figure 3.1. Appendix Figure 3.2 presents the ranges of elevated gamma readings and indicates areas of possible contamination.

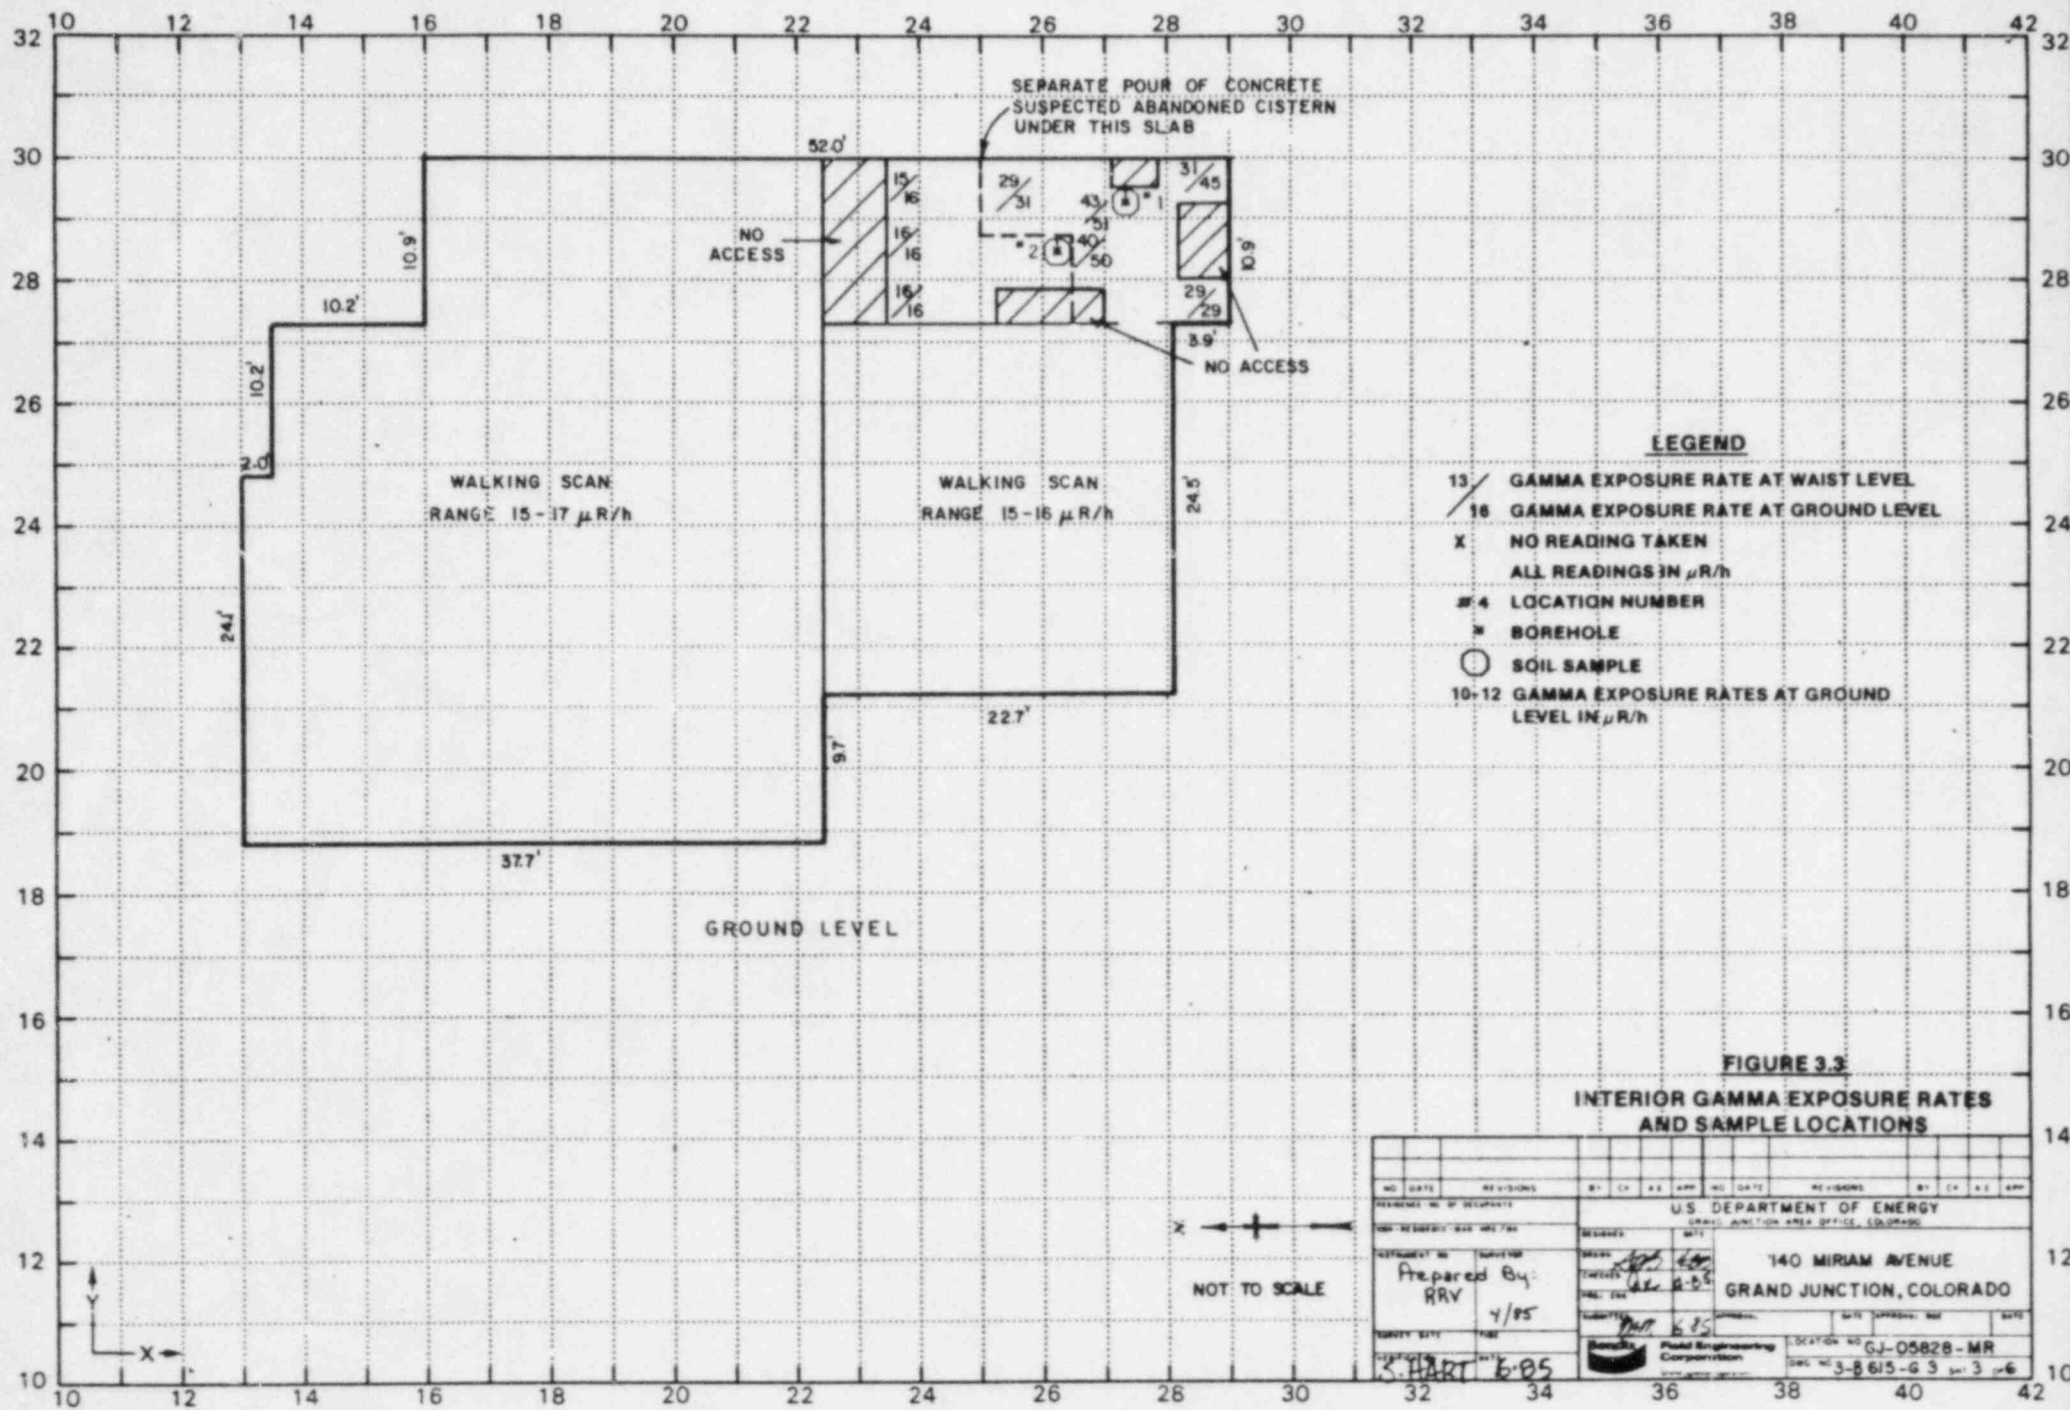
FIGURE 3.3

Background Readings: 15 to 17 uR/h
Highest Inside Gamma Reading (HIG): 51 uR/h

An interior walking scan was performed in the primary structure, also in the attached garage, laundry, and storage room. No elevated readings were found in the living quarters or garage. The laundry and storage room showed readings excessively high to background.
