RADIOLOGIC AND ENGINEERING ASSESSMENT

DOE ID NO.: GJ-00590-MR
ADDRESS: 1827 NORTH 21ST STREET

AUGUST 1985

BENDIX FIELD ENGINEERING CORPORATION
P.O. Box 1569
Grand Junction, Colorado 81502

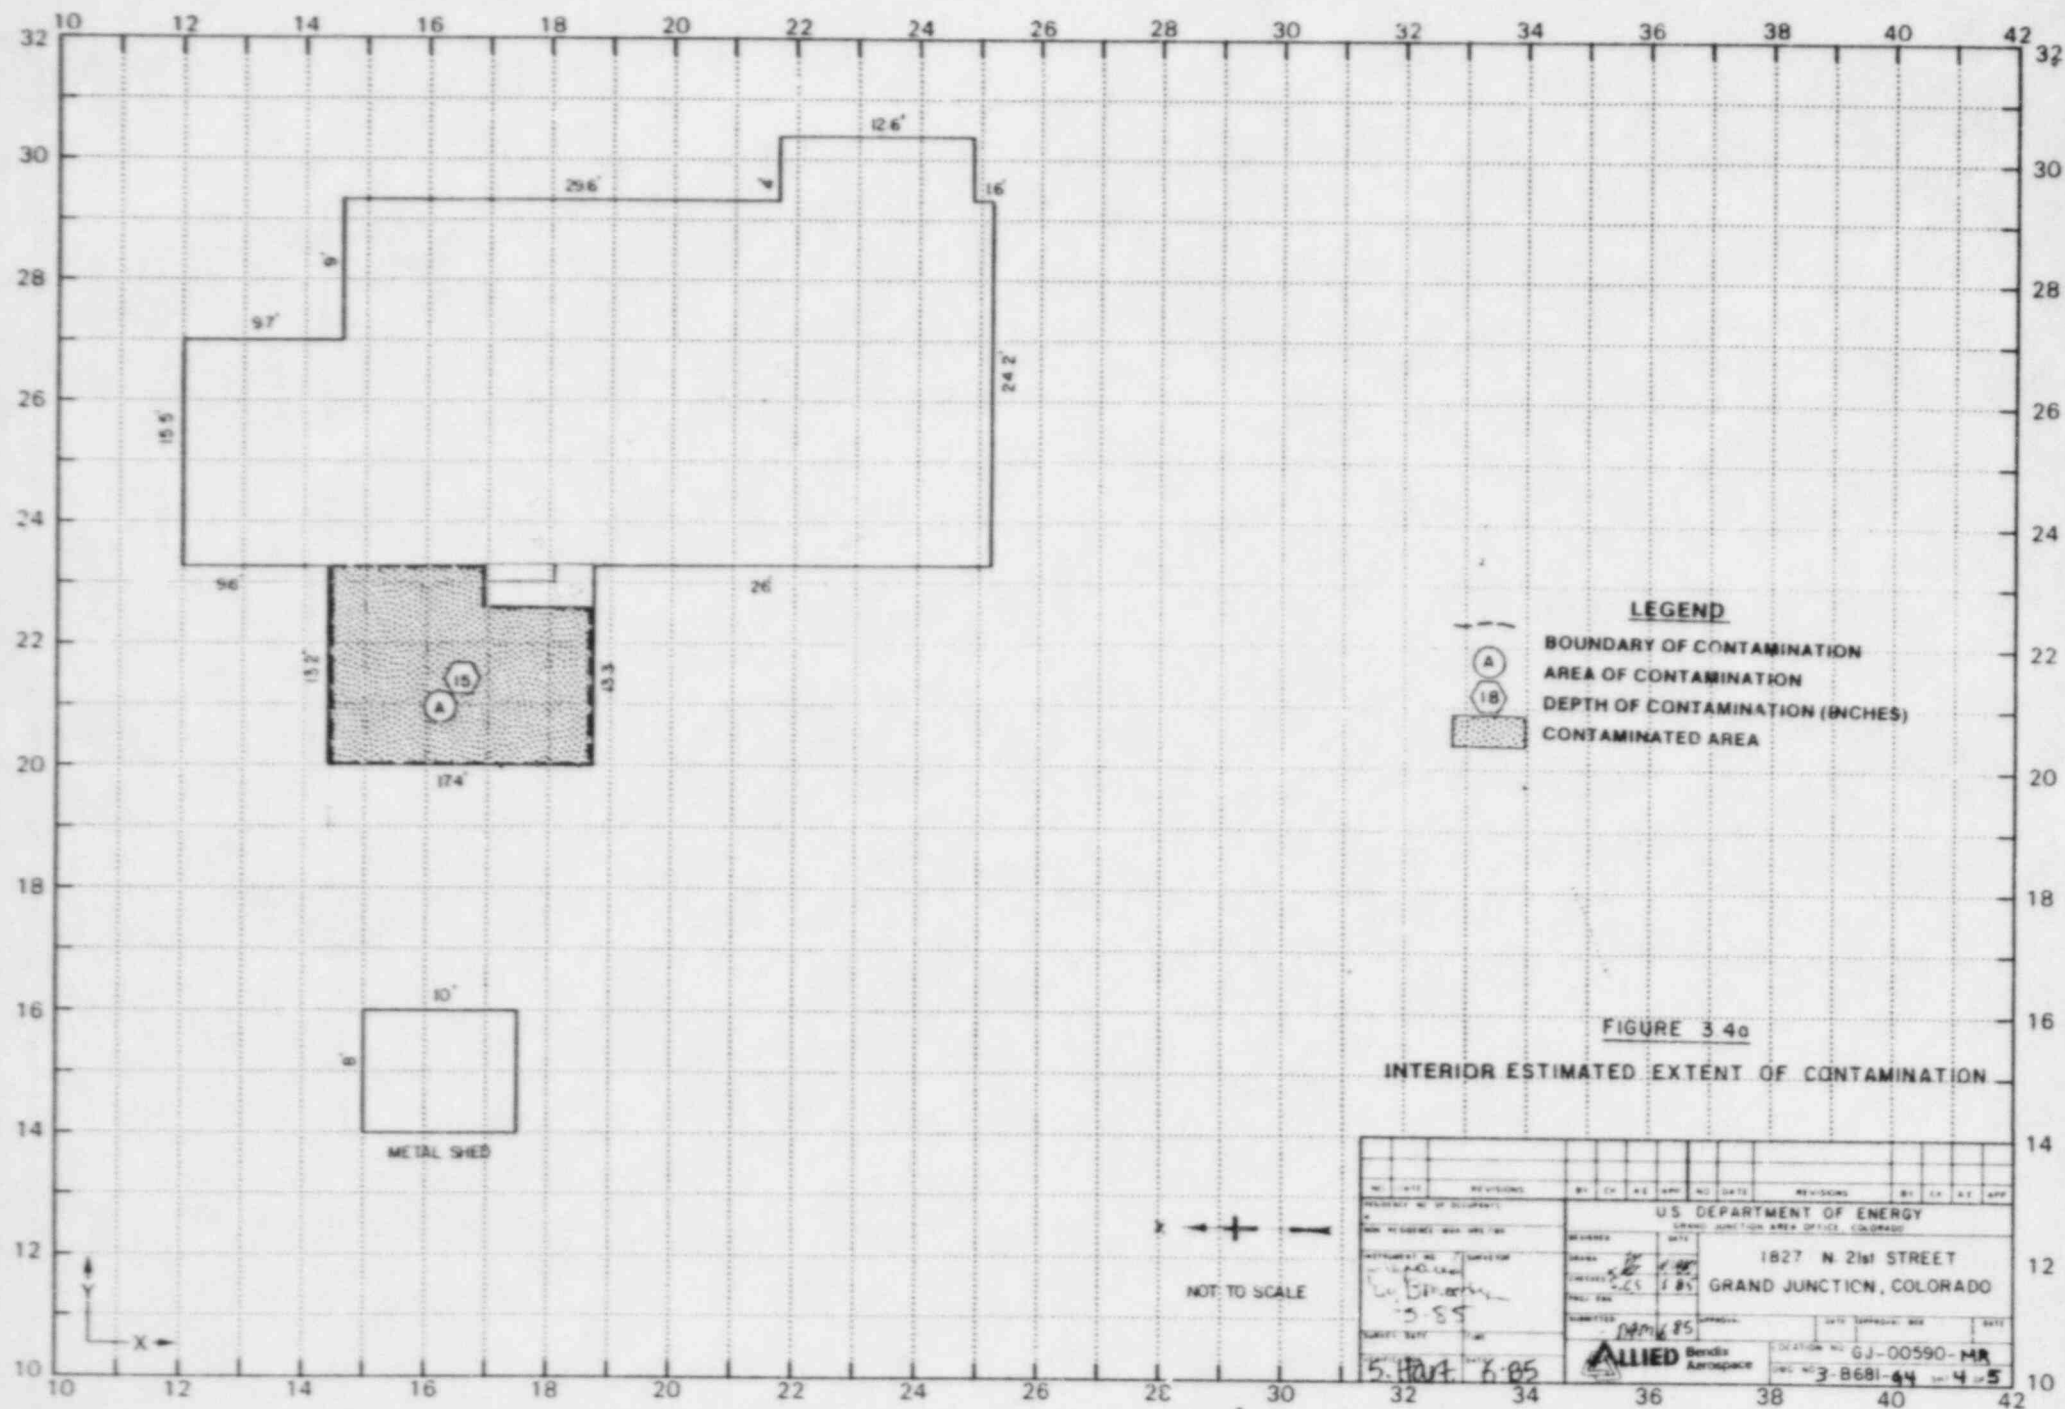
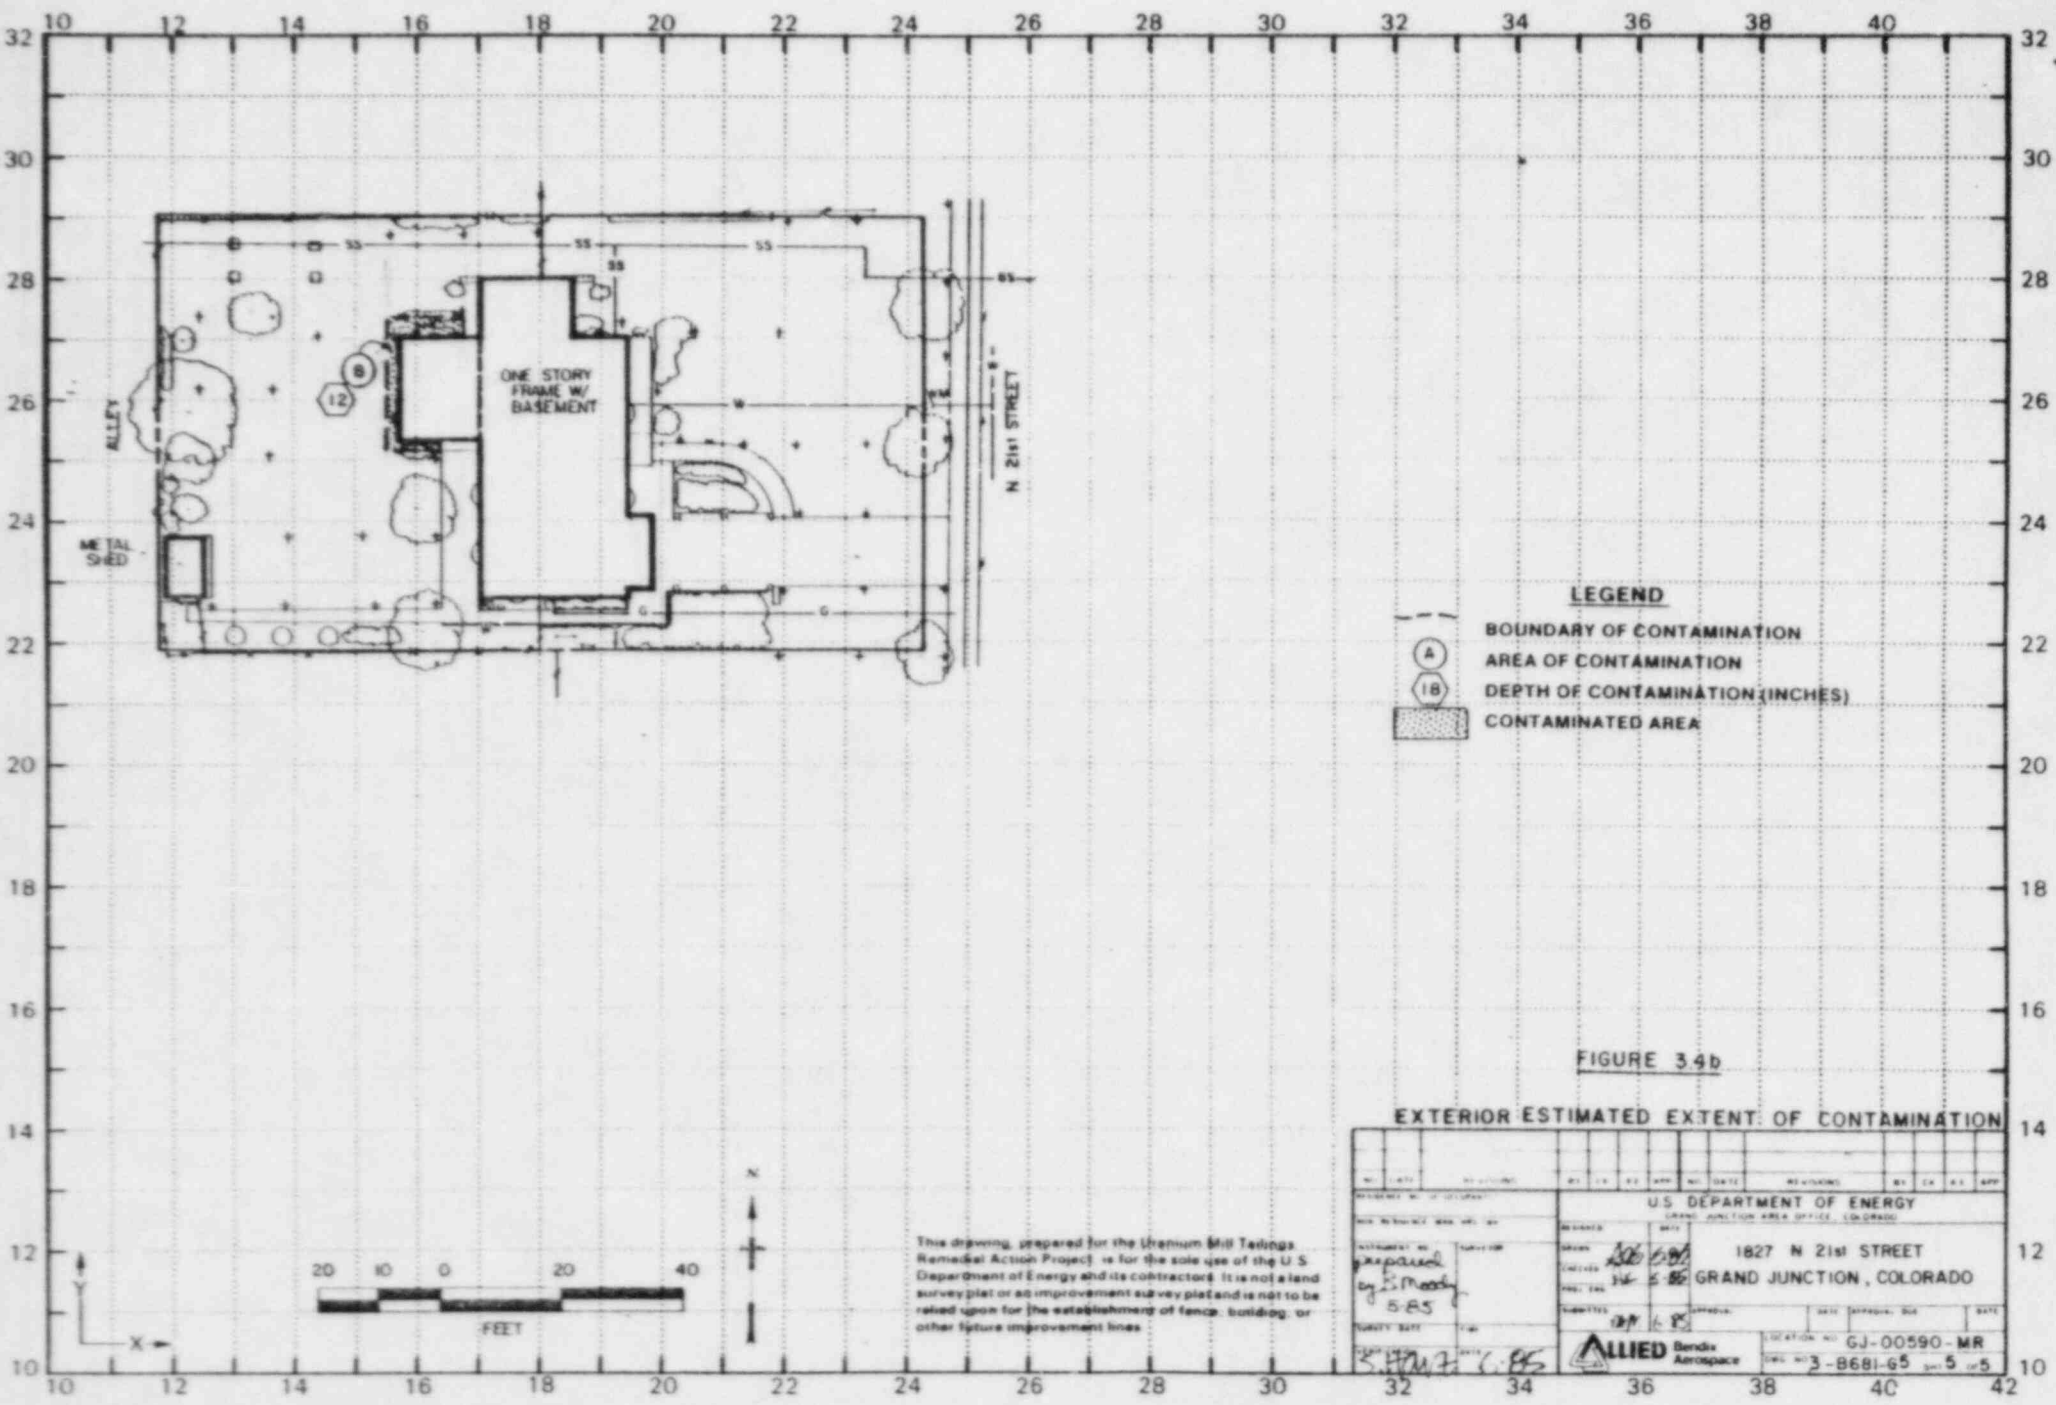
Appendix Figures 3.4a and 3.4b show identified areas and estimated depths of contamination on this property, based on assessments of all measurements taken. As noted in these figures, areas recommended for remedial action that contain identified residual radioactive materials are:

- (AREA A) The concrete patio west of the primary structure has contaminated soil beneath the 5-inch-thick uncontaminated concrete slab. The total depth of contamination is 15 inches (approximately 208 sf).
- (AREA B) Along the north, south, and west side of the patio slab the depth of contamination is 12 inches (approximately 117 sf).

The recommended remedial action for this property, DOE ID No. GJ-00590-MR, includes removal of all areas identified as containing radioactive material (as discussed in Section 3.5 and shown in Appendix Figures 3.4a and 3.4b) and transport of removed material to the disposal site.

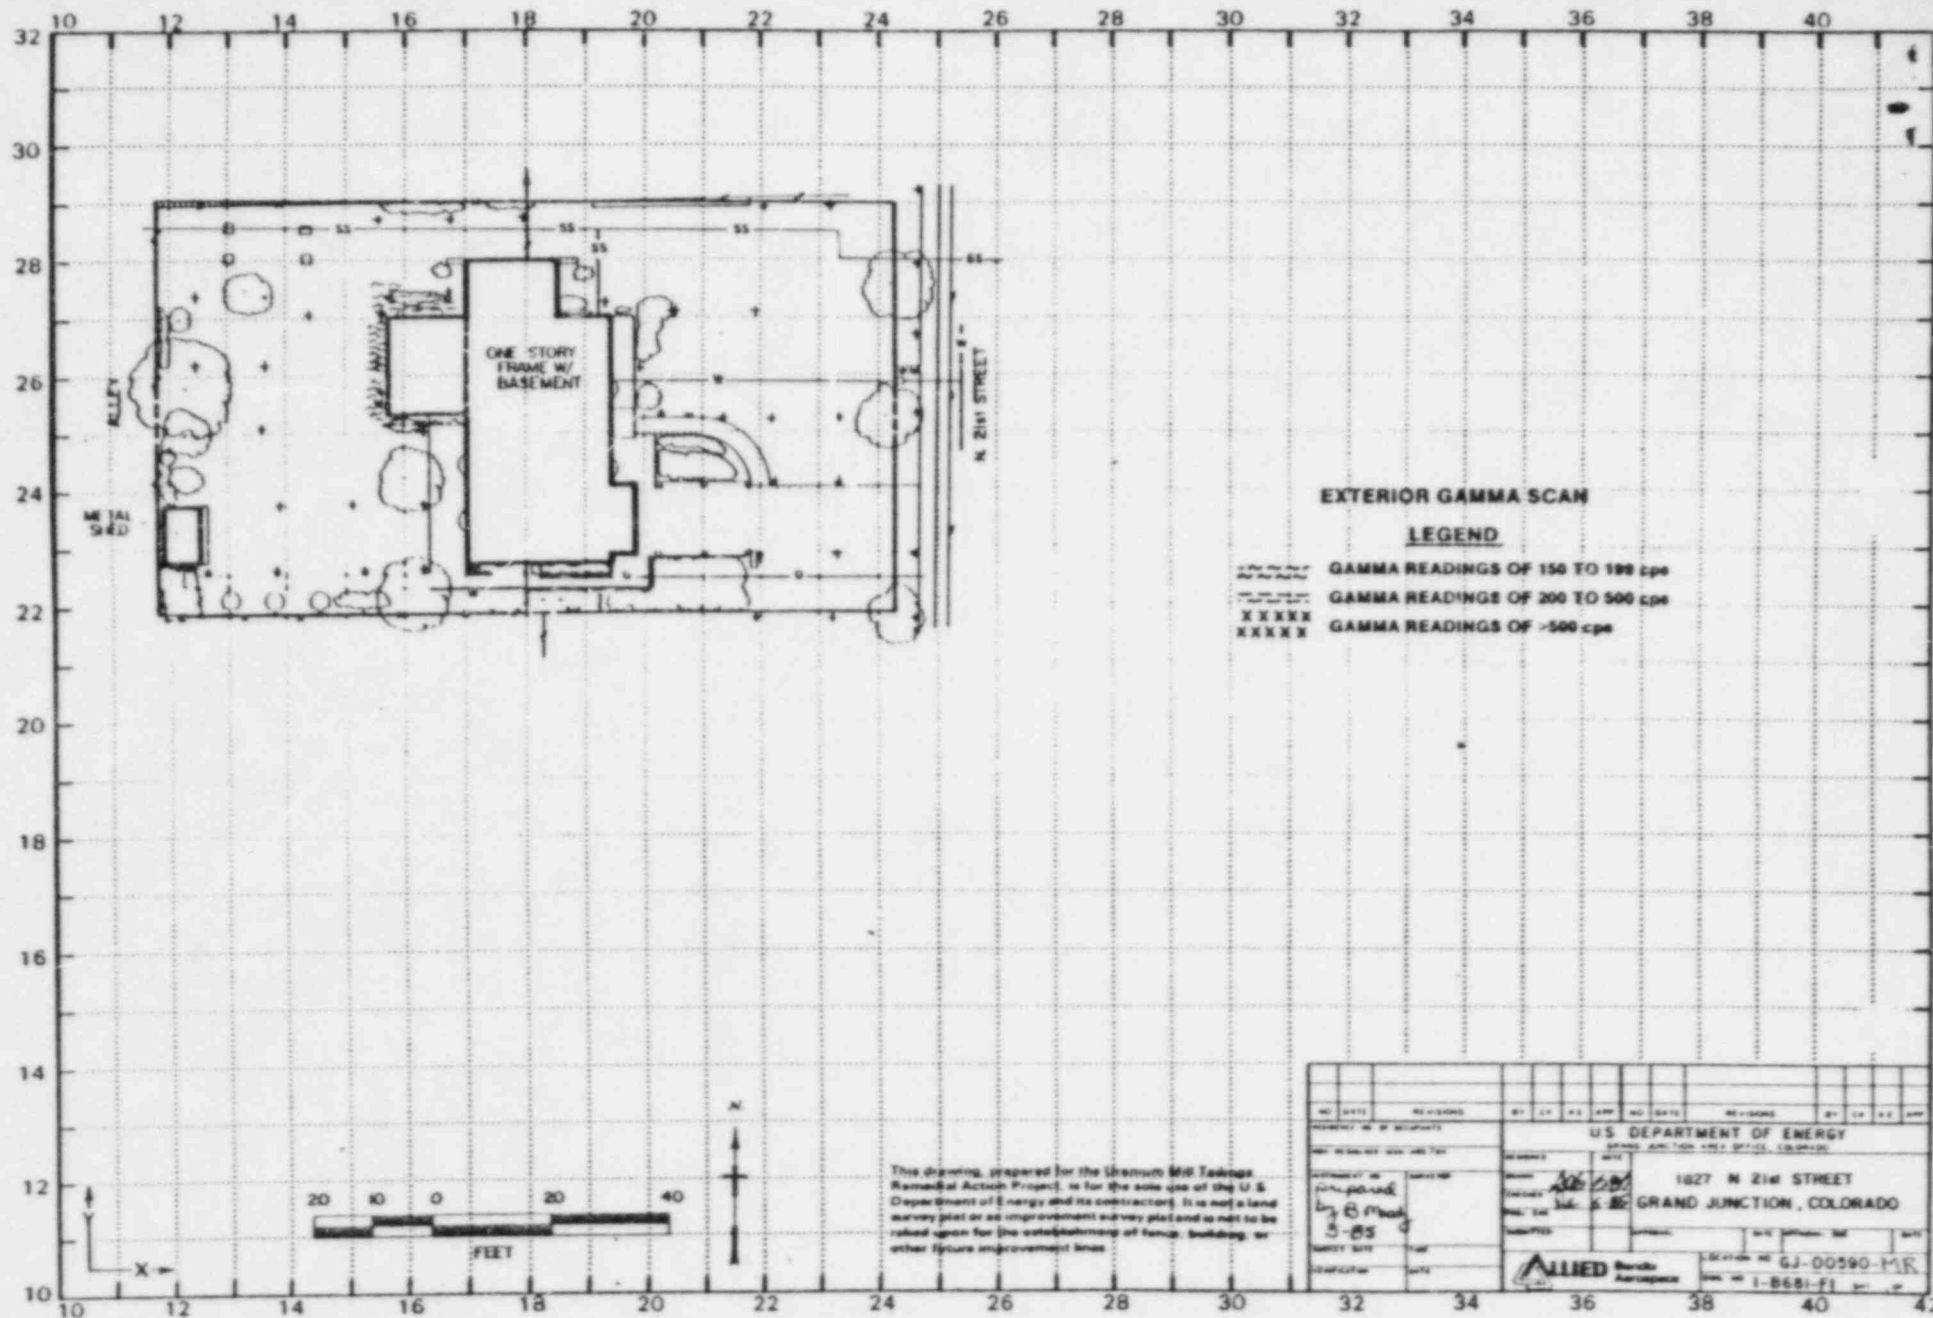
Exterior Gamma Scan Map

A complete walking scan of the exterior of the property was performed. Slightly elevated readings were found in the alley. Elevated readings were found surrounding the enclosed patio area. A walking scan performed on the ground floor and basement showed background readings. A delta was performed on the west wall and floor area. A surface spectrometer measurement was done also. Another delta was performed on the east wall of the patio to confirm readings of shine on that wall.
