James A. FitzPatrick
Nuclear Power Plant
P.O. Box 41
Lycoming, New York 13093
315-342-3840

Subject: Docket No. 50-333
LICENSEE EVENT REPORT: LER-97-002

Shutdown Cooling Isolation

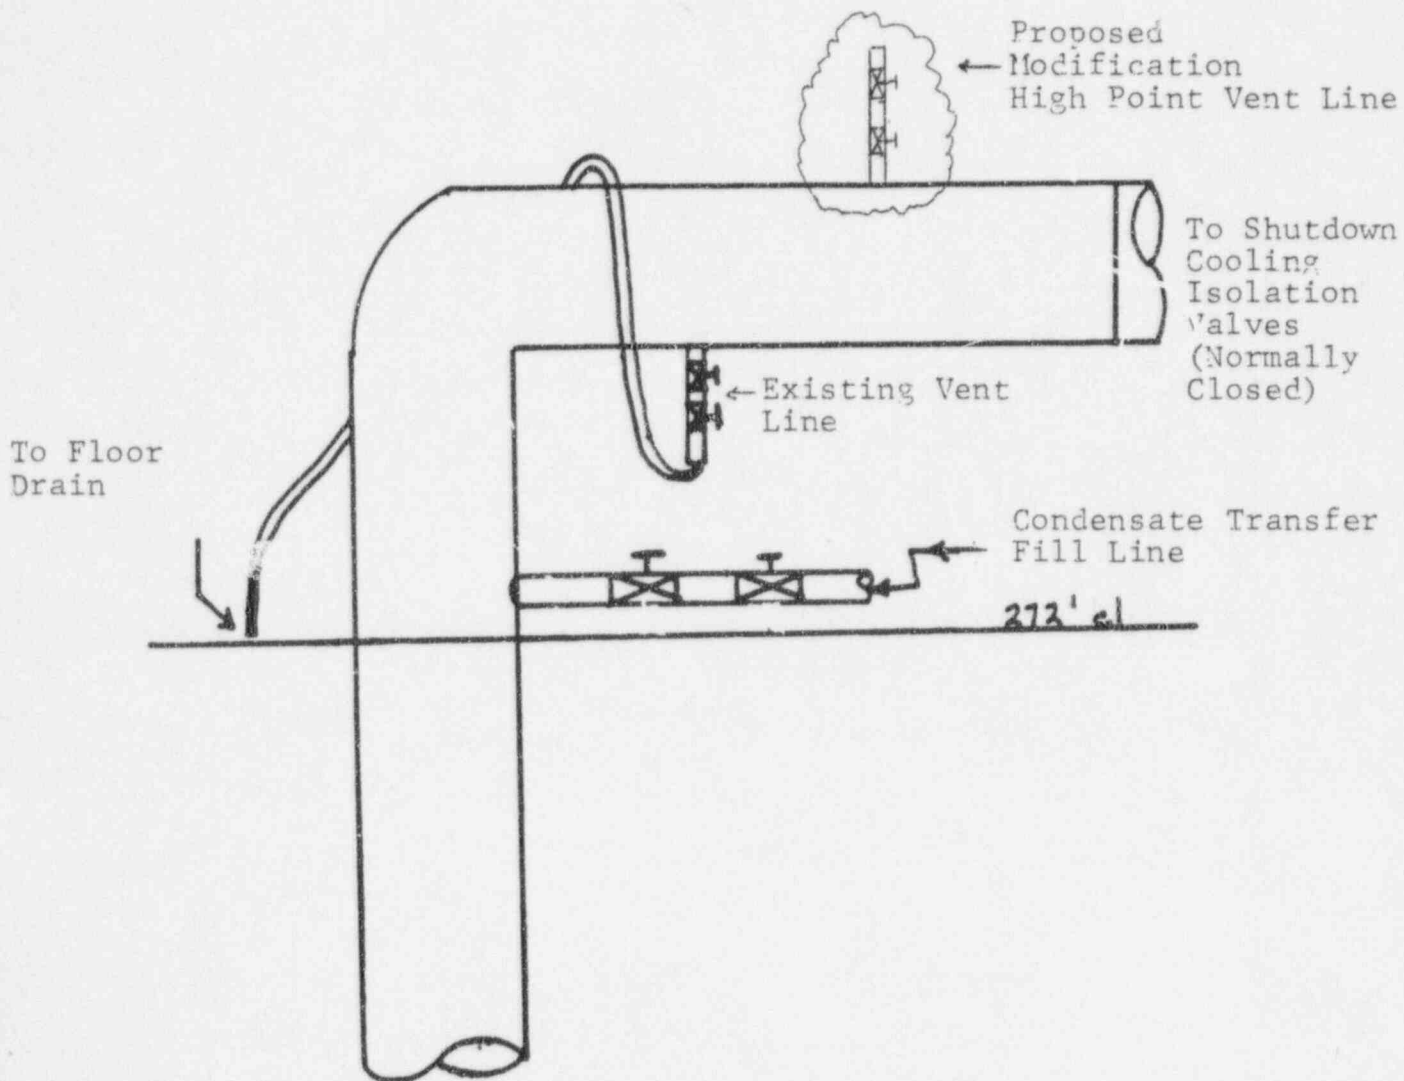
FIGURE 1

The event was caused by a pressure transient. The pressure transients cause pressure switches 02PS-128A and/or 128B to actuate isolating the shutdown cooling suction valves (10MOV-17 and 10MOV-18). The cause of the pressure transient appears to be insufficient venting of the air in the suction piping due to the configuration of the vent path on the bottom of the piping. Previous corrective actions completed to eliminate air from the system have not been fully successful.

A height difference of 30 feet exists from the primary containment [NH] pressure suppression pool (torus) water level (about 244 feet elevation) to the shutdown cooling suction outboard isolation valves (10MOV-17 at 274 feet elevation). Any leakage through the RHR suction valves or suction relief valve (10RV-40) to either the torus or radwaste [WD] could create a void (vacuum) in the piping. Eventually, air will be drawn into the piping via valve packing, flange unions, etc.

When 10MOV-17 and 10MOV-18 are opened, water from the reactor collapses any void created from the air inleakage causing a pressure transient that is felt at the pressure switches. In addition, any small amount of air trapped in the instrument tubing will cause pressure pulsations felt by the pressure switches when the RHR pumps start.

Shutdown Cooling Suction Piping

1. Shutdown cooling was placed in service after resetting the isolation logic and refilling and venting the system in accordance with plant procedures.
2. A modification has been initiated to provide a high point vent to improve the ability to vent the RHR shutdown cooling suction piping. This will be implemented prior to startup from the next refueling outage. The Authority will monitor the effectiveness of this modification and will evaluate additional corrective actions, if necessary.
