RADIOLOGIC AND ENGINEERING ASSESSMENT

DOE ID NO.: GJ-03667-RS
ADDRESS: 2313 BUNTING AVENUE

AUGUST 1985

BENDIX FIELD ENGINEERING CORPORATION
P.O. Box 1569
Grand Junction, Colorado 81502

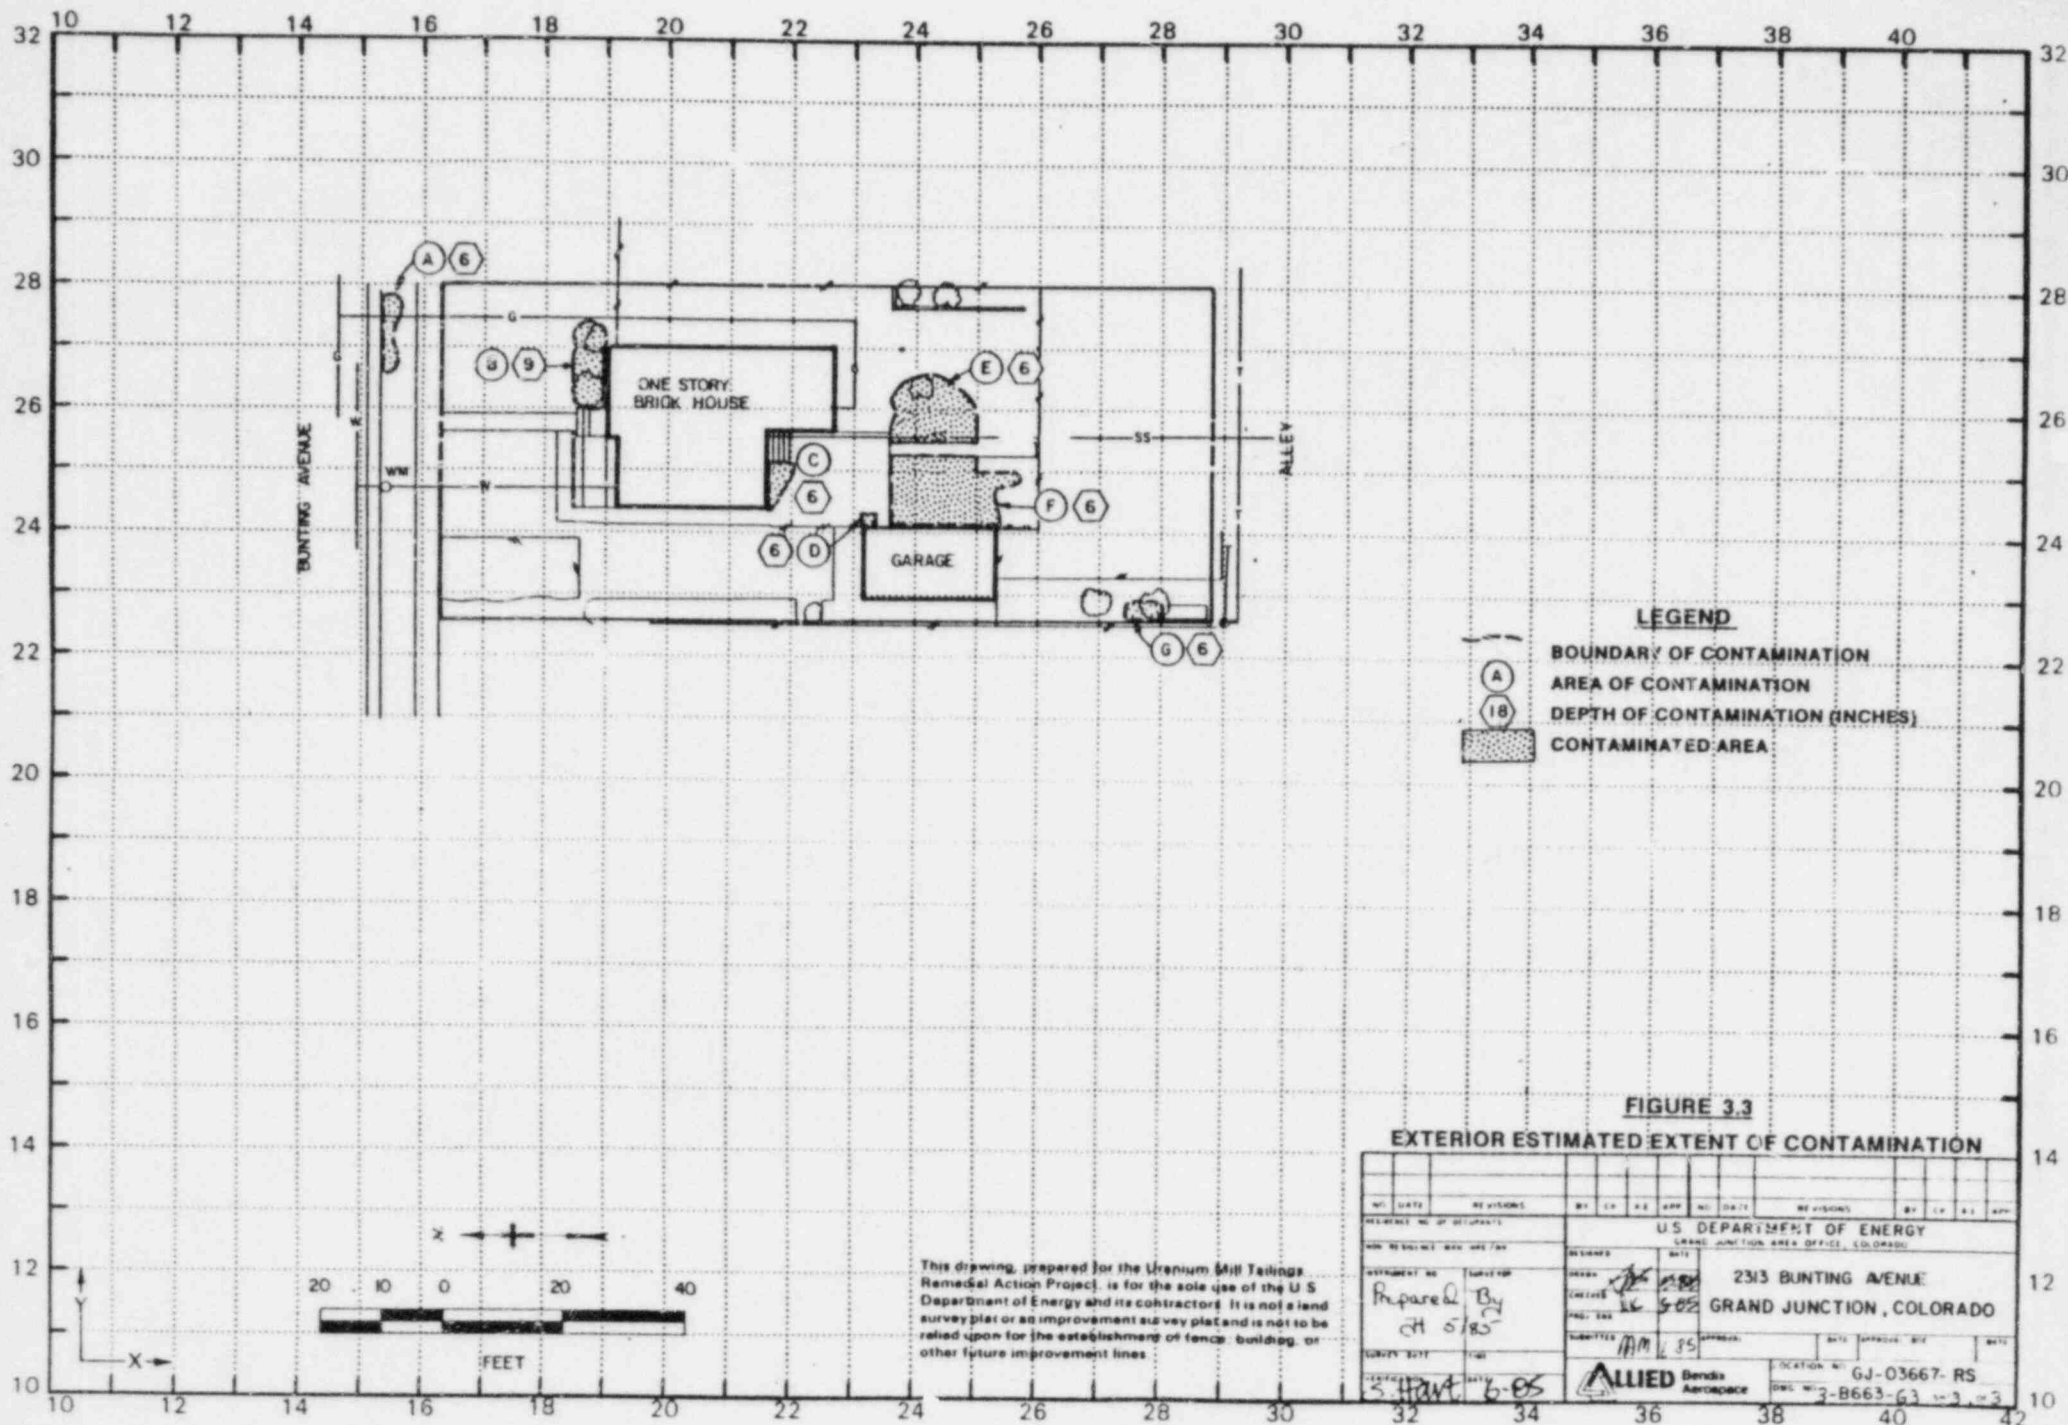
Appendix Figure 3.3 shows identified areas and estimated depths of contamination on this property, based on assessments of all measurements taken. As noted in this figure, areas recommended for remedial action that contain identified residual radioactive materials are:

- (AREA A) In the northeast corner of the property, the depth of contamination is 6 inches (approximately 52 sf).
- (AREA B) Immediately north of the primary structure, the contamination is 9 inches in depth (approximately 90 sf).

- (AREA C) Immediately south of the primary structure, in a flower bed, the contamination is 6 inches deep (approximately 16 sf).
- (AREA D) At the northeast corner of the garage, in a small flower bed, the depth of contamination is 6 inches (approximately 9 sf).

- (AREA E) In the yard south of the primary structure and east of Area F, the contamination is 6 inches deep (approximately 150 sf).
- (AREA F) In the southwest yard, adjacent to the east side of the garage, the estimated depth of contamination is 6 inches, based on the information collected in Area E (approximately 213 sf).

- (AREA G) In the southwest corner of the property, the depth of contamination is 6 inches (approximately 18 sf).

The sidewalk in the south yard may have contamination beneath its concrete surface. The gamma survey did not show any elevated readings, but there are tailings deposits on both sides.

The recommended remedial action for this property, DOE ID No. GJ-03667-RS, includes removal of all areas identified as containing radioactive material (as discussed in Section 3.5 and shown in Appendix Figure 3.3) and transport of removed material to the disposal site.

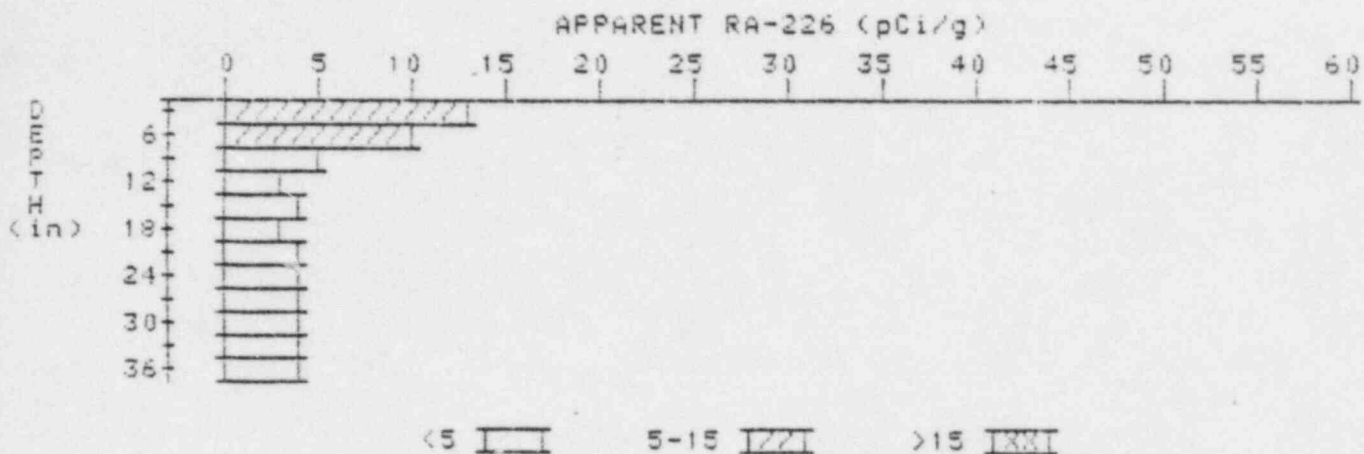
7

Depth (in)	Apparent Radium-226 (pCi/g) Undeconvolved	Apparent Radium-226 (pCi/g) Deconvolved
3	12.6	12.6
6	9.7	9.9
9	6.7	4.6
12	4.9	2.6
15	4.4	4.2
18	4.0	3.3
21	4.0	4.2
24	3.9	3.7
27	3.9	4.1
30	3.8	3.6
33	3.8	4.0
36	3.7	3.7
