RADIOLOGIC AND ENGINEERING ASSESSMENT

DOE ID NO.: GJ-06775-RS
ADDRESS: 1840 NORTH 18TH STREET

AUGUST 1985

URANIUM MILL TAILINGS REMEDIAL ACTION PROJECT OFFICE

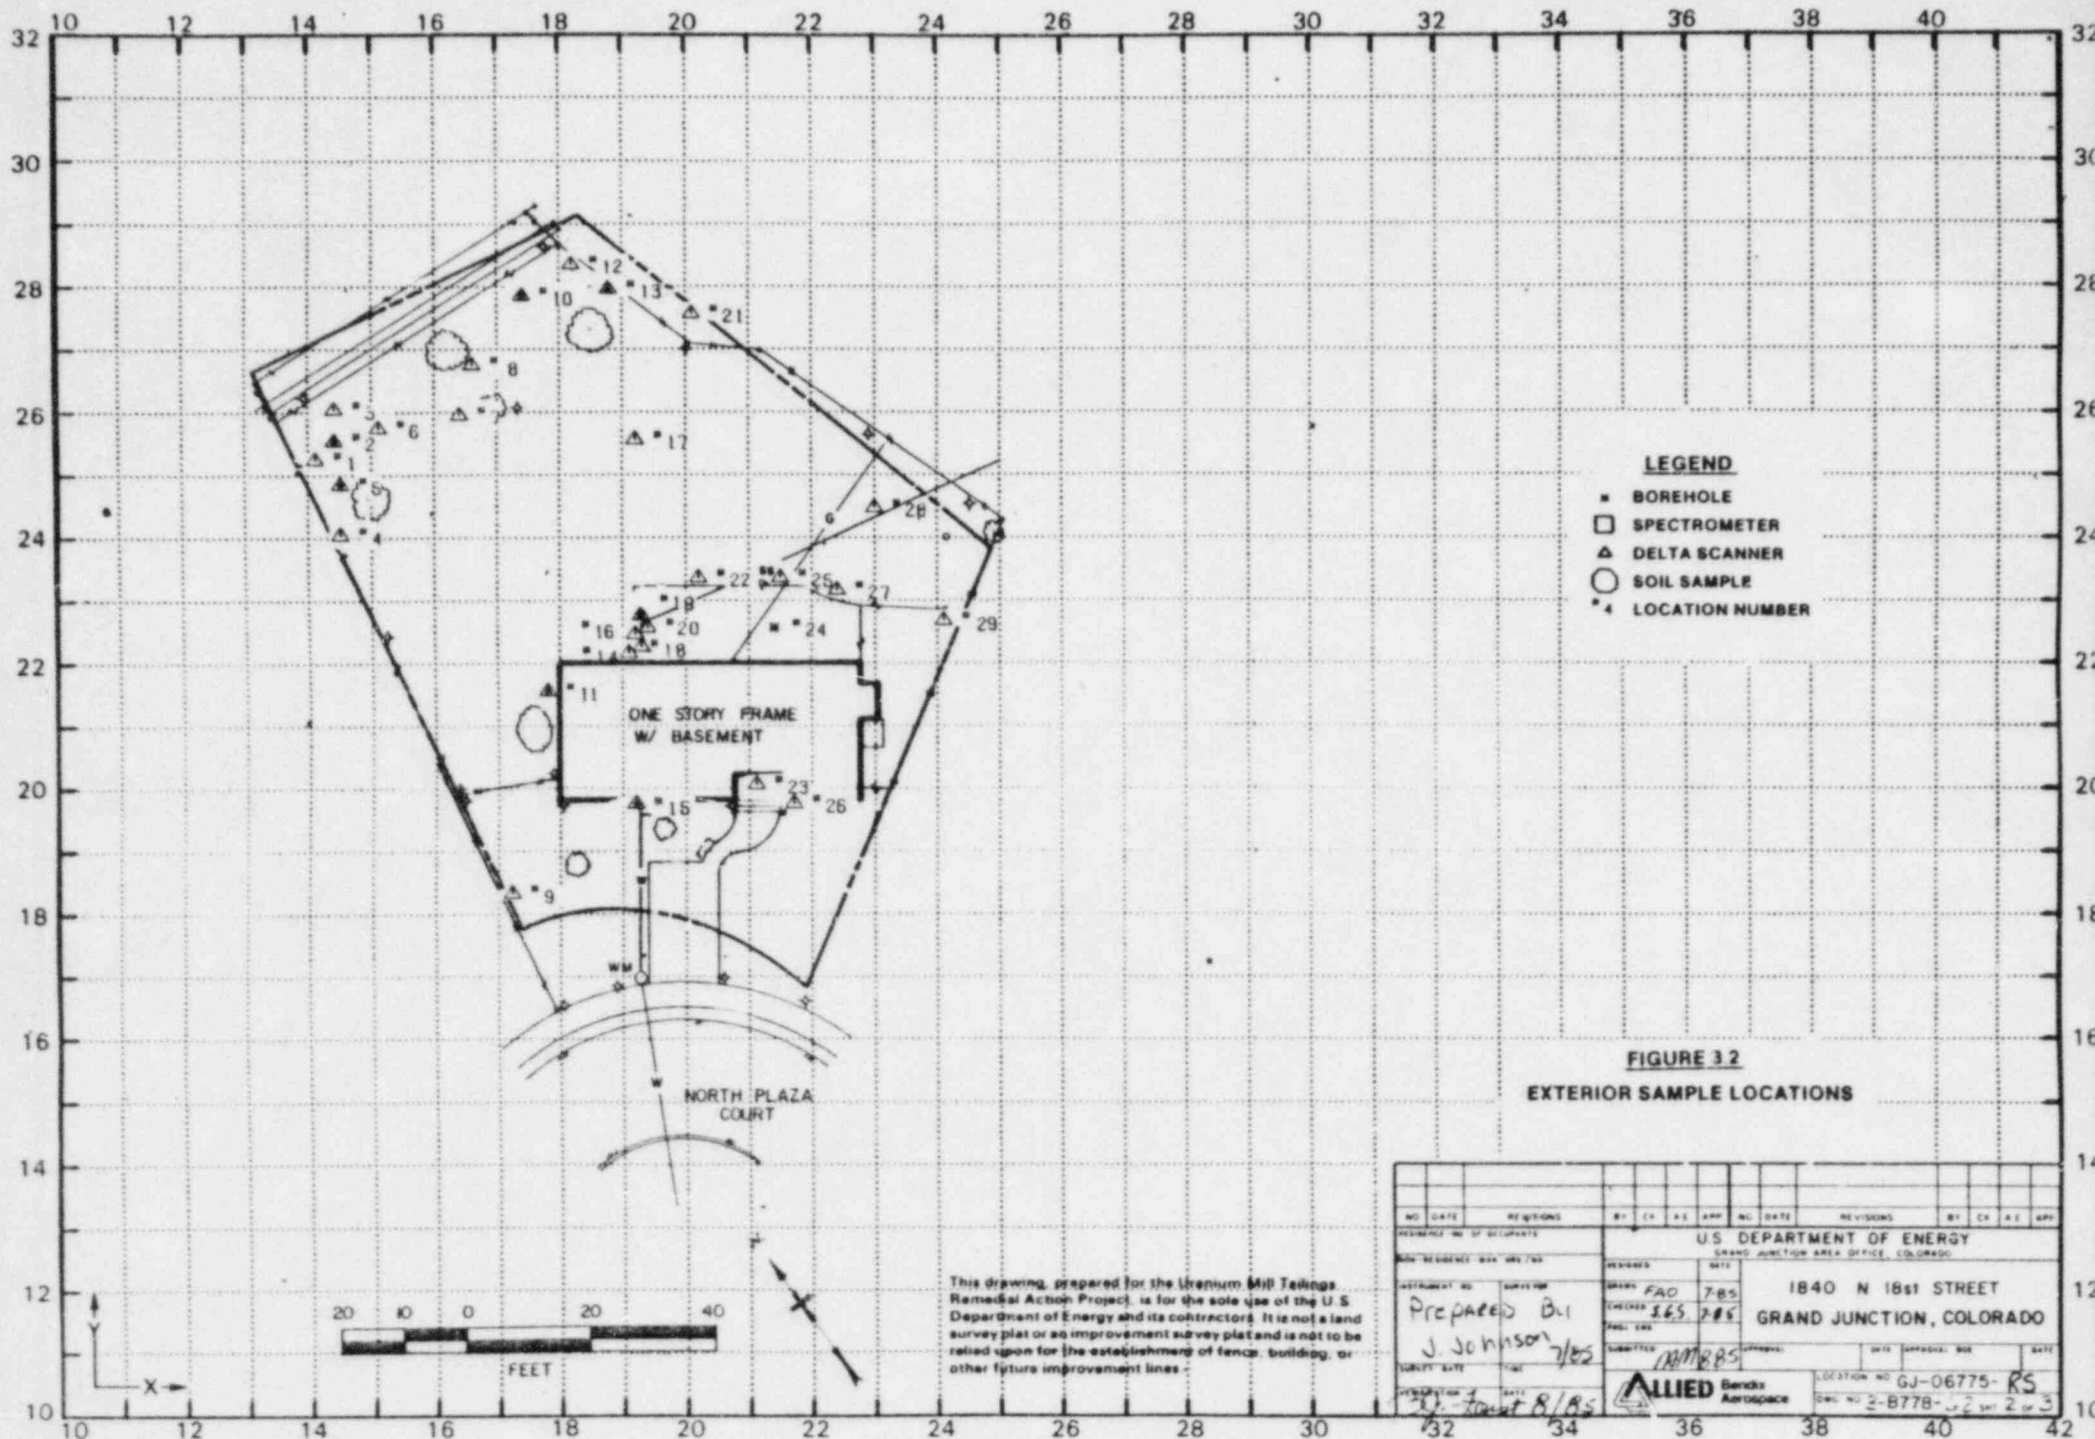
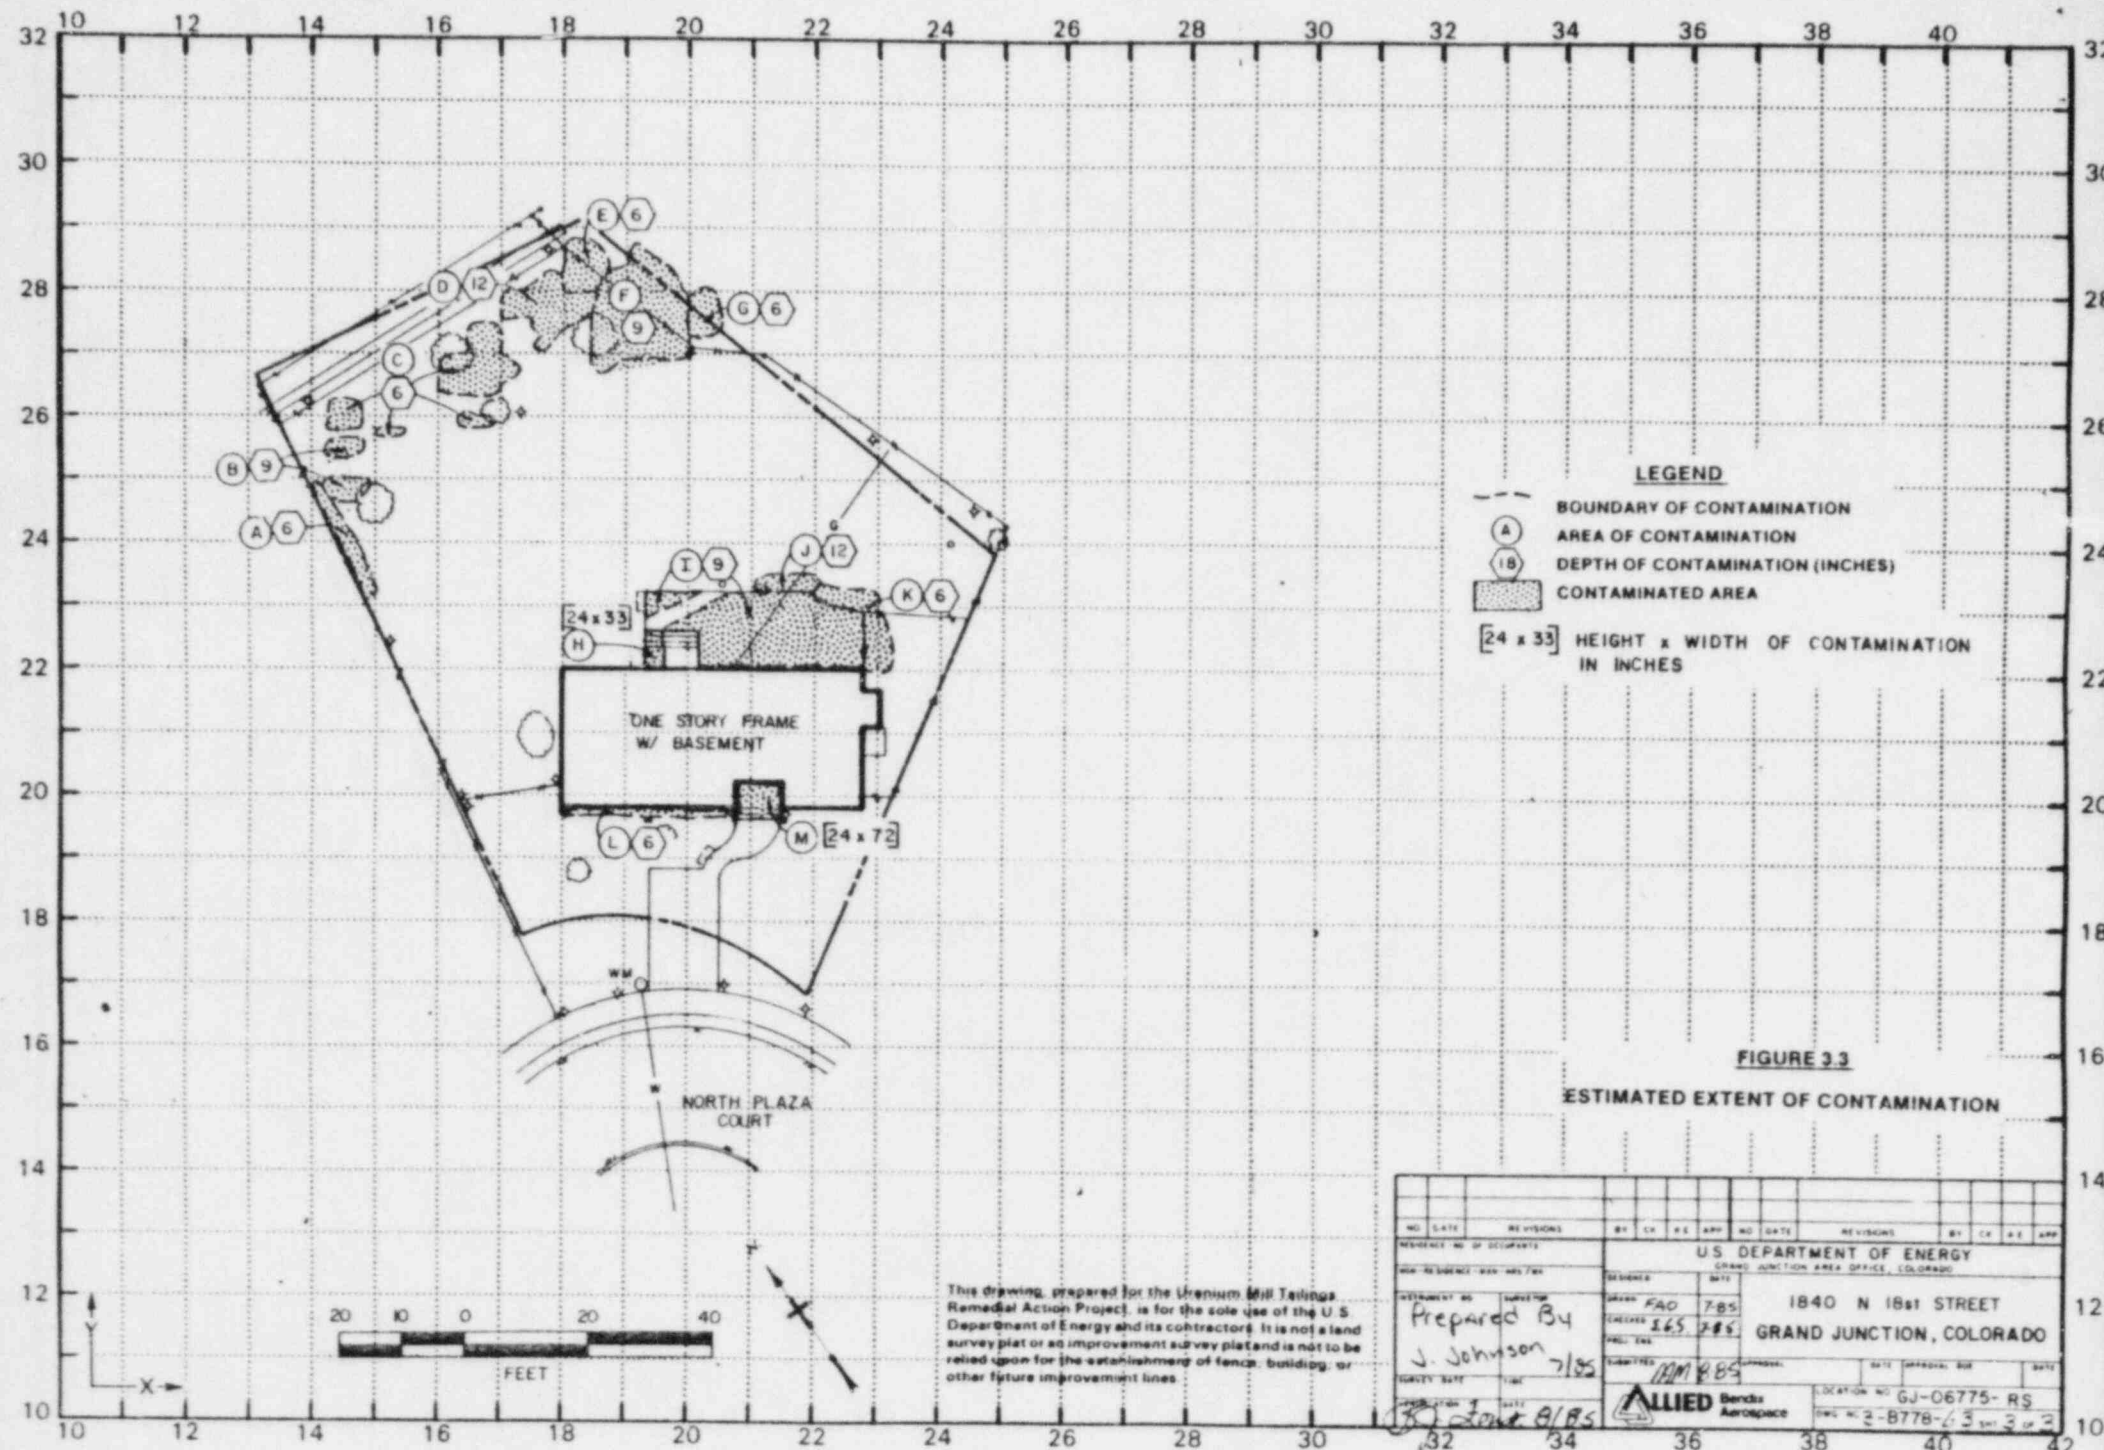
Appendix Figure 3.3 shows identified areas and estimated depths of contamination on this property, based on assessments of all measurements taken. As noted in this figure, areas recommended for remedial action that contain identified residual radioactive materials are:

- (Area A) Surface Material: Lawn
Direction From Primary Structure: North
Other Directions: By the west property line
Total Depth of Contamination: 6 inches
Approximate Square Footage: 60

- (Area B) Surface Material: Lawn
Direction From Primary Structure: North
Total Depth of Contamination: 9 inches
Comments: There are two deposits in this area.
Approximate Square Footage: 46

- (Area C) Surface Material: Lawn
Direction From Primary Structure: North
Total Depth of Contamination: 6 inches
Comments: This area includes 4 small deposits.
Approximate Square Footage: 178

- (Area D) Surface Material: Unkept lawn
Direction From Primary Structure: Northeast
Total Depth of Contamination: 12 inches
Approximate Square Footage: 109

- (Area E) Surface Material: Unkept lawn
Direction From Primary Structure: Northeast
Total Depth of Contamination: 6 inches
Comments: A chain link fence runs through this area.
Approximate Square Footage: 64

- (Area F) Surface Material: Unkept lawn
Direction From Primary Structure: Northeast
Total Depth of Contamination: 9 inches
Comments: A chain link fence runs through this area.
Approximate Square Footage: 250

- (Area G) Surface Material: Weeds
Direction From Primary Structure: Northeast
Total Depth of Contamination: 6 inches
Approximate Square Footage: 35

- (Area H) Surface Material: Concrete
Direction From Primary Structure: North
Other Directions: By the north patio
Other (height or thickness): 24 inches high x 33 inches
wide
Approximate Square Footage: 16

- (Area I) Surface Material: Concrete
Direction From Primary Structure: Northeast
Total Depth of Contamination: 9 inches
Other (height or thickness): 3-inch-thick concrete
Comments: A portion of the concrete was removed when
a sewer line was put in.
Approximate Square Footage: 375

- (Area J) Surface Material: Lawn
Direction From Primary Structure: Northeast
Other Directions: Adjacent to Area I
Total Depth of Contamination: 12 inches
Comments: A gas line runs through this area.
Approximate Square Footage: 30

- (Area K) Surface Material: Lawn
Direction From Primary Structure: Northeast
Total Depth of Contamination: 6 inches
Approximate Square Footage: 70
- (Area L) Surface Material: Lawn
Direction From Primary Structure: Southwest
Total Depth of Contamination: 6 inches
Approximate Square Footage: 56

- (Area M) Surface Material: Concrete
Direction From Primary Structure: South
Other (height or thickness): 24 inches high x 72 inches
wide
Approximate Square Footage: 42

The recommended remedial action for this property, DOE ID No. GJ-06775-RS, includes removal of all areas identified as containing radioactive material (as discussed in Section 3.5 and shown in Appendix Figure 3.3) and transport of removed material to the disposal site.

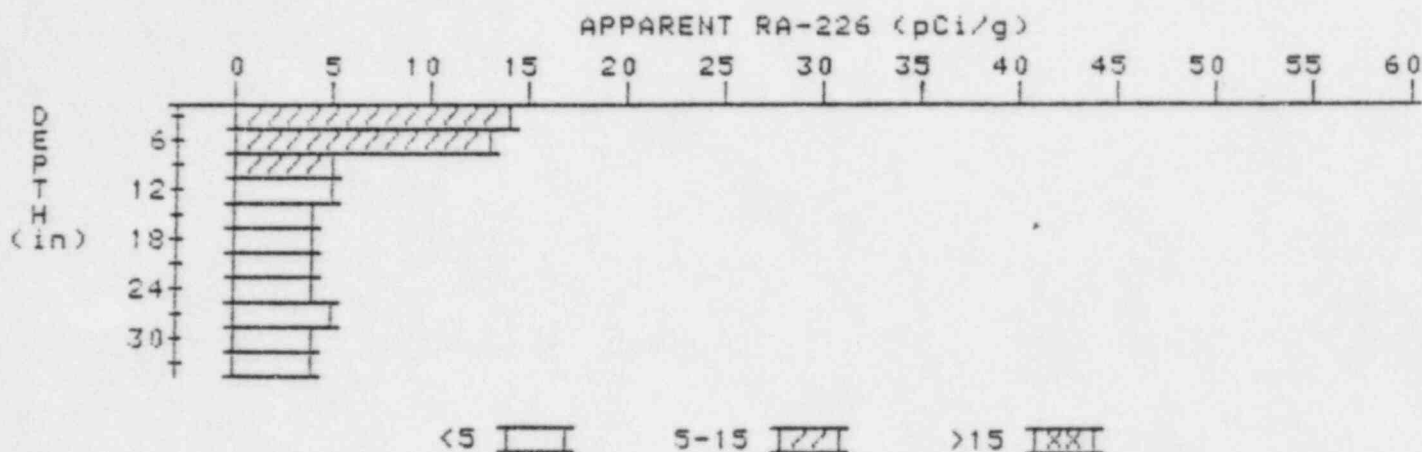
HOLE NUMBER: 13

Depth (in)	Apparent Radium-226 (pCi/g) Undeconvolved	Apparent Radium-226 (pCi/g) Deconvolved
3	14.0	14.0
6	11.5	13.1
9	8.1	5.4
12	6.2	5.0
15	5.0	3.6
18	4.6	4.2
21	4.4	4.4
24	4.2	3.7
27	4.3	4.7
30	4.2	4.0
33	4.2	4.2

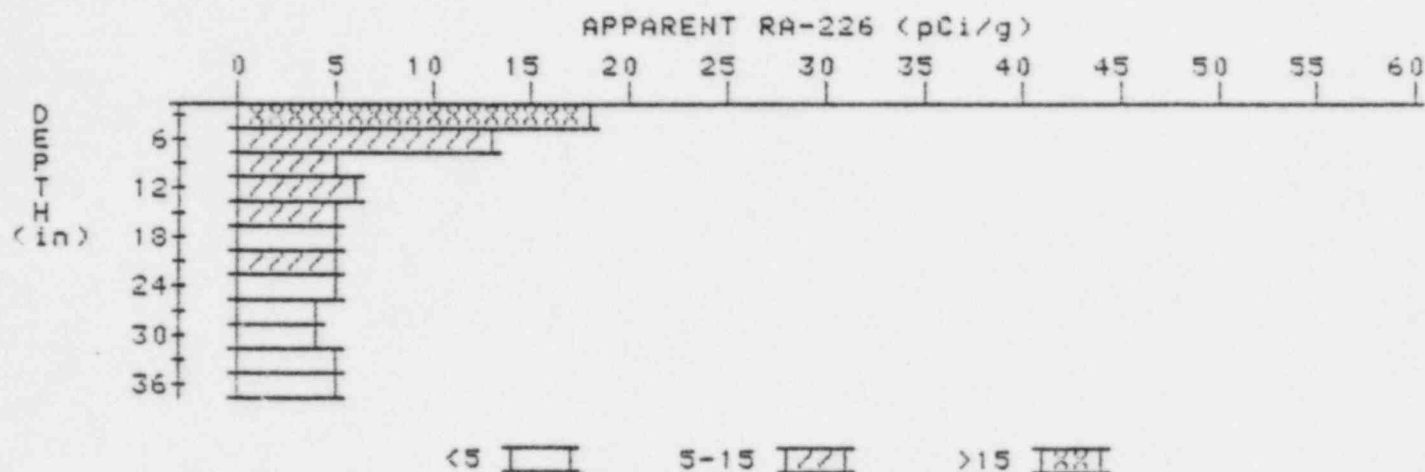
PROPERTY NUMBER: GJ-06775-RS
HOLE NUMBER: 24
LOCATION: 215225

Depth (in)	Apparent Radium-226 (pCi/g) Undeconvolved	Apparent Radium-226 (pCi/g) Deconvolved
3	17.7	17.7
6	13.4	13.2
9	9.2	5.3
12	7.2	5.6
15	6.1	5.4
18	5.4	4.7
21	5.1	5.1
24	4.3	4.6
27	4.6	4.4
30	4.5	4.3
33	4.5	4.5
36	4.5	4.5

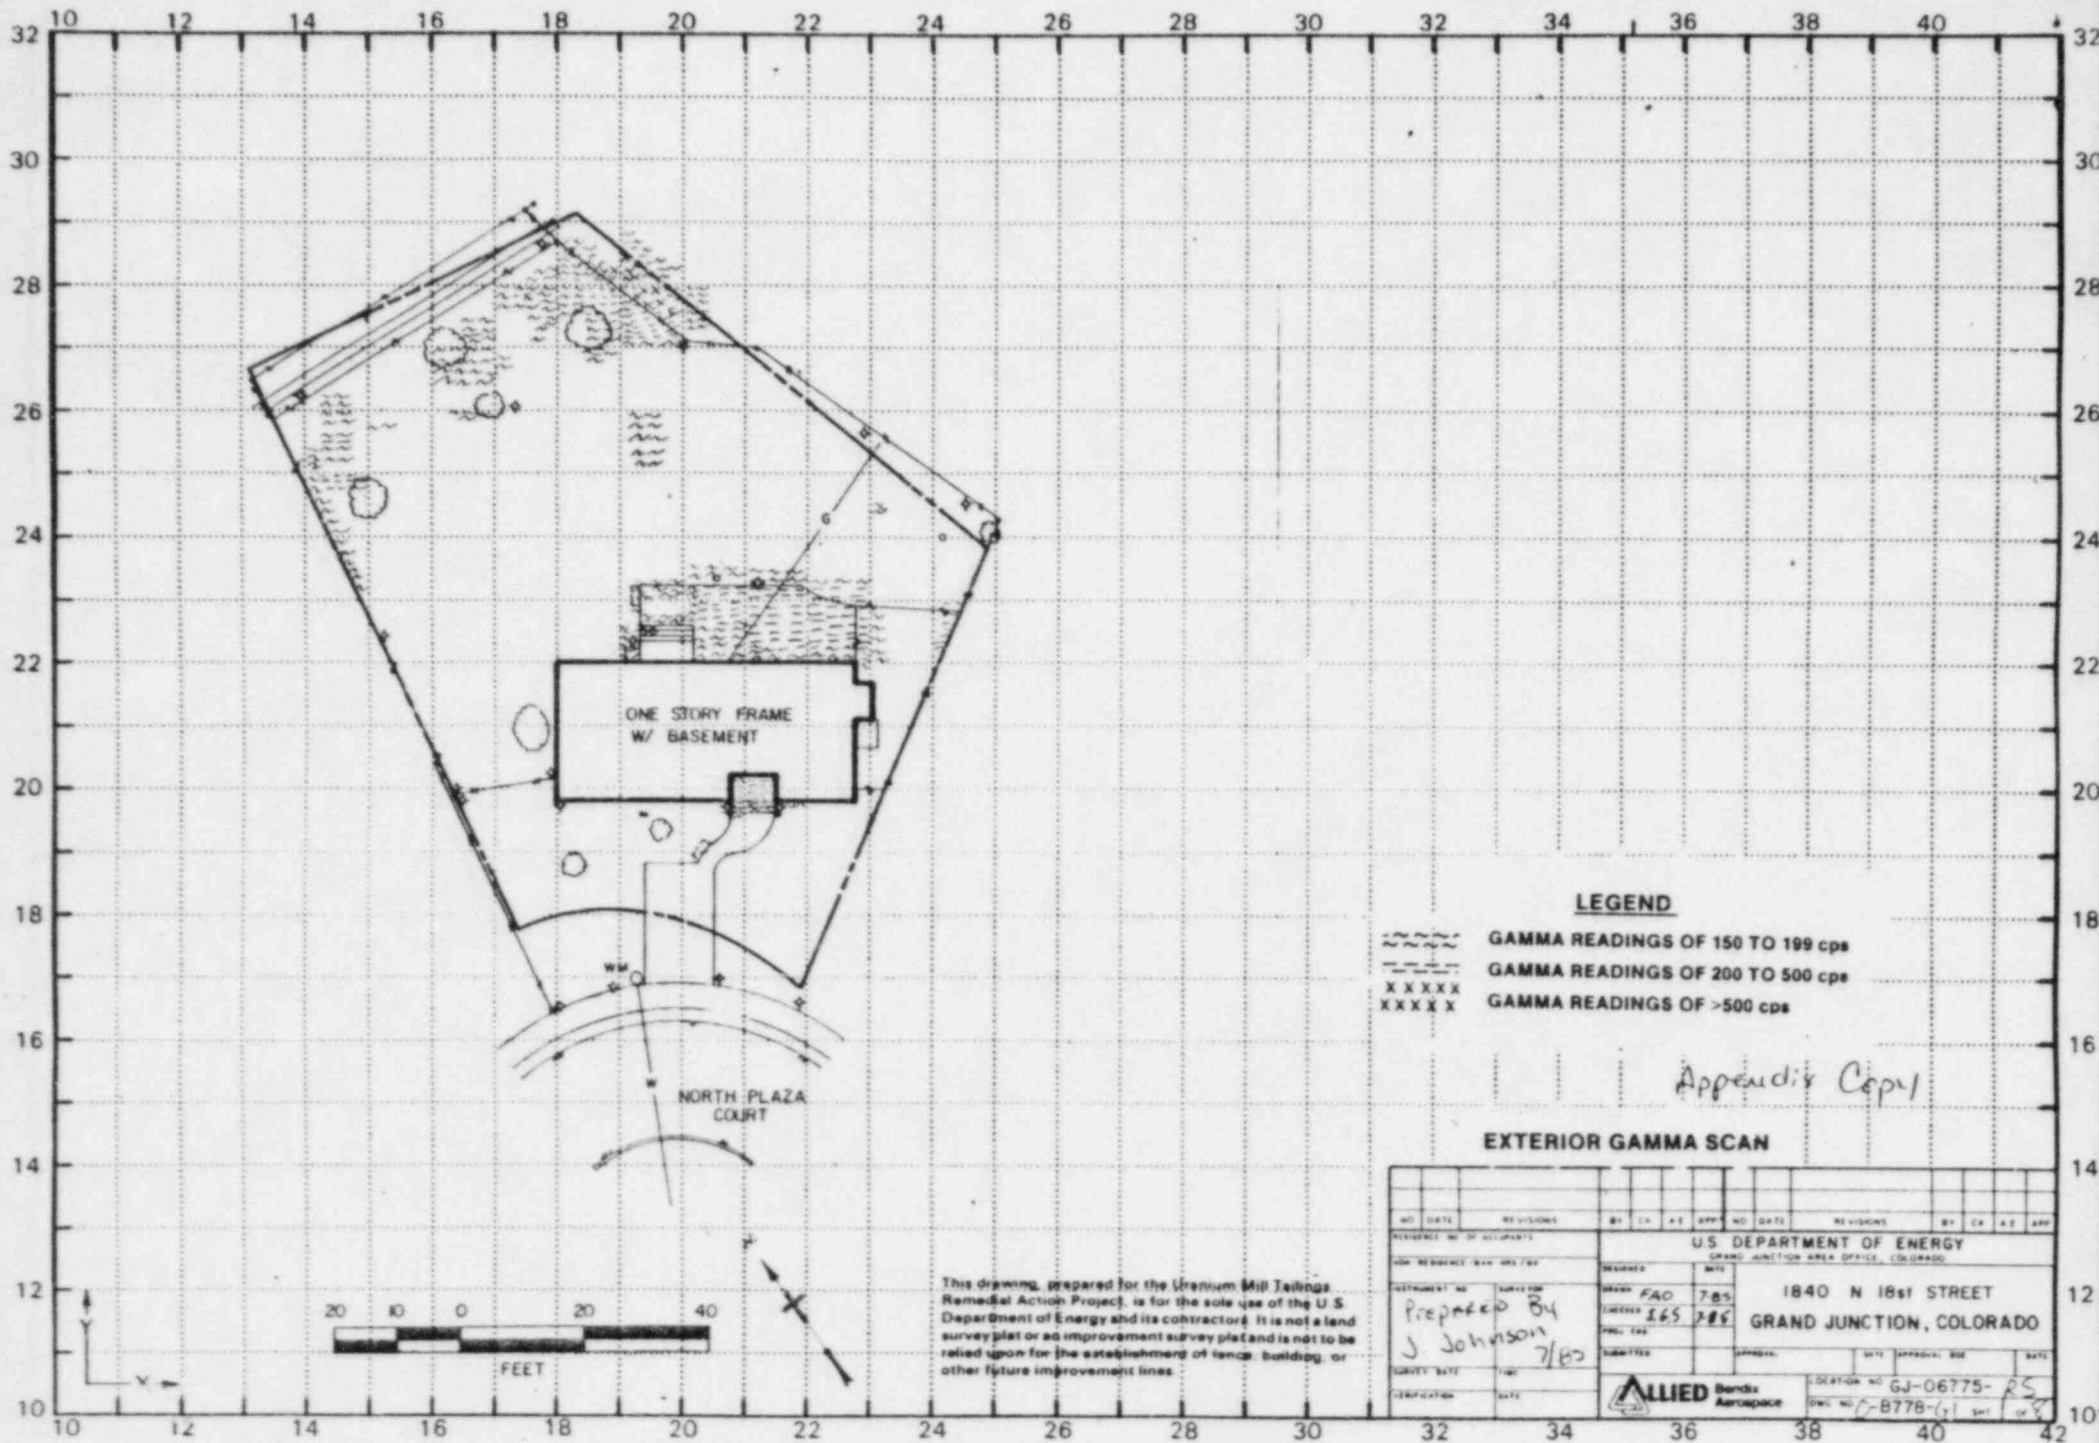
EXTERIOR GAMMA SCAN

The property was scanned with elevated readings noted in the north yard, in the north patio and stoop, along the west property line, and on the south stoop. Visible tailings were found beneath the concrete patio. Deltas were taken on top of the north stoop, on the stairs of the stoop, and underneath the stoop. All of these deltas were clean. Three horizontal deltas were taken up the west side of the stoop that were elevated.
