RADIOLOGIC AND ENGINEERING ASSESSMENT

DOE ID NO.: GJ-02961-RS  
ADDRESS: 1445 WALNUT AVENUE

AUGUST 1985

BENDIX FIELD ENGINEERING CORPORATION  
P.O. Box 1569  
Grand Junction, Colorado 81502

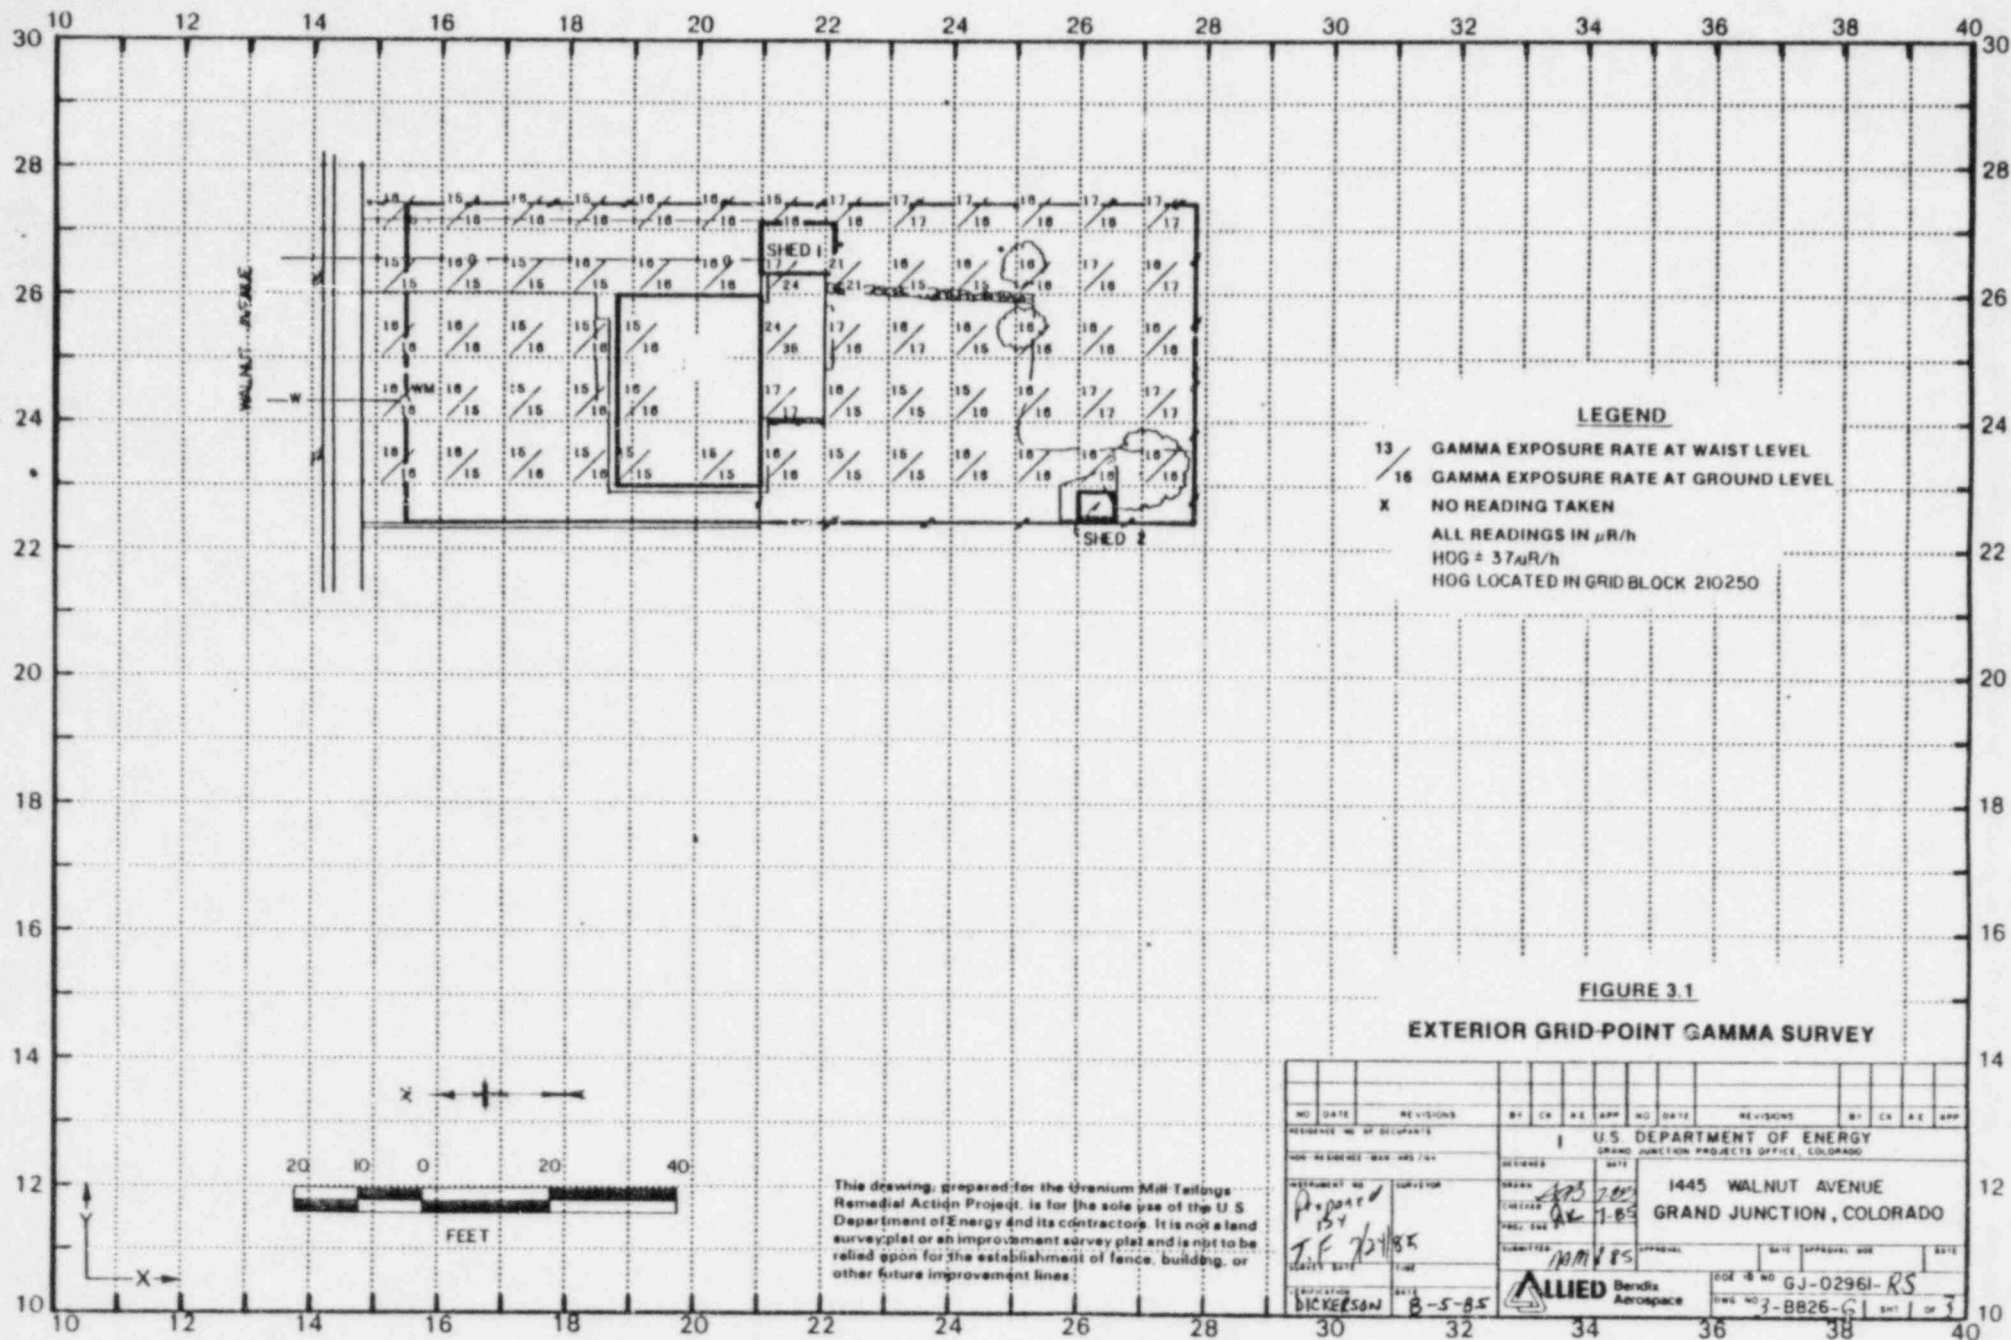
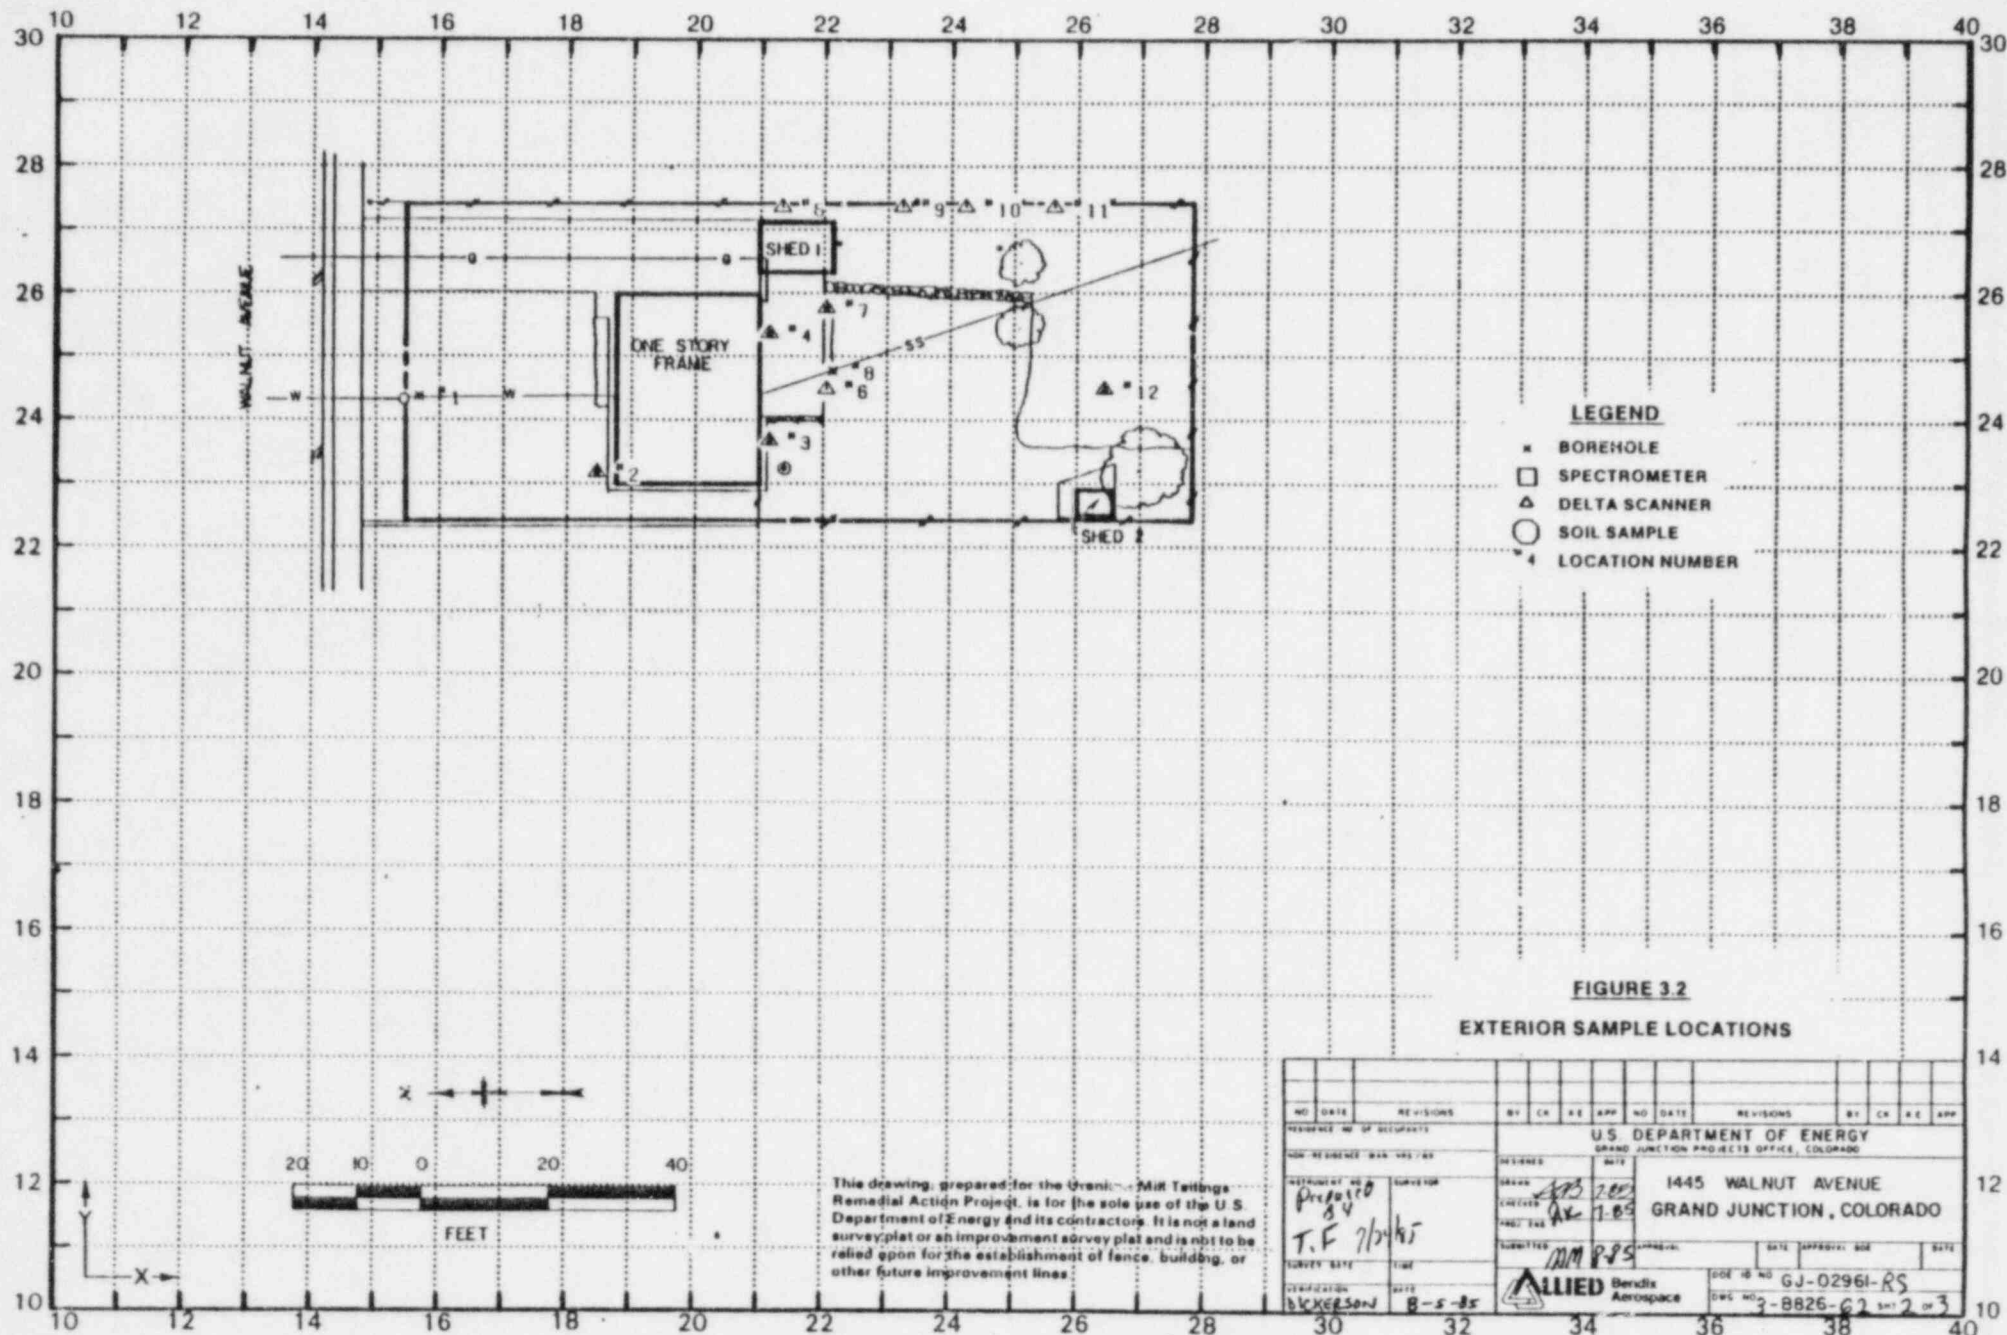
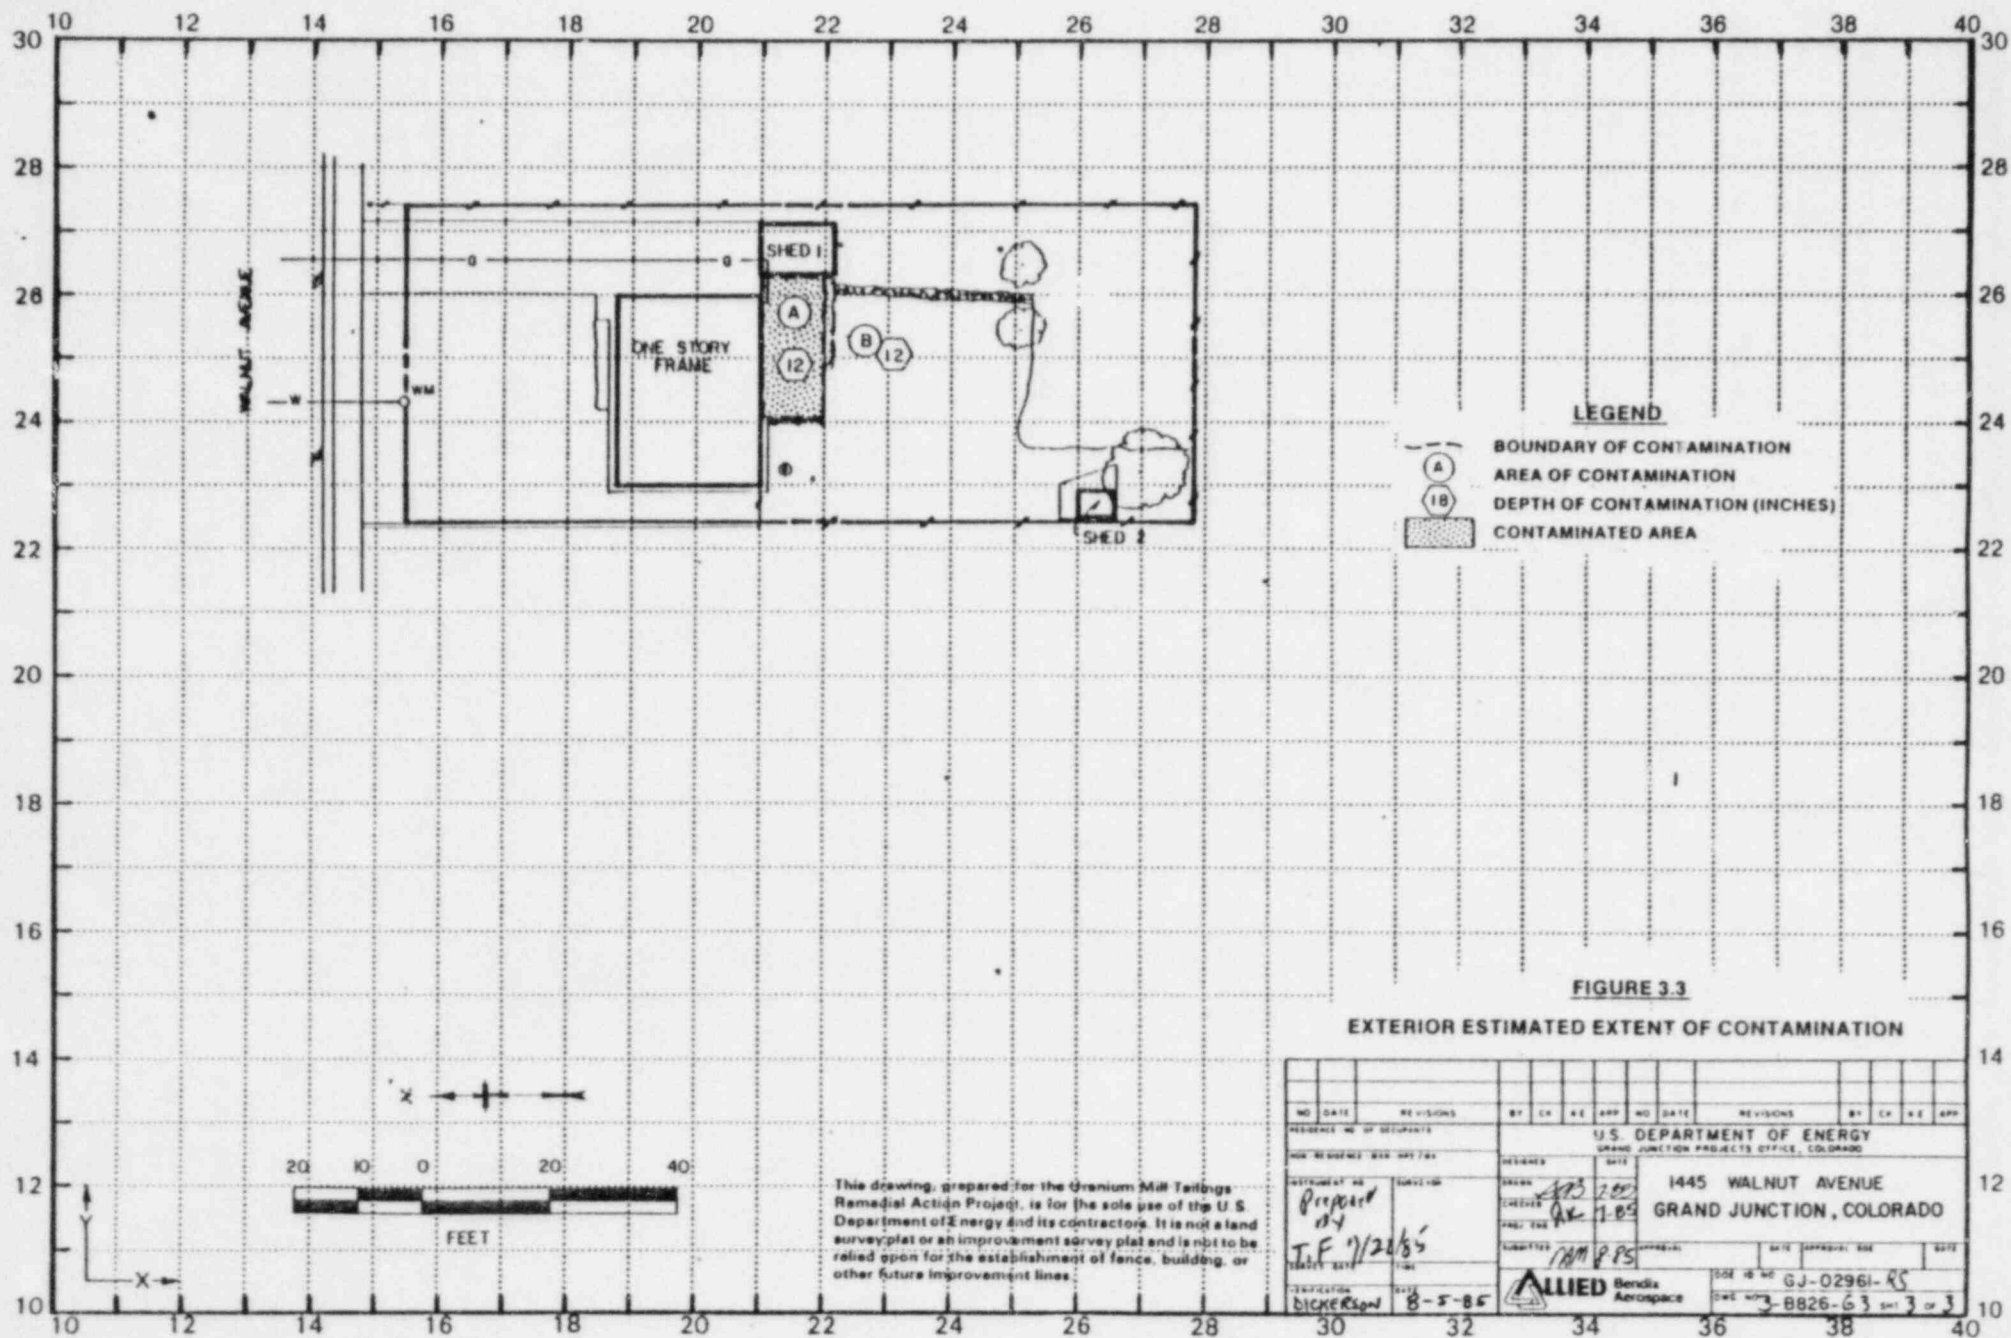
Appendix Figure 3.3 shows identified areas and estimated depths of contamination on this property, based on assessments of all measurements taken. As noted in this figure, areas recommended for remedial action that contain identified residual radioactive materials are:

(Area A) Surface Material: Concrete  
Direction From Primary Structure: South  
Total Depth of Contamination: 12 inches  
Other (height or thickness): 4-inch-thick concrete  
Approximate Square Footage: 230

(Area B) Surface Material: Soil  
Direction From Primary Structure: South  
Other Directions: West of Shed 1  
Total Depth of Contamination: 12 inches  
Comments: This is a flower bed  
Approximate Square Footage: 40

The recommended remedial action for this property, DOE ID No. GJ-02961-RS, includes removal of all areas identified as containing radioactive material (as discussed in Section 3.5 and shown in Appendix Figure 3.3) and transport of removed material to the disposal site.

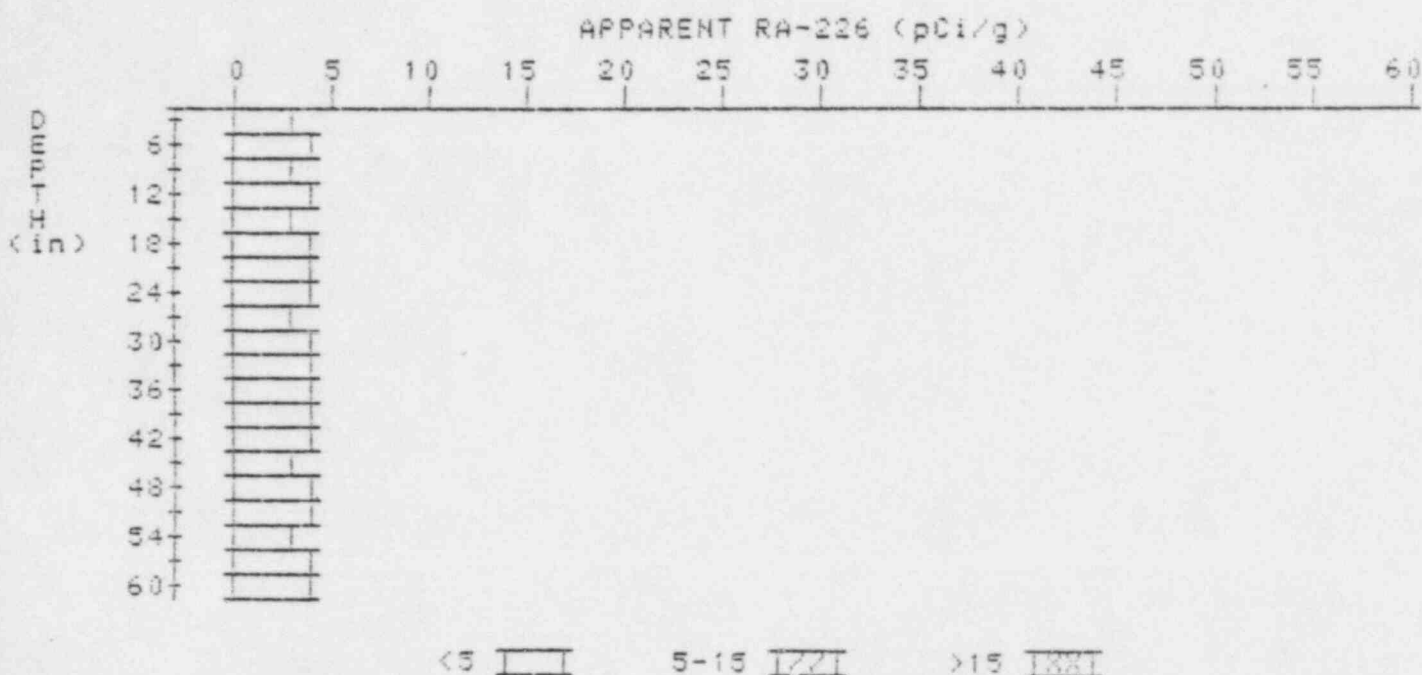
HOLE NUMBER: 1

Loc #	Grid Location	Depth (in.)	Meas. Type	In Situ Ra-226 (pCi/g)		Chem Ra-226 (pCi/g)	Comments
				Tot. C <sub>t</sub>	Spectr.		
1	157244	03	TC	3.0		*	Water line DC = 0 inches
		06	TC	3.3		*	
		09	TC	3.4		*	
		12	TC	3.7		*	
		15	TC	3.6		*	
		18	TC	3.7		*	
		21	TC	3.8		*	
		24	TC	3.9		*	
		27	TC	3.8		*	
		30	TC	3.9		*	
		33	TC	4.0		*	
		36	TC	3.9		*	
		39	TC	3.7		*	
		42	TC	3.6		*	
		45	TC	3.5		*	
		48	TC	3.6		*	
		51	TC	3.6		*	
		54	TC	3.5		*	
		57	TC	3.5		*	
		60	TC	3.5		*	
2	185232	00	DS	<1.0		*	North of primary structure DC = 0 inches
		03	TC	2.9		*	
		06	TC	3.2		*	
		09	TC	3.5		*	
		12	TC	3.5		*	
		15	TC	3.5		*	
		18	TC	3.6		*	
		21	TC	3.5		*	
		24	TC	3.5		*	
		27	TC	3.5		*	
		30	TC	3.4		*	
		33	TC	3.5		*	
3	212237	00	DS	1.1		*	South side of primary structure DC = 0 inches
		03	TC	3.1		*	
		06	TC	3.4		*	
		09	TC	3.5		*	
		12	TC	3.7		*	
		15	TC	3.8		*	
		18	TC	3.9		*	
		21	TC	4.0		*	
		24	TC	4.0		*	
		27	TC	3.9		*

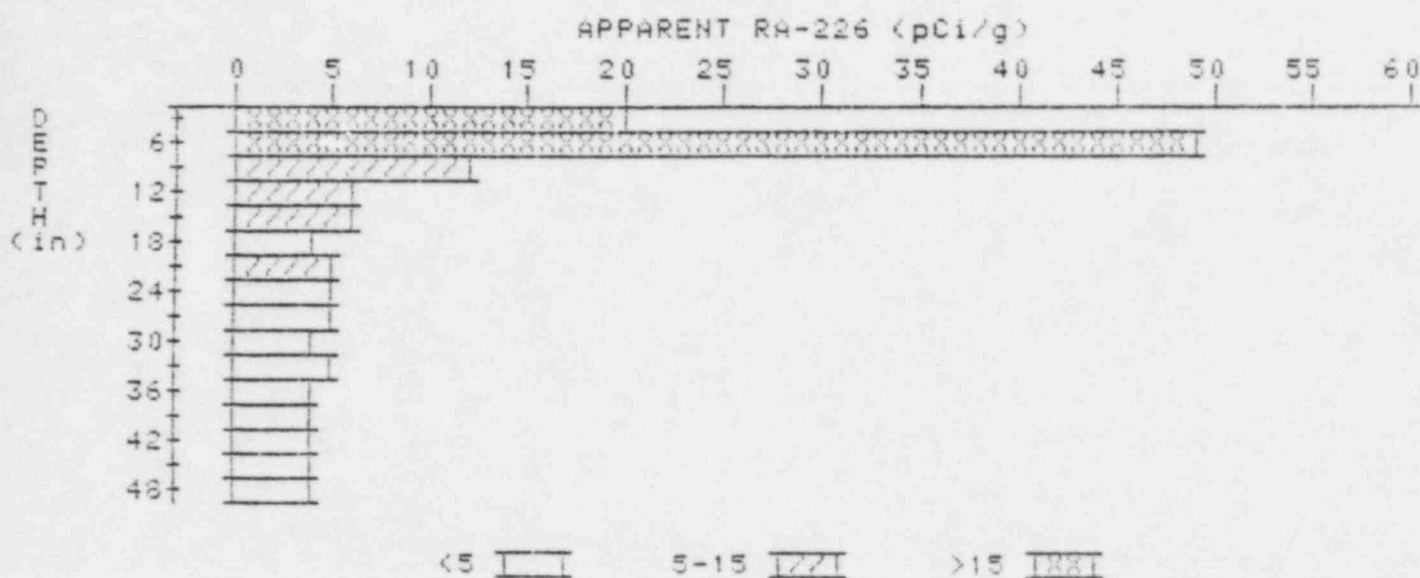
HOLE NUMBER: 4

Loc #	Grid Location	Depth (in.)	Meas. Type	In Situ Ra-226 (pCi/g)		Chem Ra-226 (pCi/g)	Comments
				Tot. Ct	Spectr.		
3	212237	30	TC	3.8		*	
		33	TC	3.8		*	
		36	TC	3.7		*	
		39	TC	3.7		*	
4	212254	00	DS	20.3		*	On patio
		03	TC	20.4		*	South of primary
		06	TC	25.3		*	structure
		09	TC	16.8		*	DC = 12 inches
		12	TC	10.9		*	based on the
		15	TC	7.9		*	deconvolution graph
		18	TC	6.1		*	
		21	TC	5.5		*	
		24	TC	5.1		*	
		27	TC	4.8		*	
		30	TC	4.6		*	
		33	TC	4.6		*	
		36	TC	4.4		*	
		39	TC	4.2		*	
		42	TC	4.0		*	
		45	TC	3.8		*	
		48	TC	3.7		*	
5	214274	00	DS	2.0		*	
		06	DS	<1.0		*	
6	221245	00	DS	1.4		*	
		06	DS	1.2		*	
		06	DS	3.3		*	Horizontal
7	221258	00	DS	9.2		*	South of primary
		06	DS	4.0		*	structure on patio
		08	DS	15.5		*	DC = 12 inches
		03	TC	6.6		*	based on all
		06	TC	6.2		*	available data
		09	TC	5.6		*	
		12	TC	4.9		*	
		15	TC	4.5		*	
		18	TC	4.3		*	
		21	TC	4.2		*	
		24	TC	4.3		*	
		27	TC	4.2		*	
		30	TC	4.3		*

A core was drilled through the patio and the total count showed contamination to 12 inches. A horizontal delta was taken underneath the patio.

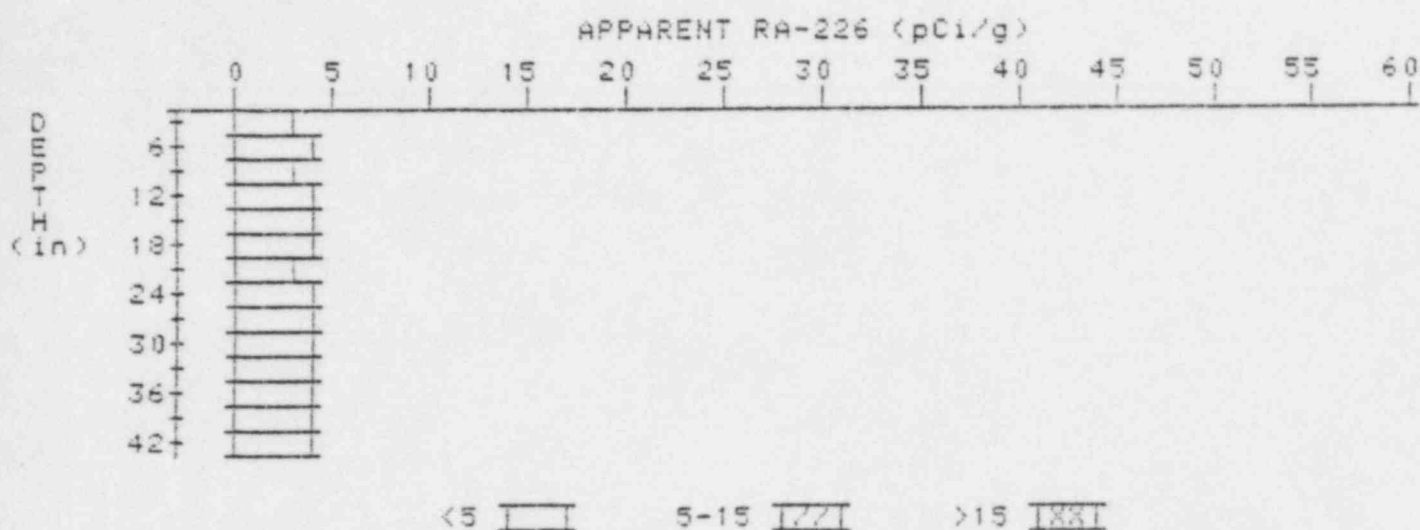
HOLE NUMBER: 8

Loc #	Grid Location	Depth (in.)	Meas. Type	In Situ Ra-226 (pCi/g)		Chem Ra-226 (pCi/g)	Comments
				Tot. Ct	Spectr.		
7	221258	36	TC	4.3		*	
		39	TC	4.3		*	
		42	TC	4.1		*	
		45	TC	4.0		*	
8	222248	03	TC	3.0		*	Sewer line DC = 0 inches
		06	TC	3.3		*	
		09	TC	3.4		*	
		12	TC	3.5		*	
		15	TC	3.6		*	
		18	TC	3.6		*	
		21	TC	3.6		*	
		24	TC	3.7		*	
		27	TC	3.9		*	
		30	TC	3.9		*	
		33	TC	3.9		*	
		36	TC	4.0		*	
9	233274	00	DS	1.1		*	Southeast of primary structure
		06	DS	<1.0		*	
10	243274	00	DS	1.8		*	Southeast of primary structure
		06	DS	1.2		*	
11	257274	00	DS	1.6		*	Southeast of primary structure
		06	DS	1.1		*	
12	265245	00	DS	1.4		*	Background DC = 0 inches
		03	TC	3.1		*	
		06	TC	3.5		*	
		09	TC	3.7		*	
		12	TC	3.7		*	
		15	TC	3.7		*	
		18	TC	3.7		*	
		21	TC	3.7		*	
		24	TC	3.7		*	
		27	TC	3.8		*	
		33	TC	3.8		*	
		36	TC	3.7		*	
		39	TC	3.7		*	
		30	TC	3.8		*
