RADIOLOGIC AND ENGINEERING ASSESSMENT

DOE ID NO.: GJ-11549-MR
ADDRESS: 2860 BUNTING AVENUE

AUGUST 1985

BENDIX FIELD ENGINEERING CORPORATION
P.O. Box 1569
Grand Junction, Colorado 81502

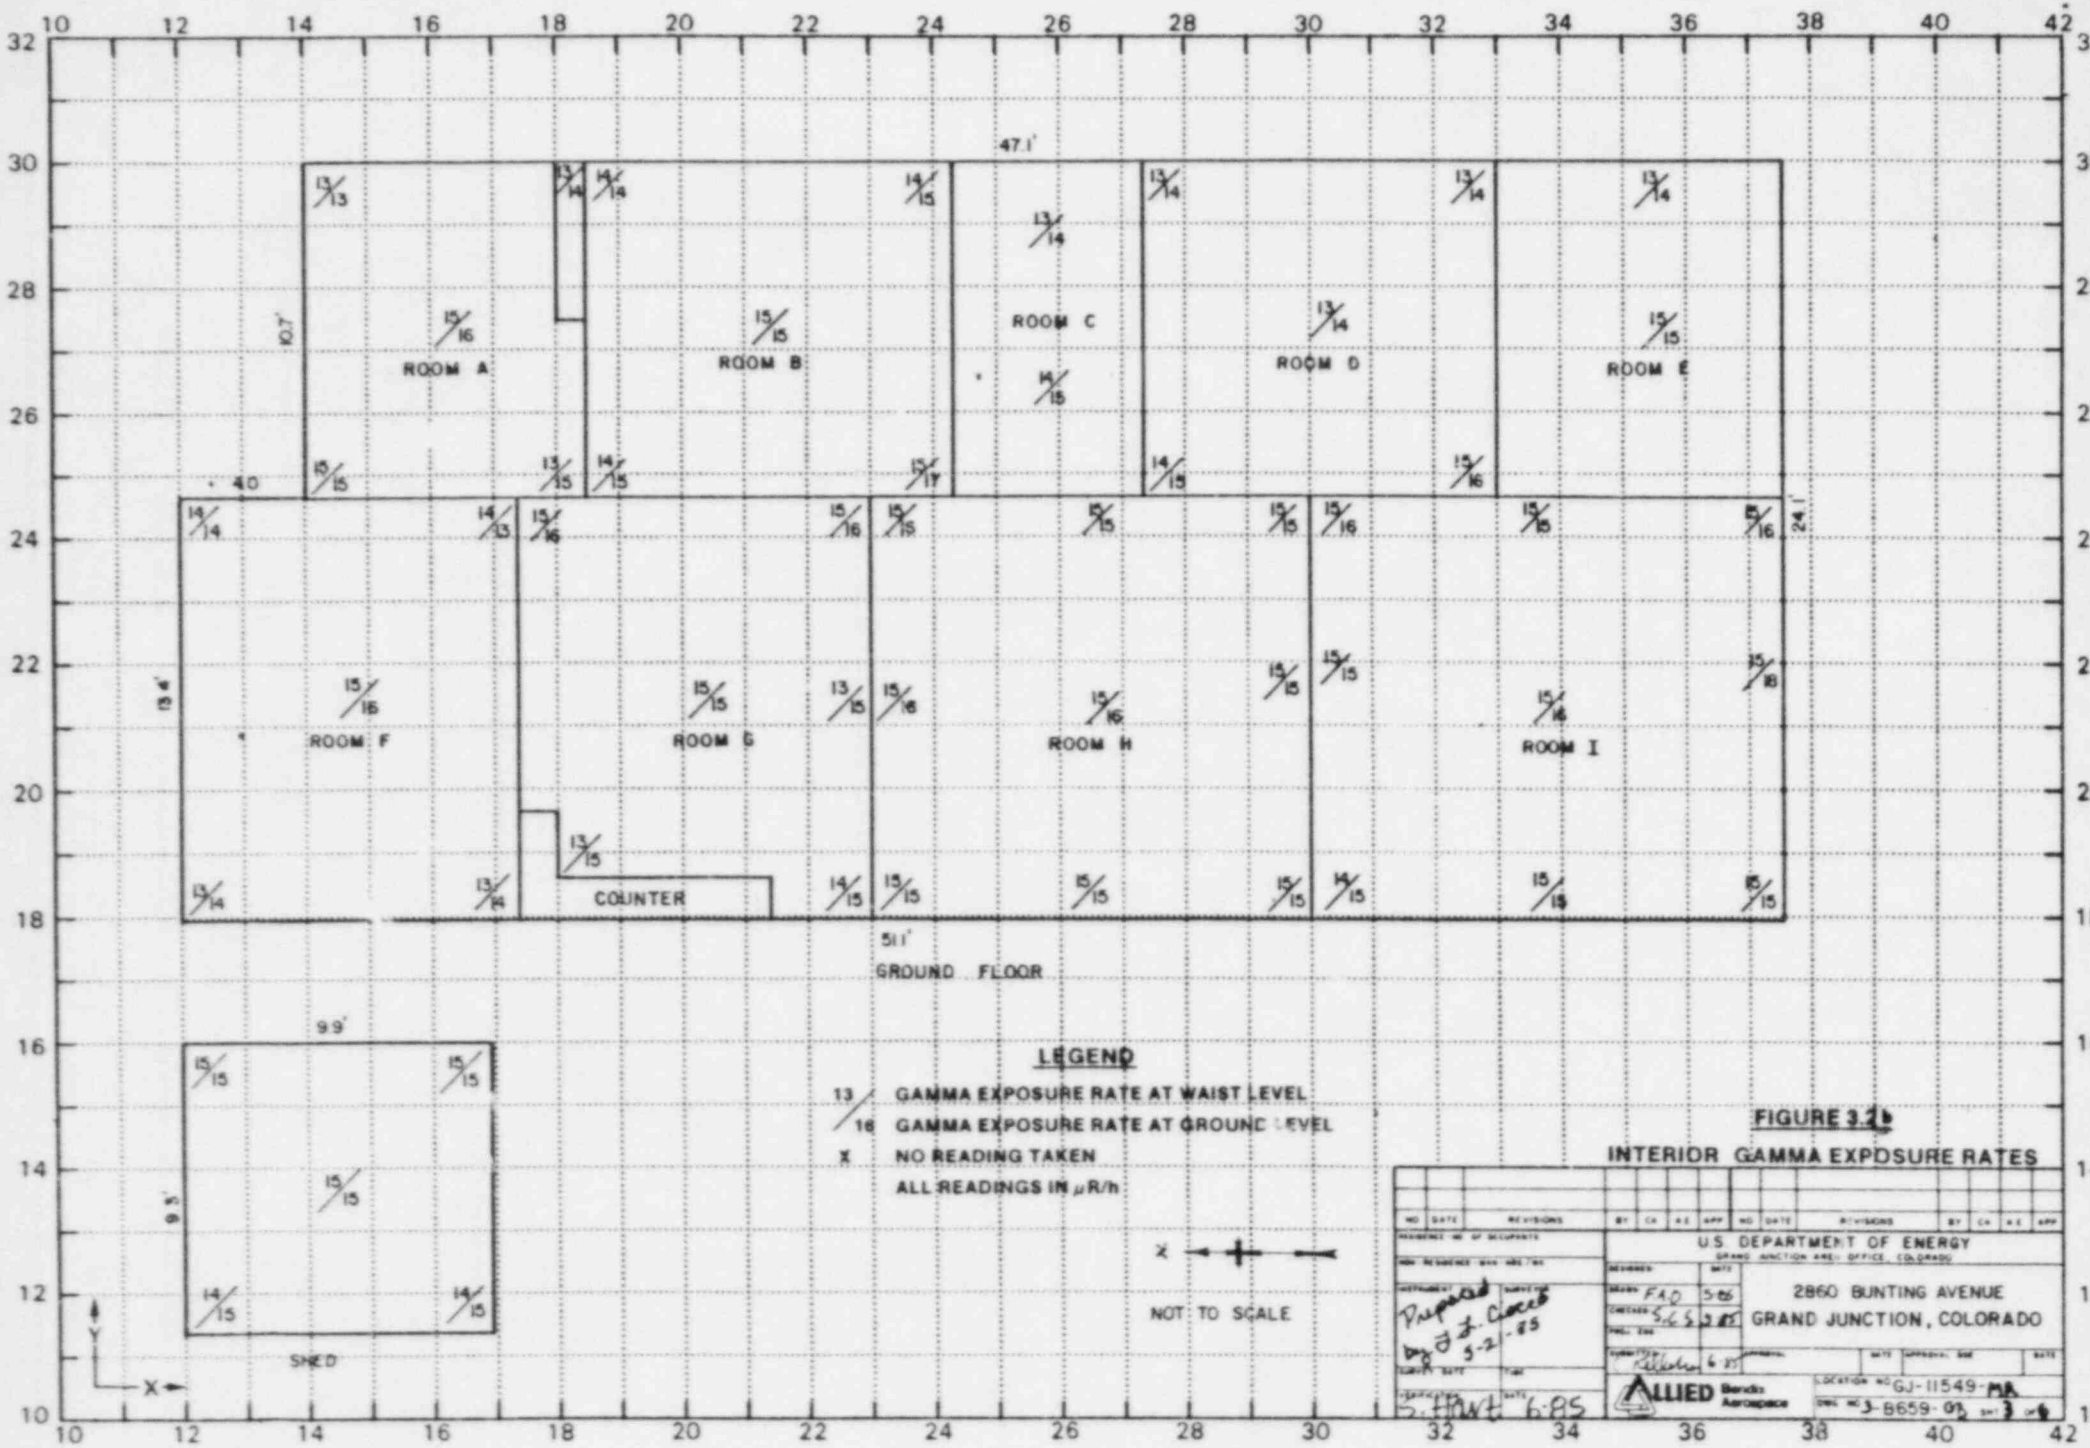
FIGURE 3.2b

INTERIOR GAMMA EXPOSURE RATES

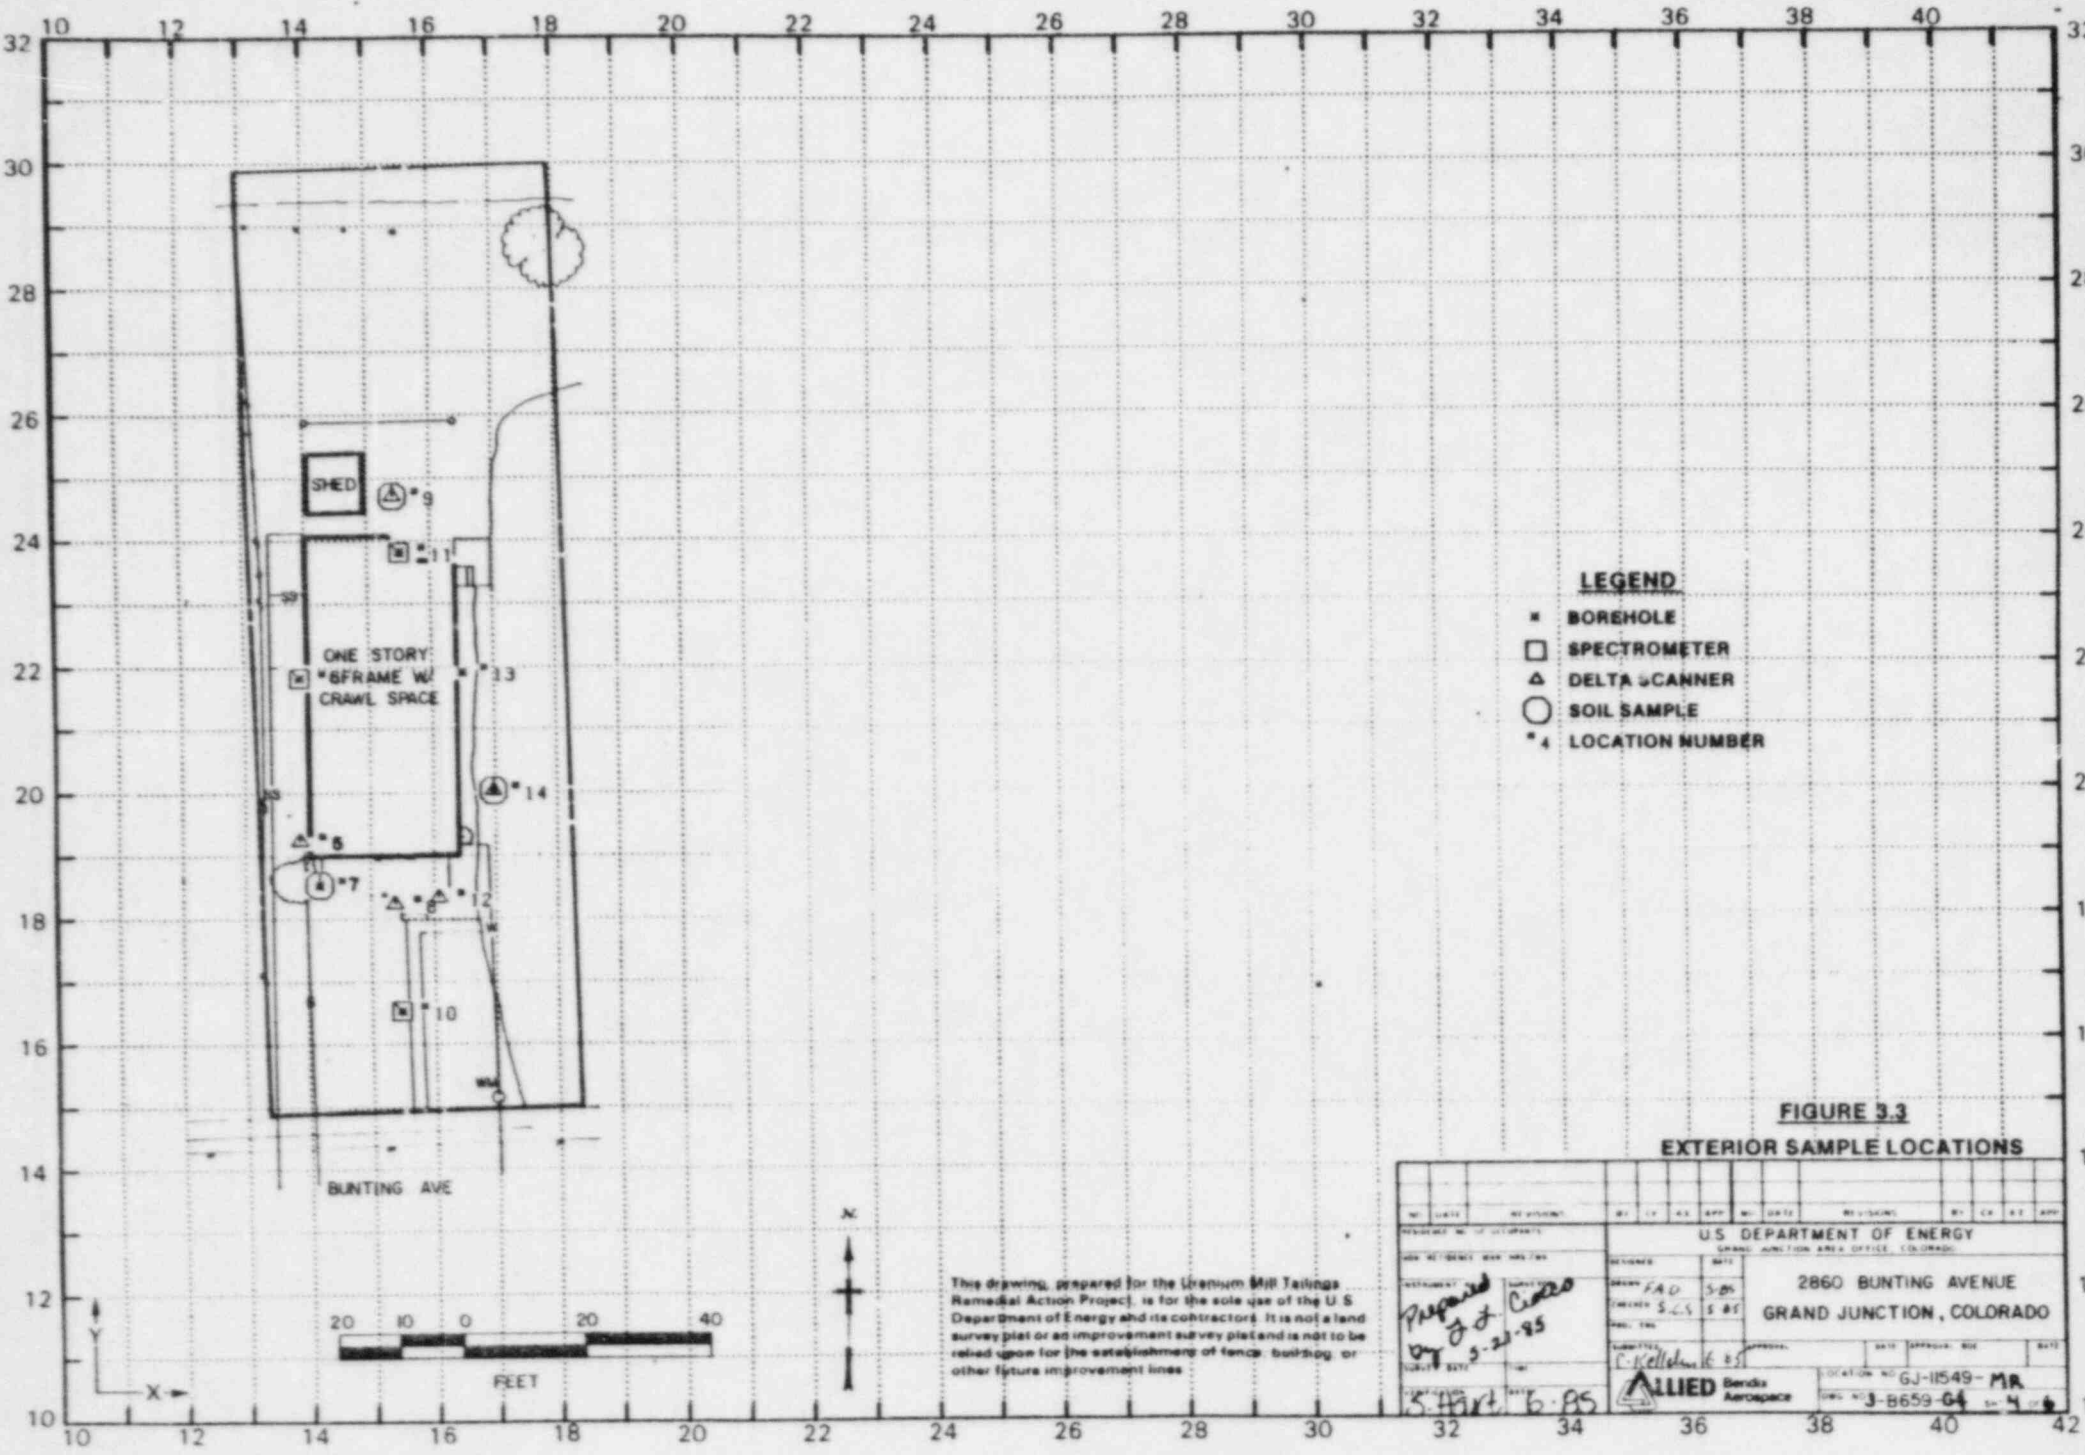
FIGURE 3.3
EXTERIOR SAMPLE LOCATIONS

Areas which displayed elevated gamma levels were further investigated; these areas are shown in Appendix Figures 3.2a and 3.3. Data from these investigations are included in Appendix Tables 3.1 and 3.2.

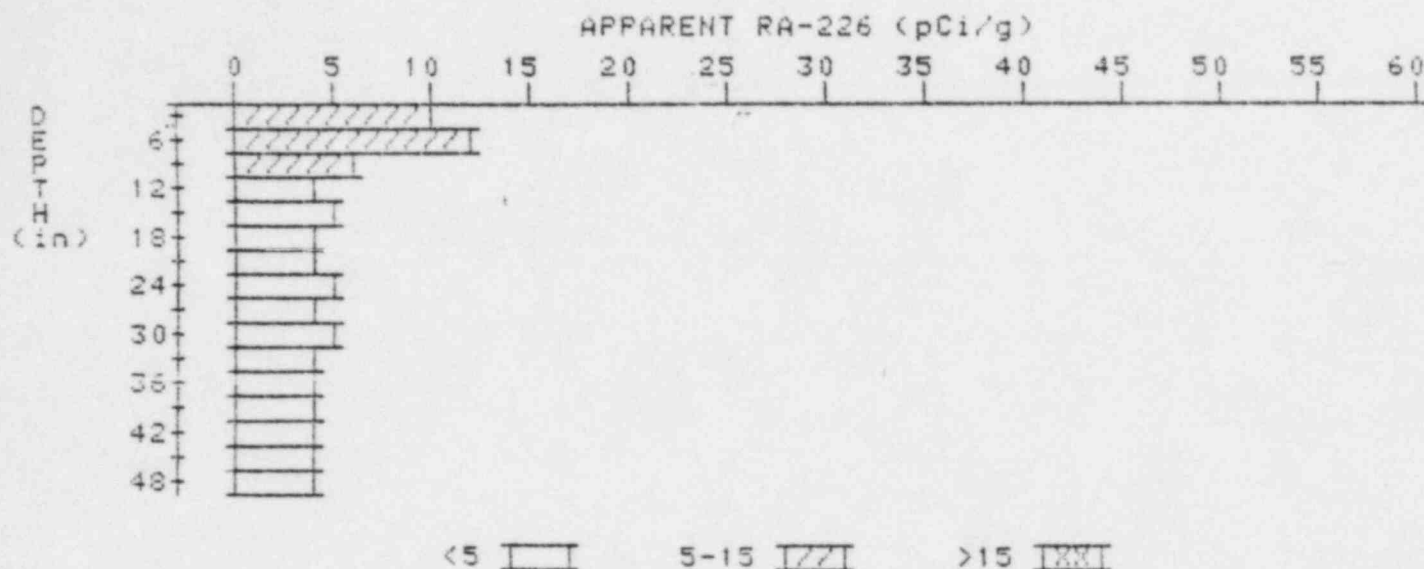
APPARENT RADIUM-226 CONCENTRATION 10 DECONVOLUTION GRAPH

12	BH	5.9	3.9	*	DC = 12 inches
		15	TC	5.2		*	Based on the
		18	TC	4.8		*	deconvolution graph

Depth (in)	Apparent Radium-226 (pCi/g) Undeconvolved	Apparent Radium-226 (pCi/g) Deconvolved
3	10.1	10.1
6	9.5	12.2
9	7.4	6.3
12	5.9	4.5
15	5.2	4.7
18	4.8	4.4
21	4.6	4.4
24	4.5	4.5
27	4.4	4.2
30	4.4	4.6
33	4.3	4.1
36	4.3	4.3
39	4.3	4.5
42	4.2	4.2
45		4.1
48	4.0	4.0
