RADIOLOGIC AND ENGINEERING ASSESSMENT

DOE ID NO.: GJ-01007-RS
ADDRESS: 2512 TEXAS AVENUE

AUGUST 1985

BENDIX FIELD ENGINEERING CORPORATION
F.O. Box 1569
Grand Junction, Colorado 81502

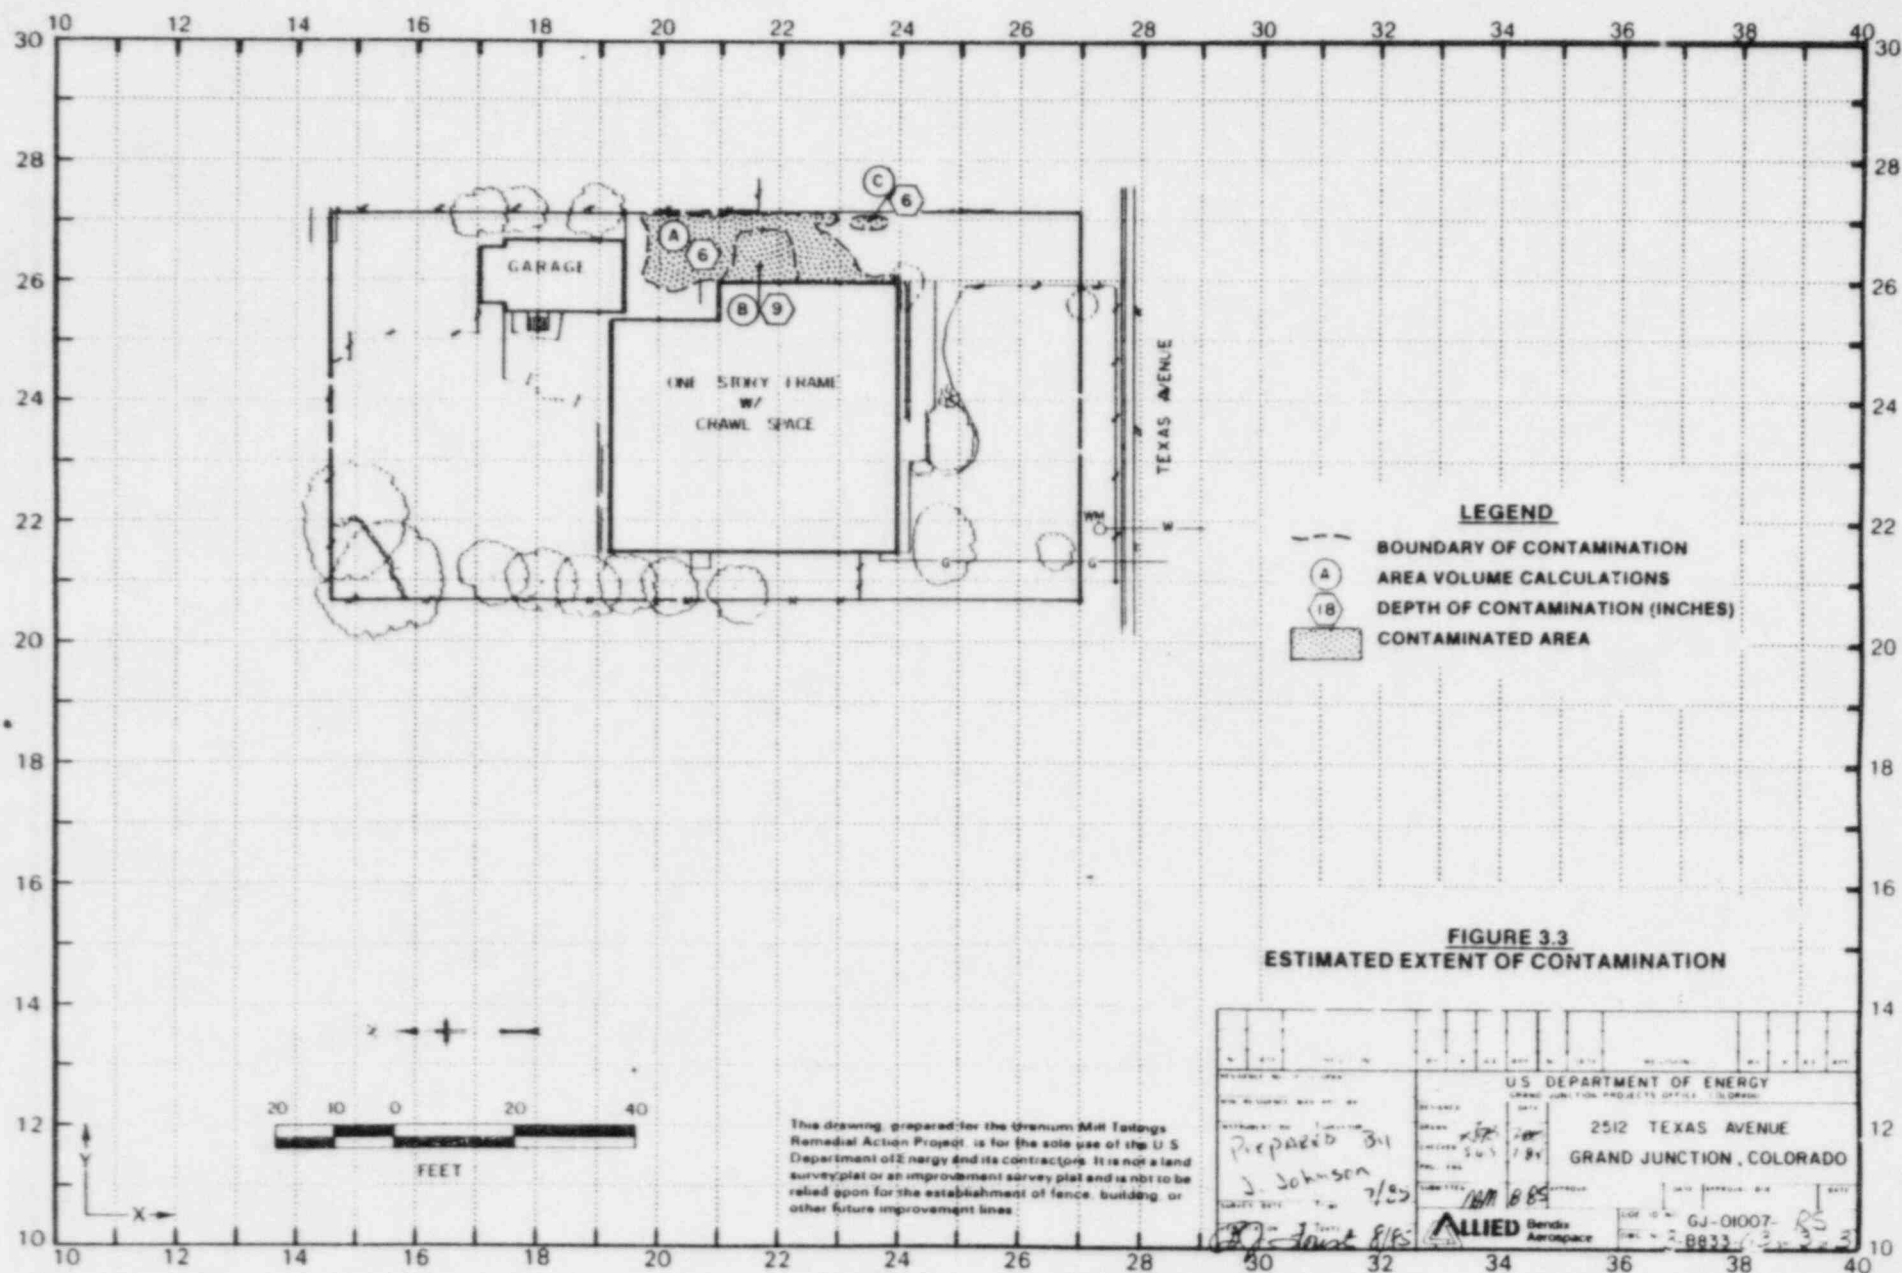
Appendix Figure 3.3 shows identified areas and estimated depths of contamination on this property, based on assessments of all measurements taken. As noted in this figure, areas recommended for remedial action that contain identified residual radioactive materials are:

- (Area A) Surface Material: Gravel and soil
Direction From Primary Structure: East
Other Directions: South of the garage
Total Depth of Contamination: 6 inches
Approximate Square Footage: 283
- (Area B) Surface Material: Gravel and soil
Direction From Primary Structure: East
Other Directions: Encircled by Area A
Total Depth of Contamination: 9 inches
Approximate Square Footage: 80
- (Area C) Surface Material: Gravel and soil
Direction From Primary Structure: East
Total Depth of Contamination: 6 inches
Approximate Square Footage: 10

The recommended remedial action for this property, DOE ID No. GJ-01007-RS, includes removal of all areas identified as containing radioactive material (as discussed in Section 3.5 and shown in Appendix Figure 3.3) and transport of removed material to the disposal site.

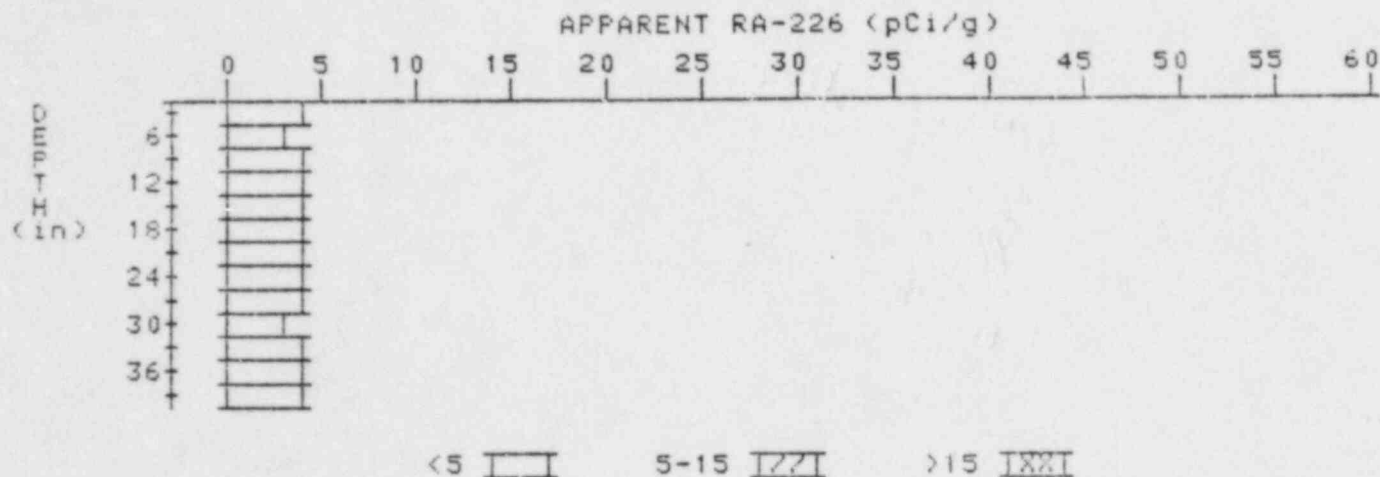
7

LOCATION: 205263

Depth (in)	Apparent Radium-226 (pCi/g) Undeconvolved	Apparent Radium-226 (pCi/g) Deconvolved
3	3.9	3.9
6	3.8	3.4
9	3.9	3.9
12	4.0	4.4
15	3.9	3.9
18	3.8	3.8
21	3.7	3.5
24	3.7	3.7
27	3.7	3.9
30	3.6	3.4
33	3.6	3.6
36	3.6	3.6
39	3.6	3.6

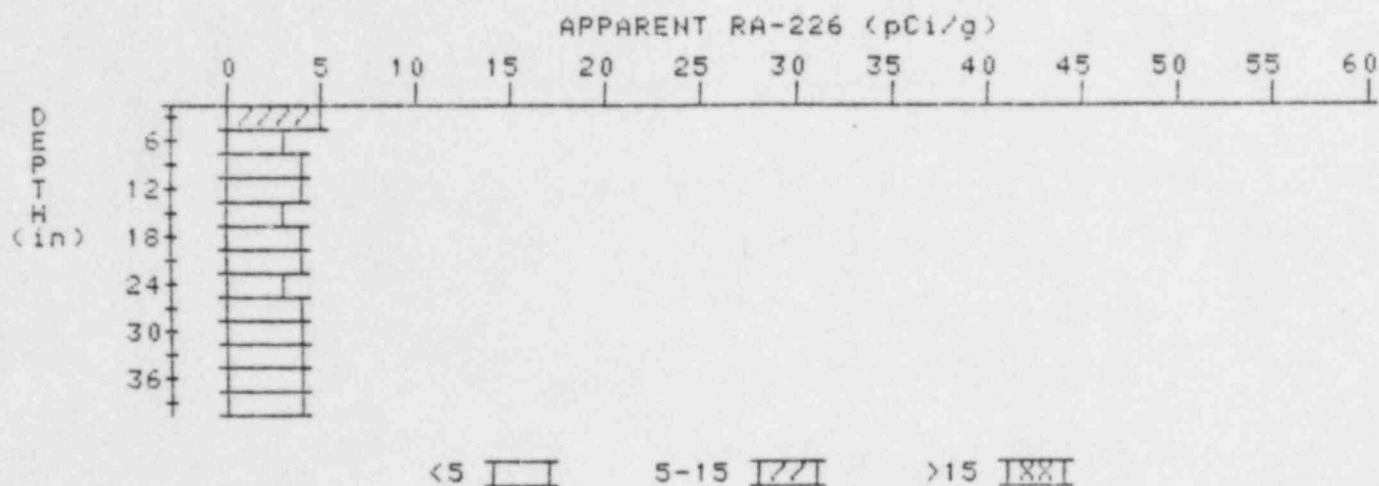
PROPERTY NUMBER: GJ-01007-RS
HOLE NUMBER: 8
LOCATION: 206267

Depth (in)	Apparent Radium-226 (pCi/g) Undeconvolved	Apparent Radium-226 (pCi/g) Deconvolved
3	5.2	5.2
6	4.3	3.2
9	4.0	3.8
12	3.8	3.6
15	3.7	3.3
18	3.8	4.0
21	3.8	4.0
24	3.7	3.3
27	3.8	4.0
30	3.8	3.8
33	3.8	4.0
36	3.7	3.5
39	3.7	3.7

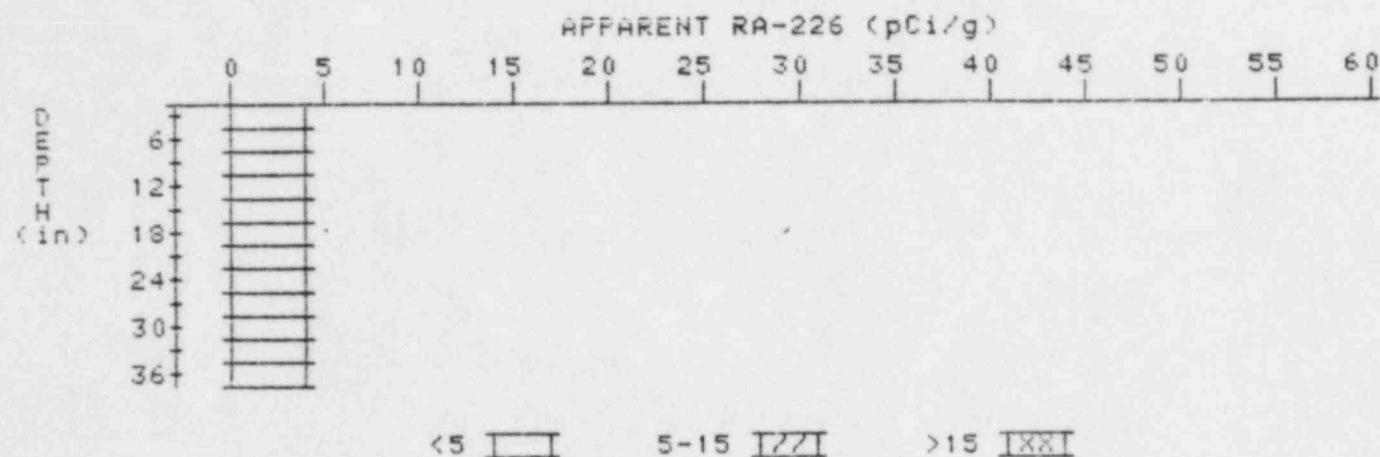
LOCATION: 210270

Depth (in)	Apparent Radium-226 (pCi/g) Undeconvolved	Apparent Radium-226 (pCi/g) Deconvolved
3	3.9	3.9
6	3.8	3.6
9	3.8	4.0
12	3.7	3.5
15	3.7	3.7
18	3.7	3.7
21	3.7	3.7
24	3.7	3.7
27	3.7	3.7
30	3.7	3.7
33	3.7	3.7
36	3.7	3.7

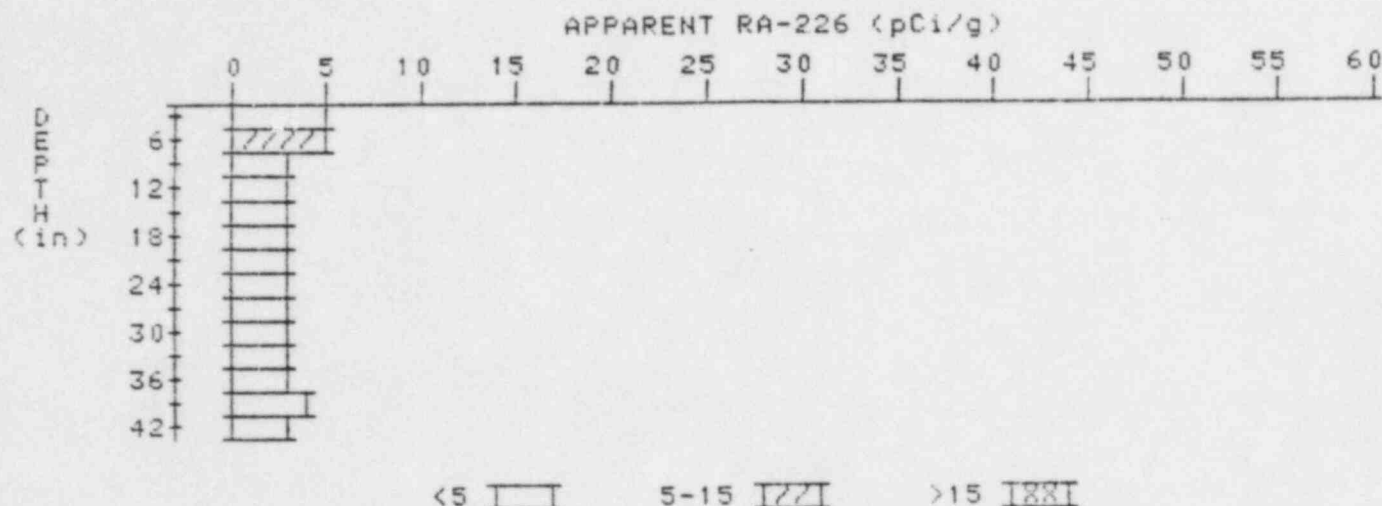
APPARENT RADIUM-226 CONCENTRATION DECONVOLUTION GRAPH 10

PROPERTY NUMBER: GJ-01007-RS
HOLE NUMBER: 10
LOCATION: 217265

Depth (in)	Apparent Radium-226 (pCi/g) Undeconvolved	Apparent Radium-226 (pCi/g) Deconvolved
3	4.7	4.7
6	4.5	5.4
9	3.8	3.3
12	3.4	3.0
15	3.2	3.0
18	3.1	3.1
21	3.0	2.6
24	3.1	3.1
27	3.2	3.4
30	3.2	3.2
33	3.2	3.2
36	3.2	3.0
39	3.3	3.7
42	3.2	3.2

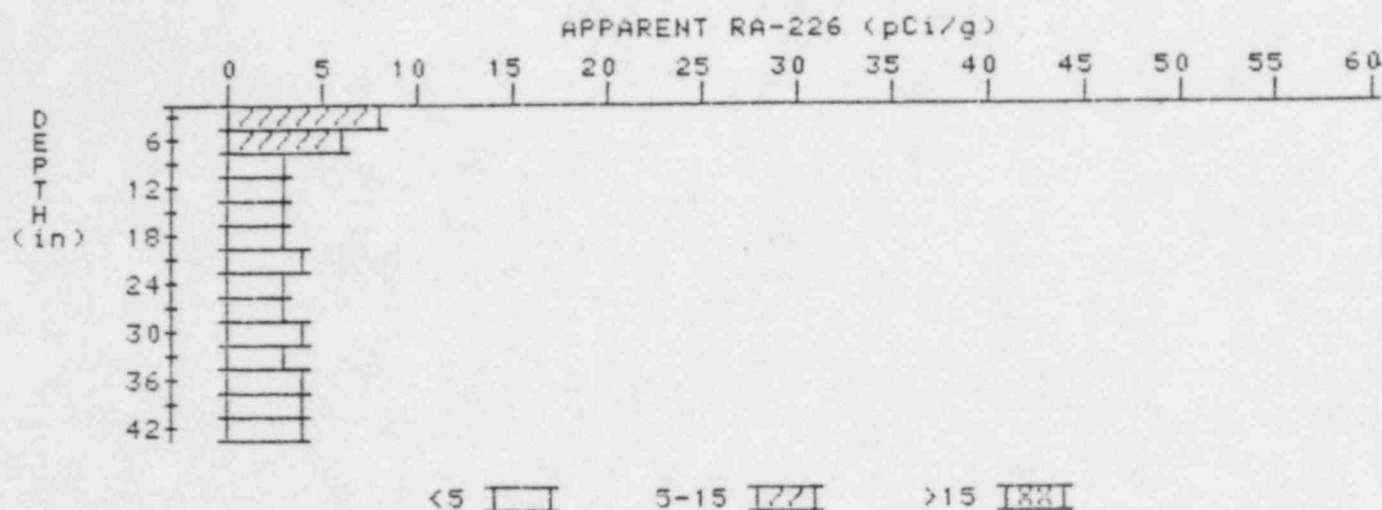
PROPERTY NUMBER: GJ-01007-RS
HOLE NUMBER: 12
LOCATION: 220260

Depth (in)	Apparent Radium-226 (pCi/g) Undeconvolved	Apparent Radium-226 (pCi/g) Deconvolved
3	7.7	7.7
6	6.2	6.2
9	4.7	3.3
12	4.0	3.5
15	3.6	3.1
18	3.5	3.3
21	3.5	3.7
24	3.4	3.4
27	3.3	2.9
30	3.4	3.6
33	3.4	3.2
36	3.5	3.7
39	3.5	3.5
42	3.5	3.5
