DUKE POWER

Subject: Catawba Nuclear Station
Docket No. 50-414
LER 414/96-005

LICENSEE EVENT REPORT (LER)

Unit 2 Standby Shutdown System potentially outside design basis

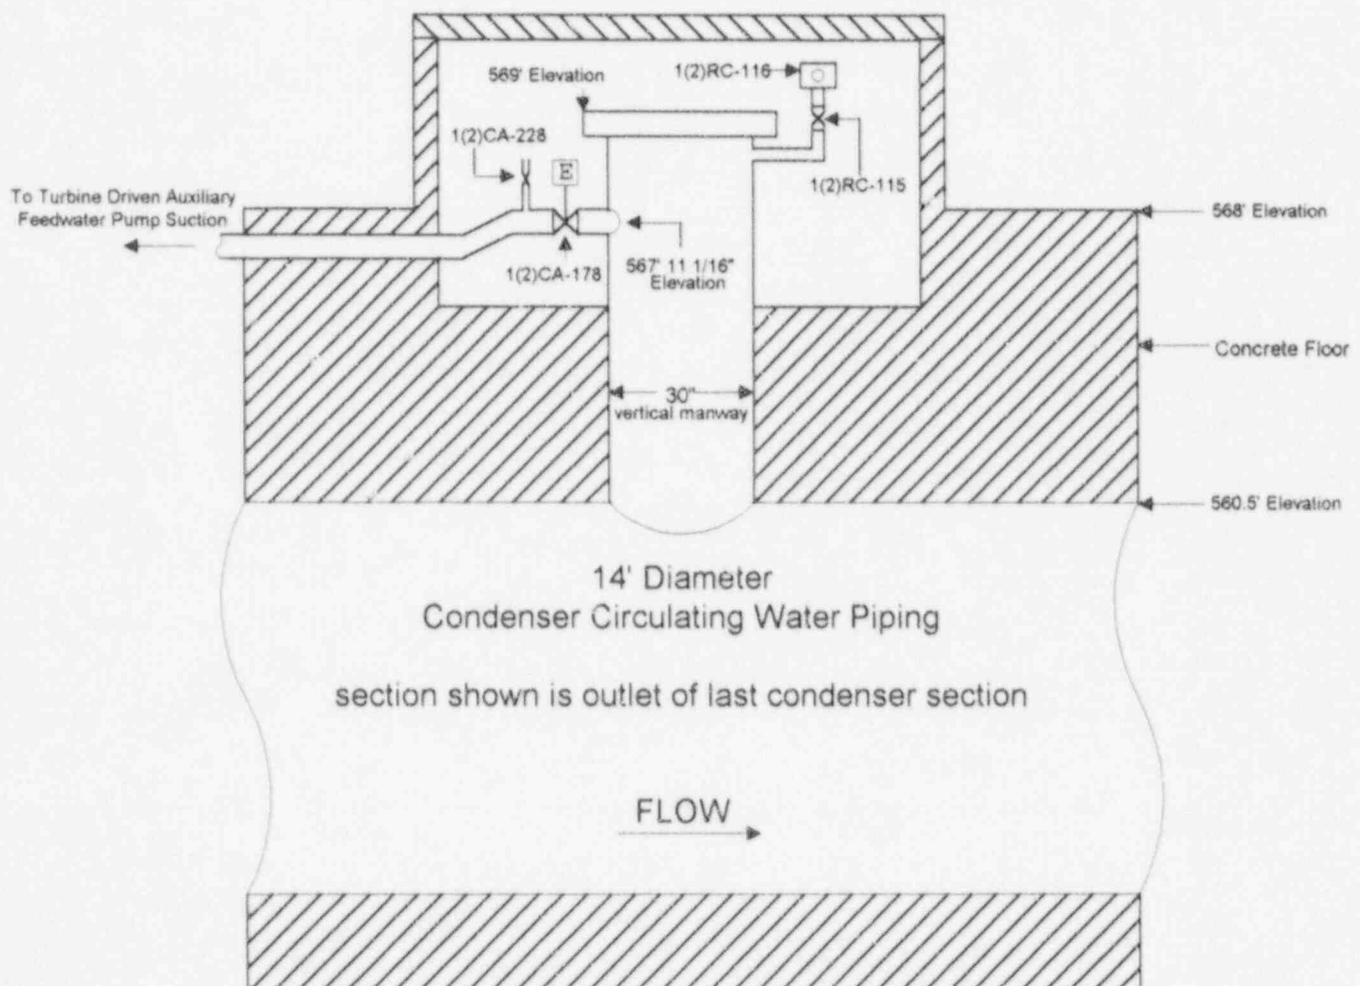
ATTACHMENT 1**GENERAL ARRANGEMENT**

The CA system is connected to the RC system about 1 foot from the top of a 5 foot vertical manway used to access the main RC piping leaving the main condenser [EIIS:COND] during drained maintenance. To ensure that the RC to CA piping is filled during RC system gravity fill from a drained condition, an automatic vent valve [EIIS:VTV] is provided at a high point above the CA system connection to the RC system. The connection of the CA system to the RC system is in an enclosed, secured, "vital area" in the lowest elevation of the unit's Turbine Building. The automatic venting design of the vent valve precludes the necessity for having to enter the sealed "vital area" for system venting. (See ATTACHMENT 1, GENERAL ARRANGEMENT)

On July 10, 1996, Site Engineering discovered that 2RC-116, the self-contained, mechanical, float type, vent valve in the RC system, was stuck in the closed position by impacted mud and corrosion, internal to the valve. This prevented the float from operating freely. Since it could not be repaired, 2RC-116 was replaced with a new valve on the day of discovery. 1RC-116, the corresponding unit 1 valve, was examined and found to be functioning properly.

Because of the vent valve failure, air was trapped at the high point of the manway where the vent valve was installed. The vent valve was isolated, removed, and the as found water level in the manway was above the point of connection of the CA system piping. Therefore the nonsafety grade, noncondensate quality water supply required for SG inventory maintenance during SSS operation was assured at the time of discovery.

- 1) 2RC-116 was replaced with a new valve under corrective work order number 96054693.
- 2) 1RC-116 was determined to be operable based on its proper operation.

- 1) Valves 1RC-116 and 2RC-116 have been included in a planned preventative maintenance schedule.
- 2) Valves 1RC-116 and 2RC-116 have been listed as components required for Standby Shutdown System OPERABILITY.
