November 27, 1996
LIC-96-0175

Subject: Licensee Event Report 96-011 Revision 0 for the Fort Calhoun Station

TITLE (4) <div style="text-align: center;">Loss of Containment Closure Due to a Maintenance Activity During Refueling</div>											
EVENT DATE (5)			LER NUMBER (6)			REPORT DATE (7)			OTHER FACILITIES INVOLVED (8)		
MONTH	DAY	YEAR	YEAR	SEQUENTIAL NUMBER	REVISION NUMBER	MONTH	DAY	YEAR	FACILITY NAME	DOCKET NUMBER	
10	30	96	96	-- 011	-- 00	11	27	96	FACILITY NAME	DOCKET NUMBER	
										05000	
										05000	
OPERATING MODE (9)		5	THIS REPORT IS SUBMITTED PURSUANT TO THE REQUIREMENTS OF 10 CFR (Check one or more) (11)								
POWER LEVEL (10)		0	20.2201(b)		20.2203(a)(2)(v)		<input checked="" type="checkbox"/>		50.73(a)(2)(i)	50.73(a)(2)(viii)

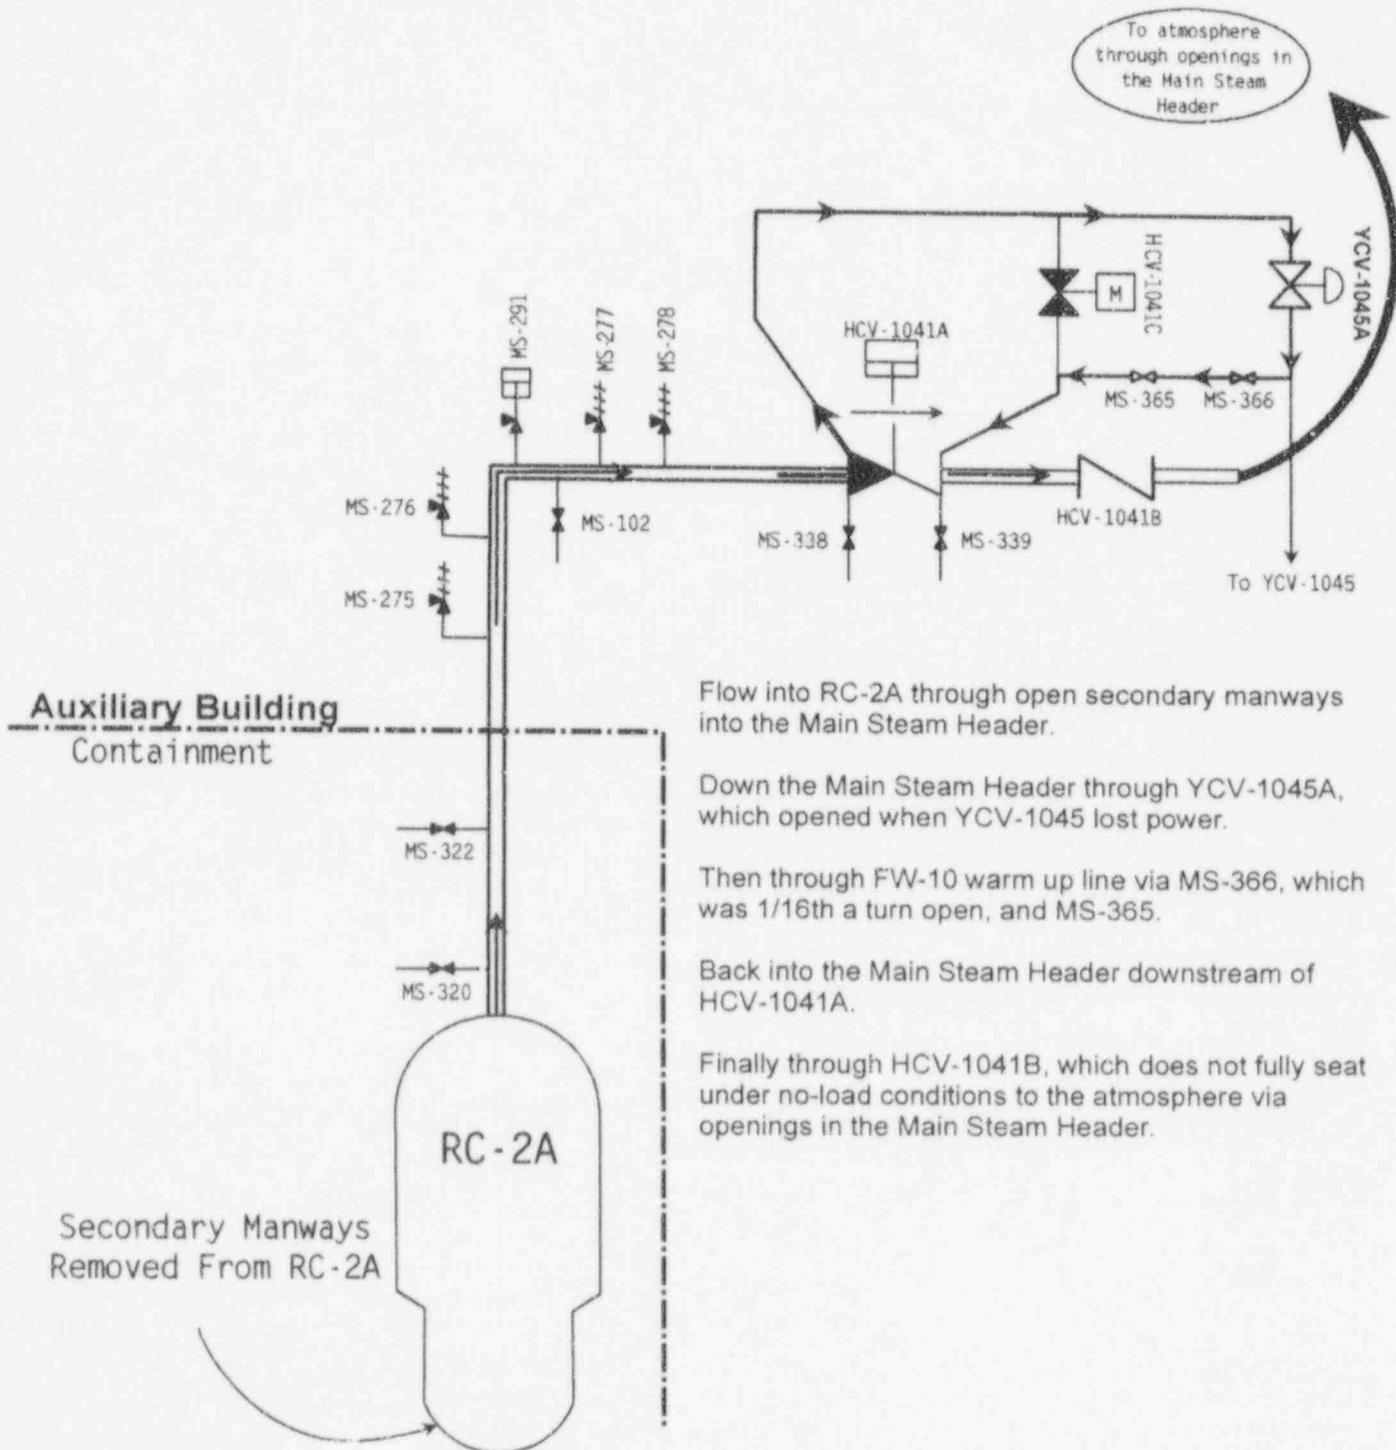
Figure 1

Each of the two steam supply lines for FW-10 is connected to the MS bypass lines through two 1/2 inch valves, one (MS-365 for the 'A' steam line) is an isolation valve and the other (MS-366 for the 'A' steam line) is a throttle valve. A check of the valves in this warm up line showed MS-365 open and MS-366 one-sixteenth (1/16) of a turn open. This provided a path from containment, through RC-2A, down the MS line, through YCV-1045A, back through MS-366 and MS-365 to the MS line downstream of MS-1041A to atmosphere through other openings in the MS header. (See Figure 1.) During the time that this condition existed, two fuel assemblies were loaded into the core.

Flow into RC-2A through open secondary manways into the Main Steam Header.

Down the Main Steam Header through YCV-1045A, which opened when YCV-1045 lost power.

Then through FW-10 warm up line via MS-366, which was 1/16th a turn open, and MS-365.

Back into the Main Steam Header downstream of HCV-1041A.

Finally through HCV-1041B, which does not fully seat under no-load conditions to the atmosphere via openings in the Main Steam Header.
