## LICENSEE EVENT REPORT (LER)

FACILITY NAME (1) Kewaunee Nuclear Power Plant DOCKET NUMBER (2) 0 5 0 0 0 3 0 5 1 OF 0 3

Manual Reactor Trip Due To Rupture of Steam Vent Line

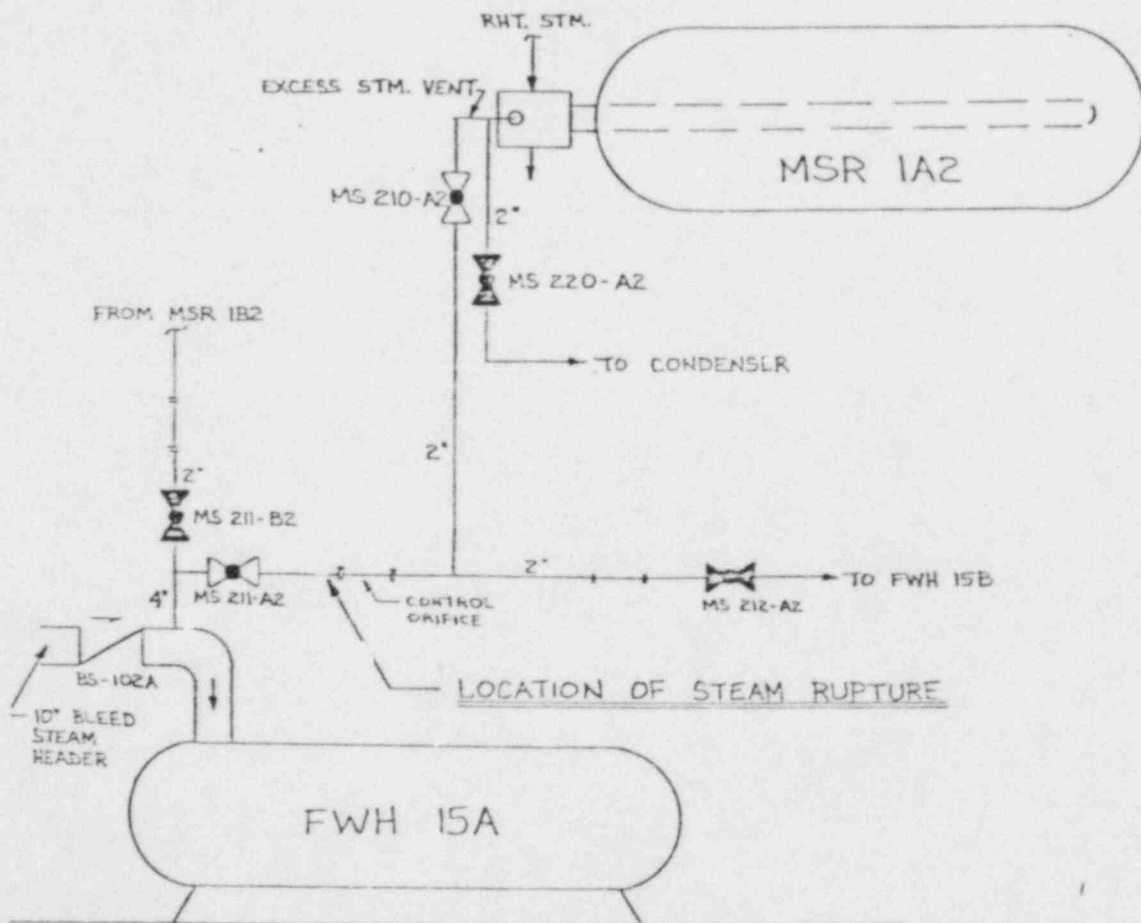
On August 8, 1985 at 0032 a manual reactor trip from 73% power was required in order to isolate the ruptured excess steam vent line from the 1A2 moisture separator reheater [MSR] (SB) to the 15A high pressure feedwater heater (SN). The vent line ruptured at approximately 0025 during the performance of the monthly turbine stop and governor valve operability test. A power reduction was started at 0026, but due to the amount of steam leakage and personnel safety hazard, the plant was manually tripped. See the attached sketch for exact location of the vent line rupture.

At 0058 Operations was able to isolate the ruptured section and maintenance personnel were called in to begin repair work. The ruptured line as well as three other vent lines that serve as at power excess steam vents from the MRSS to the feedwater heaters were replaced. The cause of the ruptured steam line is attributed to erosion of the carbon steel piping.

In December of 1982 a steam leak on a bleed steam line resulted in a manual reactor trip. Following this event in 1982 an extensive program was undertaken during the refueling outages to ultrasonically test secondary plant steam piping for tube wall thinning and replace degraded sections. Plans are to continue with this program.
