## B.14 LER Number 270/92-004, 269/92-011, 269/92-014, 269/92-016, 269/92-019, and 269/93-001

Event Description: Loss of Offsite Power With Failed Emergency Power

Date of Event: October 19, 1992

Plant: Oconee 2

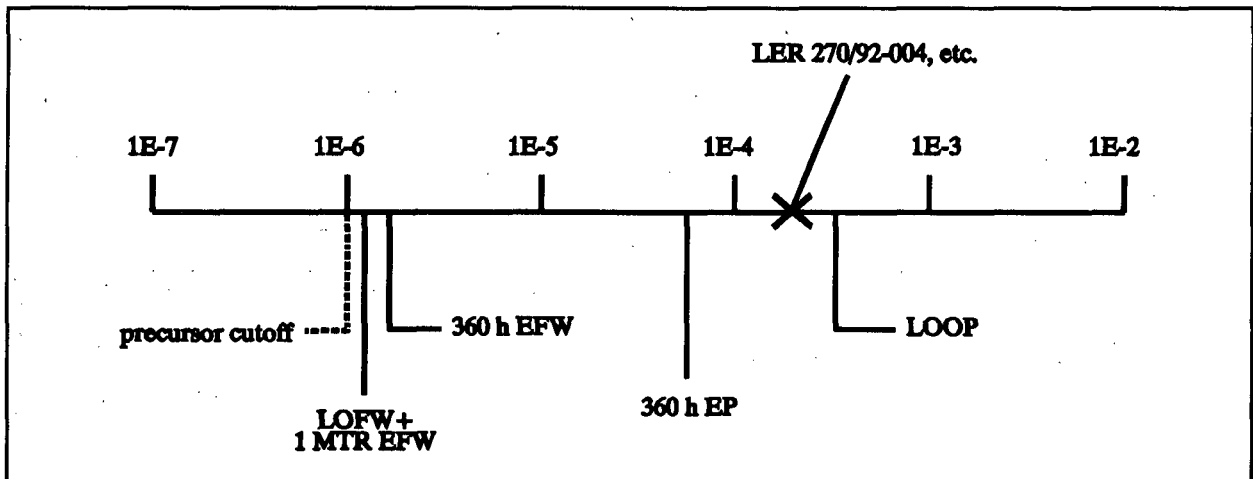
The conditional core damage probability estimated for this event is  $2.1 \times 10^{-4}$ . The relative significance of this event compared to other postulated events at Oconee is shown below in Fig. B.22.

Fig. B.22. Relative event significance of LER 270/92-004, etc., compared with other potential events at Oconee.

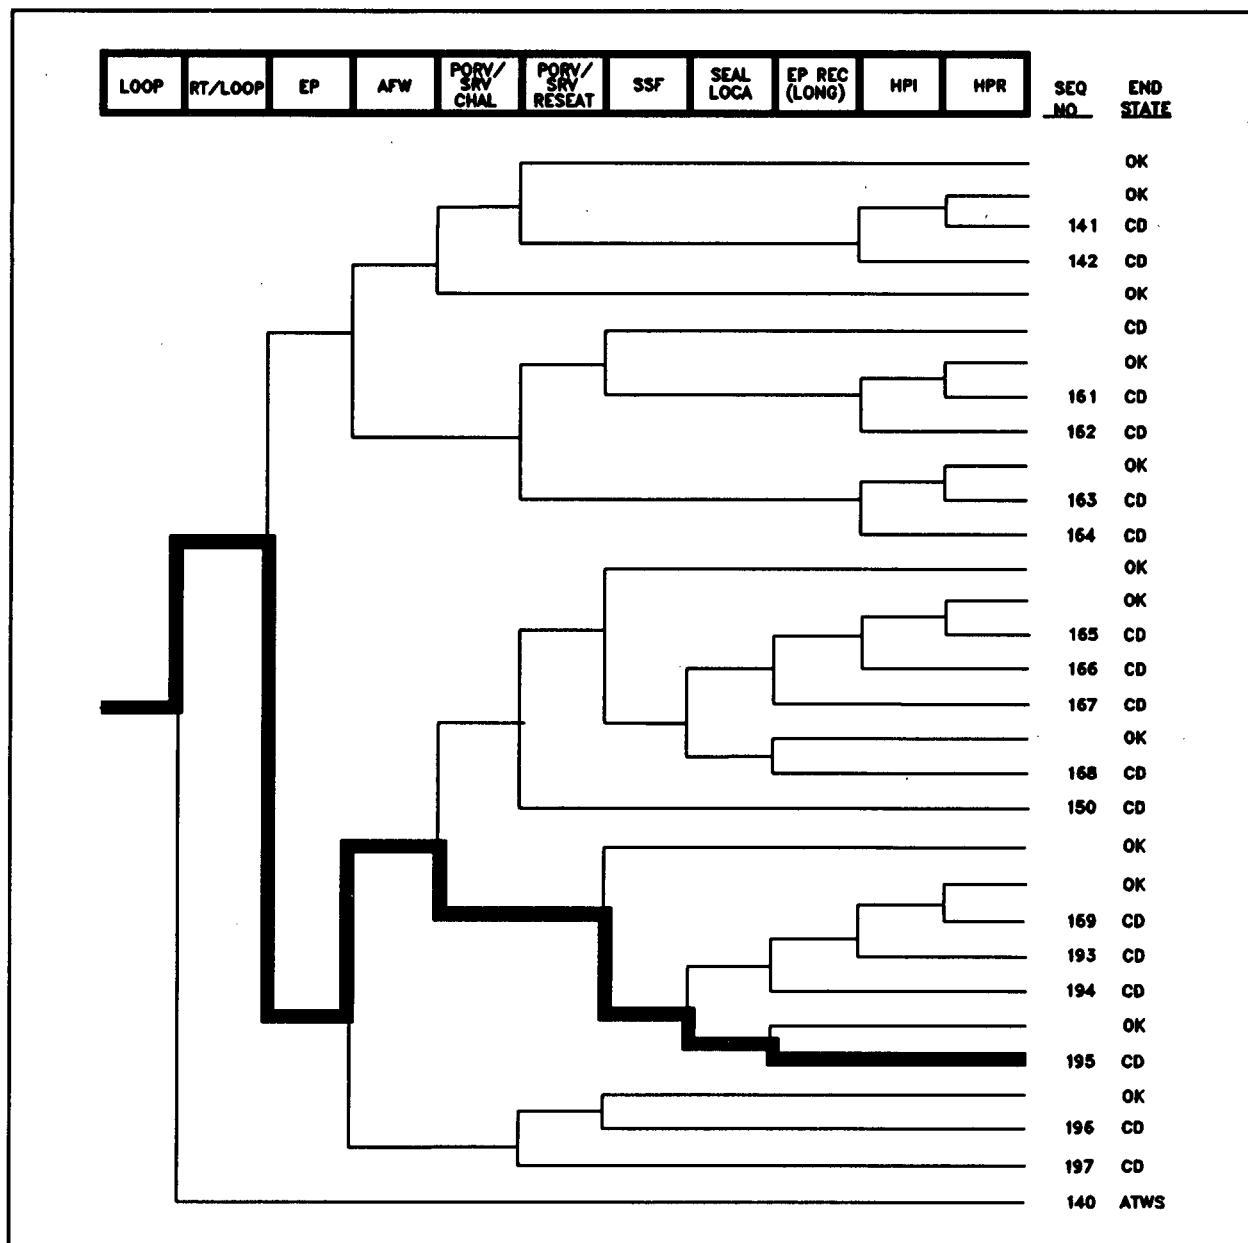
The conditional core damage probability estimated for the event is  $2.1 \times 10^{-4}$ . The dominant core damage sequence, highlighted on the event tree in Fig. B.26, involves the observed LOOP with failure to recover emergency power, failure to utilize the SSF for RCS and SG makeup, and failure to recover ac power before battery depletion.

Fig. B.26. Dominant core damage sequences for LER 270/92-004
