ACCIDENT SEQUENCE PRECURSOR PROGRAM EVENT ANALYSIS

LER Number: 293/90-013
 Event Description: Scram with RCIC failure; feedwater, HPCI, and RHR problems
 Event Date: September 2, 1990
 Plant: Pilgrim

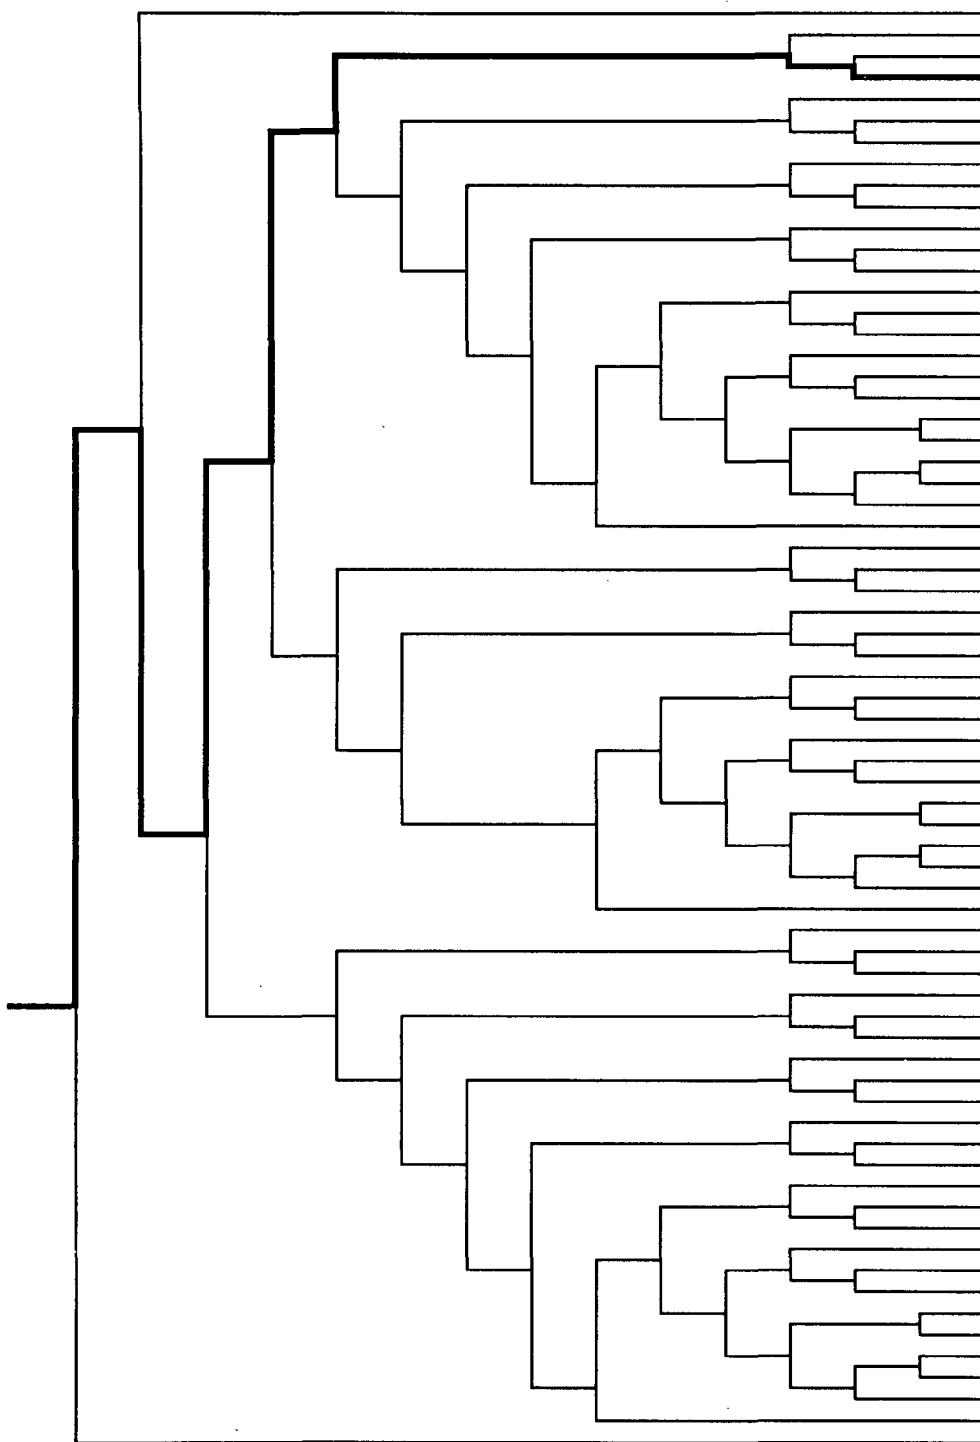
The conditional probability of severe core damage for this event is 8.4×10^{-5} . The dominant sequence for the event involves unavailability of the power conversion system, successful short-term core cooling, and failure to remove heat using RHR and suppression pool cooling in the long term. The dominant sequence for this event is highlighted on the following event tree.

Dominant core damage sequence for LER 293/90-013
