## ACCIDENT SEQUENCE PRECURSOR PROGRAM EVENT ANALYSIS

LER No.: 293/91-024, 293/91-006, 293/91-021, 293/91-025  
 Event Description: Loss of offsite power and RCIC trip  
 Date of Event: October 30, 1991  
 Plant: Pilgrim

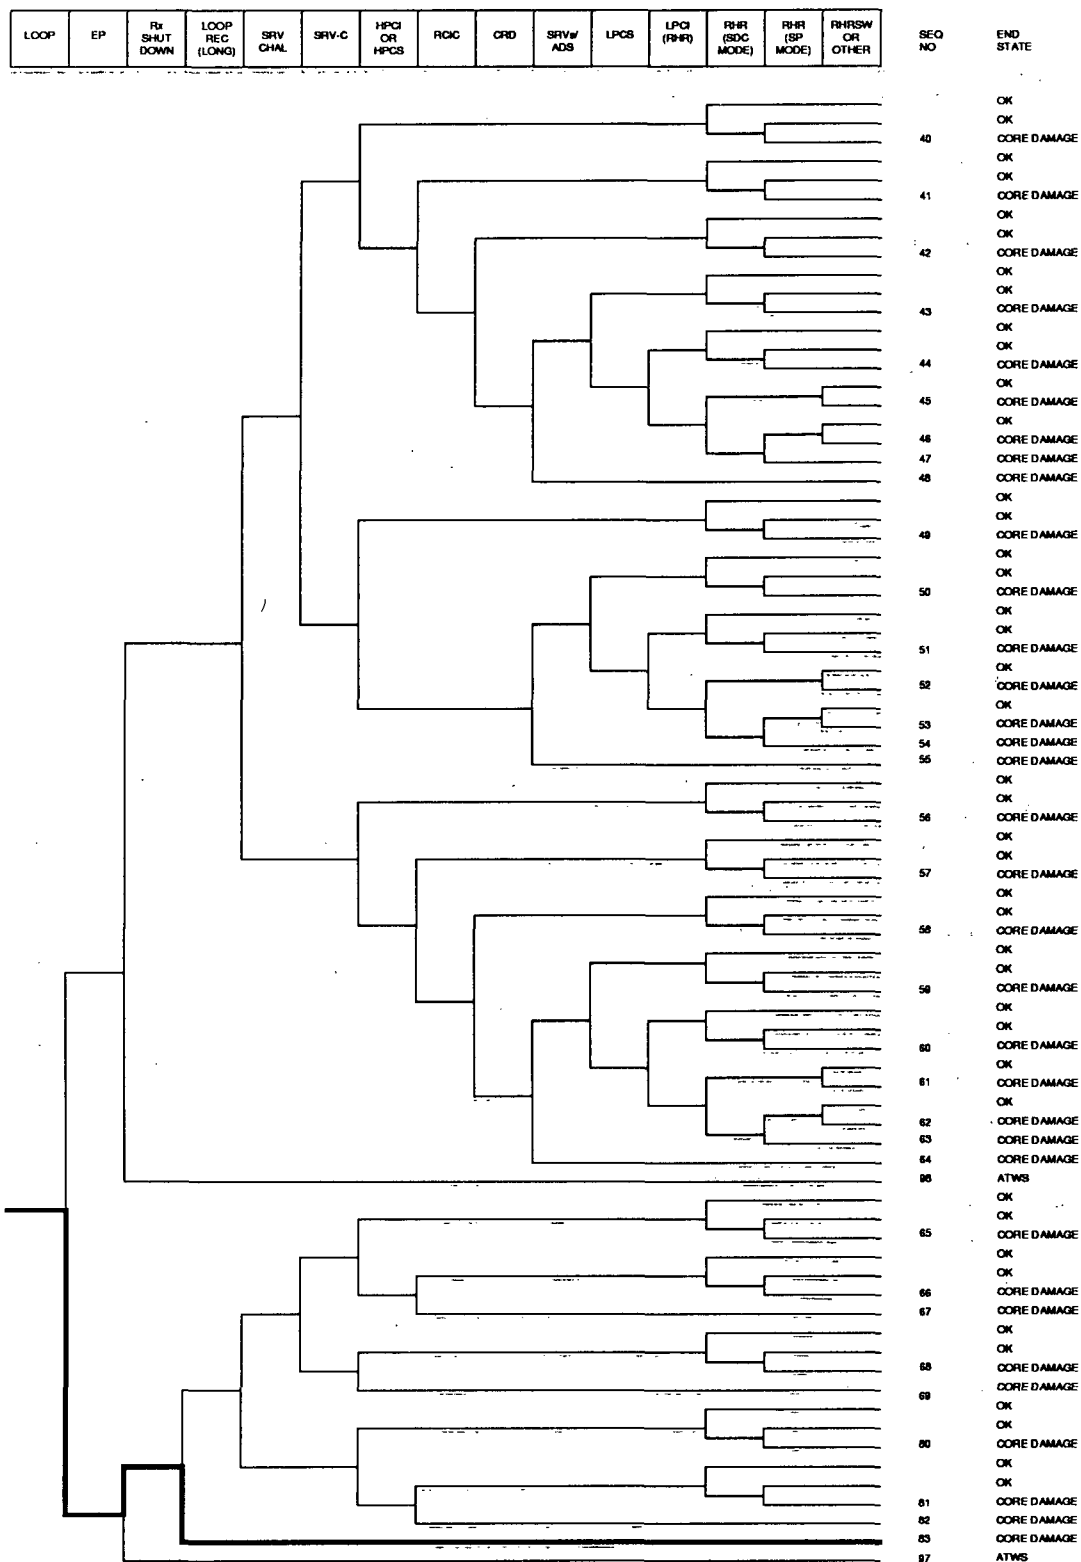
### Dominant core damage sequence for LER 293/91-024

The conditional core damage probability estimated for the event is  $1.2 \times 10^{-4}$ . The dominant sequence, highlighted on the following event tree, involves a LOOP with failure of emergency power and failure to recover AC power prior to battery depletion. The recoverable unavailability of RCIC did not significantly contribute to the core damage probability associated with the event.
