KANSAS GAS AND ELECTRIC COMPANY

KMLNRC 85-196
Re: Docket No. 50-482
Ref: KMLNRC 85-195 dated 08/09/85
from G.L. Koester, KG&E, to R.P. Denise, NRC
Subj: Cutler-Hammer Type E30 Pushbutton Switches

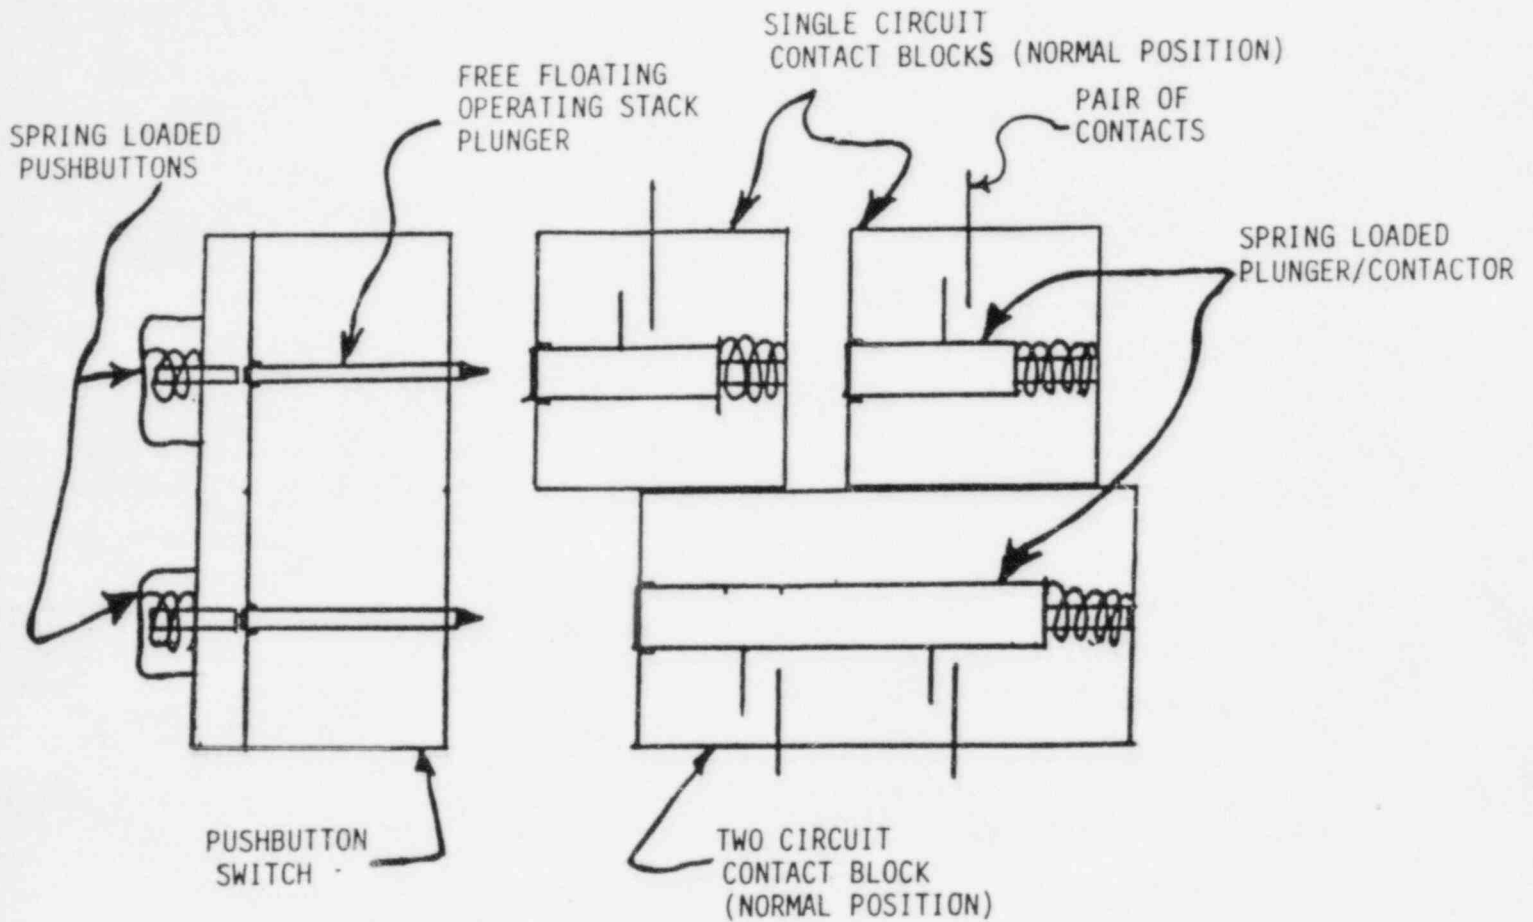
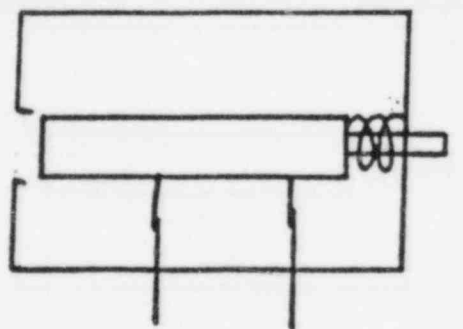
plungers. Each single circuit contact block contains a pair of contact terminals and rectangular spring return plunger/contacter which is moved by the stack operating plunger in the pushbutton switch (See Attachment). Two circuit contact blocks are identical to the single circuit contact blocks except a longer contact block and two pairs of contact terminals are provided. Two single circuit contact blocks can be utilized in place of a single two circuit contact block. The contact blocks are secured to the pushbutton switch with screws. Alignment pins are also provided to insure good contact block alignment with virtually no alignment "free play".

GG-HIS 44 was removed to facilitate in-depth examination and was replaced with a pushbutton switch assembly composed of single circuit contact blocks. Although not easily reproducible, the plunger/contacter of a two circuit contact block did at times remain in the extended position after its associated pushbutton was released. The affected contact block was removed from the pushbutton switch assembly and shipped to Cutler-Hammer for further evaluation. Preliminary investigation by Cutler-Hammer identified a piece of foreign material near the contacts which may have "bound" the plunger/contacter.

Subsequently GK-HIS 123 was removed and replaced with a pushbutton switch assembly composed of single circuit contact blocks. The "bound" plunger/contacter condition was repetitively duplicated on this hand indicating switch. The entire pushbutton switch assembly has been shipped to Cutler-Hammer for further evaluation.

TWO CIRCUIT CONTACT BLOCK (PLUNGER/CONTACTOR EXTENDED)
