LICENSEE EVENT REPORT (LER)

FACILITY NAME (1) Fort St. Vrain, Unit No. 1										DOCKET NUMBER (2) 0 5 0 0 0 2 6 7 1 OF 0 1 8									
TITLE (4) Automatic Actuation Of Basic Plant Protective System (PPS) Actions																			
EVENT DATE (5)			LER NUMBER (6)				REPORT DATE (7)			OTHER FACILITIES INVOLVED (8)									
MONTH	DAY	YEAR	YEAR	SEQUENTIAL NUMBER	REVISION NUMBER	MONTH	DAY	YEAR	FACILITY NAMES N/A					DOCKET NUMBER(S) 0 5 0 0 0					
0 7	2 0	8 5	8 5	0 1 0	0 0	0 8	1 9	8 5						0 5 0 0 0					
OPERATING MODE (9) N		THIS REPORT IS SUBMITTED PURSUANT TO THE REQUIREMENTS OF 10 CFR 5: (Check one or more of the following): (11)																	
POWER LEVEL (10) 0 1 0 1 0		20.402(b)				20.405(a)				<input checked="" type="checkbox"/> 50.73(a)(2)(iv)				73.71(b)

SUBJECT: Licensee Event Report
85-010, Final Report

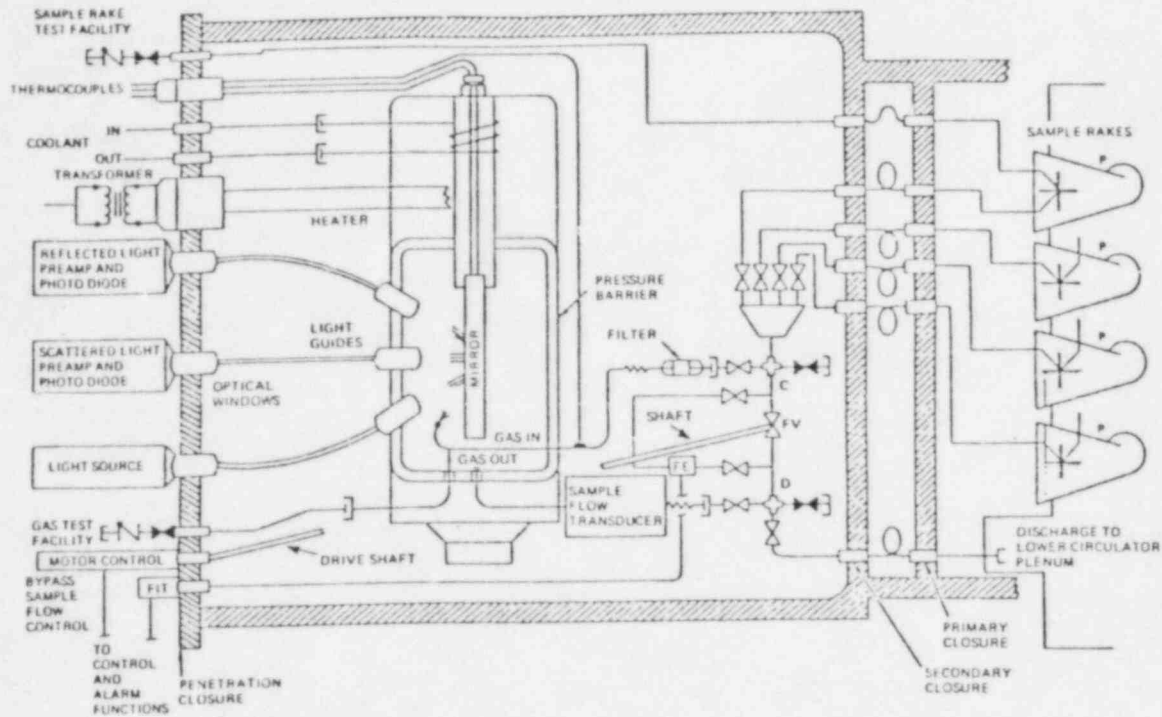
FIGURE 1

For a given helium pressure, there is a unique dew or frost point temperature corresponding to the moisture content of the helium. The moisture detector incorporates a mirror, light source, photocell, and means for controlling the mirror temperature (see Figure 1). The mirror is positioned so that the incident light from the bulb is reflected off the mirror to the photocell. If the mirror surface is highly reflective, the output signal of the photocell is maximum; when the dew or frost point temperature is reached, the output signal drops due to scattering and refraction from the dew or frost formed upon the mirror.

The detector mirror is cooled by circulating gaseous nitrogen (GN₂) through a heat exchanger extending to the mirror (see Figure 1). Mirror temperature is sensed by a thermocouple which is used by the mirror temperature controller. Fine mirror temperature control is achieved by automatically adjusting current through a heater which is an integral part of the mirror assembly. Coarse mirror temperature control is provided by a pressure differential controller which regulates GN₂ flow through the detector cooling coil to keep the heater current operating in a band around the midscale of the desired mirror temperature setting.
