St. Peter's Community Hospital

August 18, 1982

This is in reference to information requested for your evaluation of our
radiation survey report, reference control # 09893.

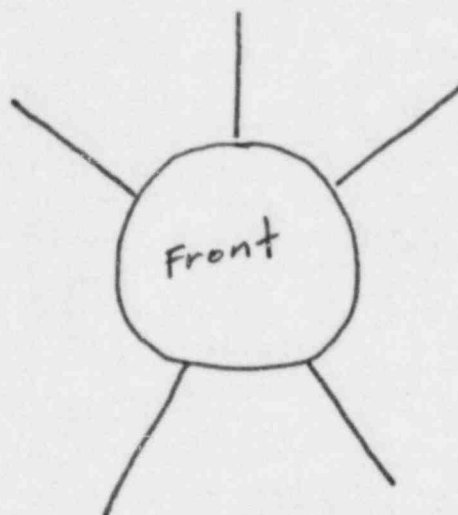
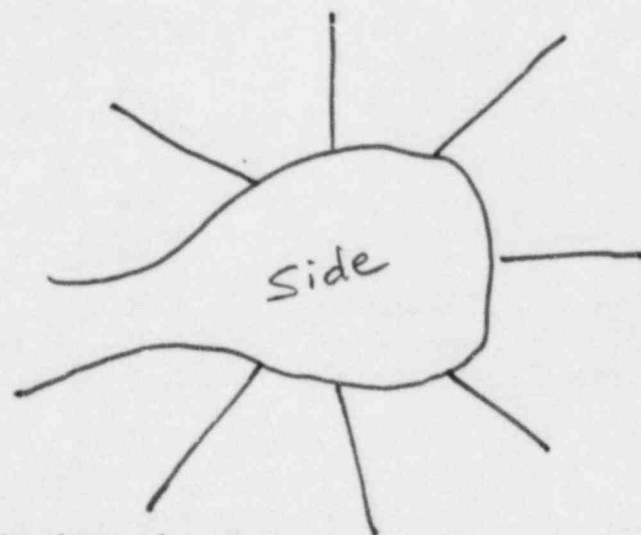
8.

The leakage measurements were taken in these planes.
